E-type engine removal

PART ONE: In the first of a two-part series, we follow the preparation work required prior to removing the engine and gearbox from an E-type

PART TWO: In the final instalment, we follow the 4.2-litre XK engine and manual gearbox being removed from a Series I E-type

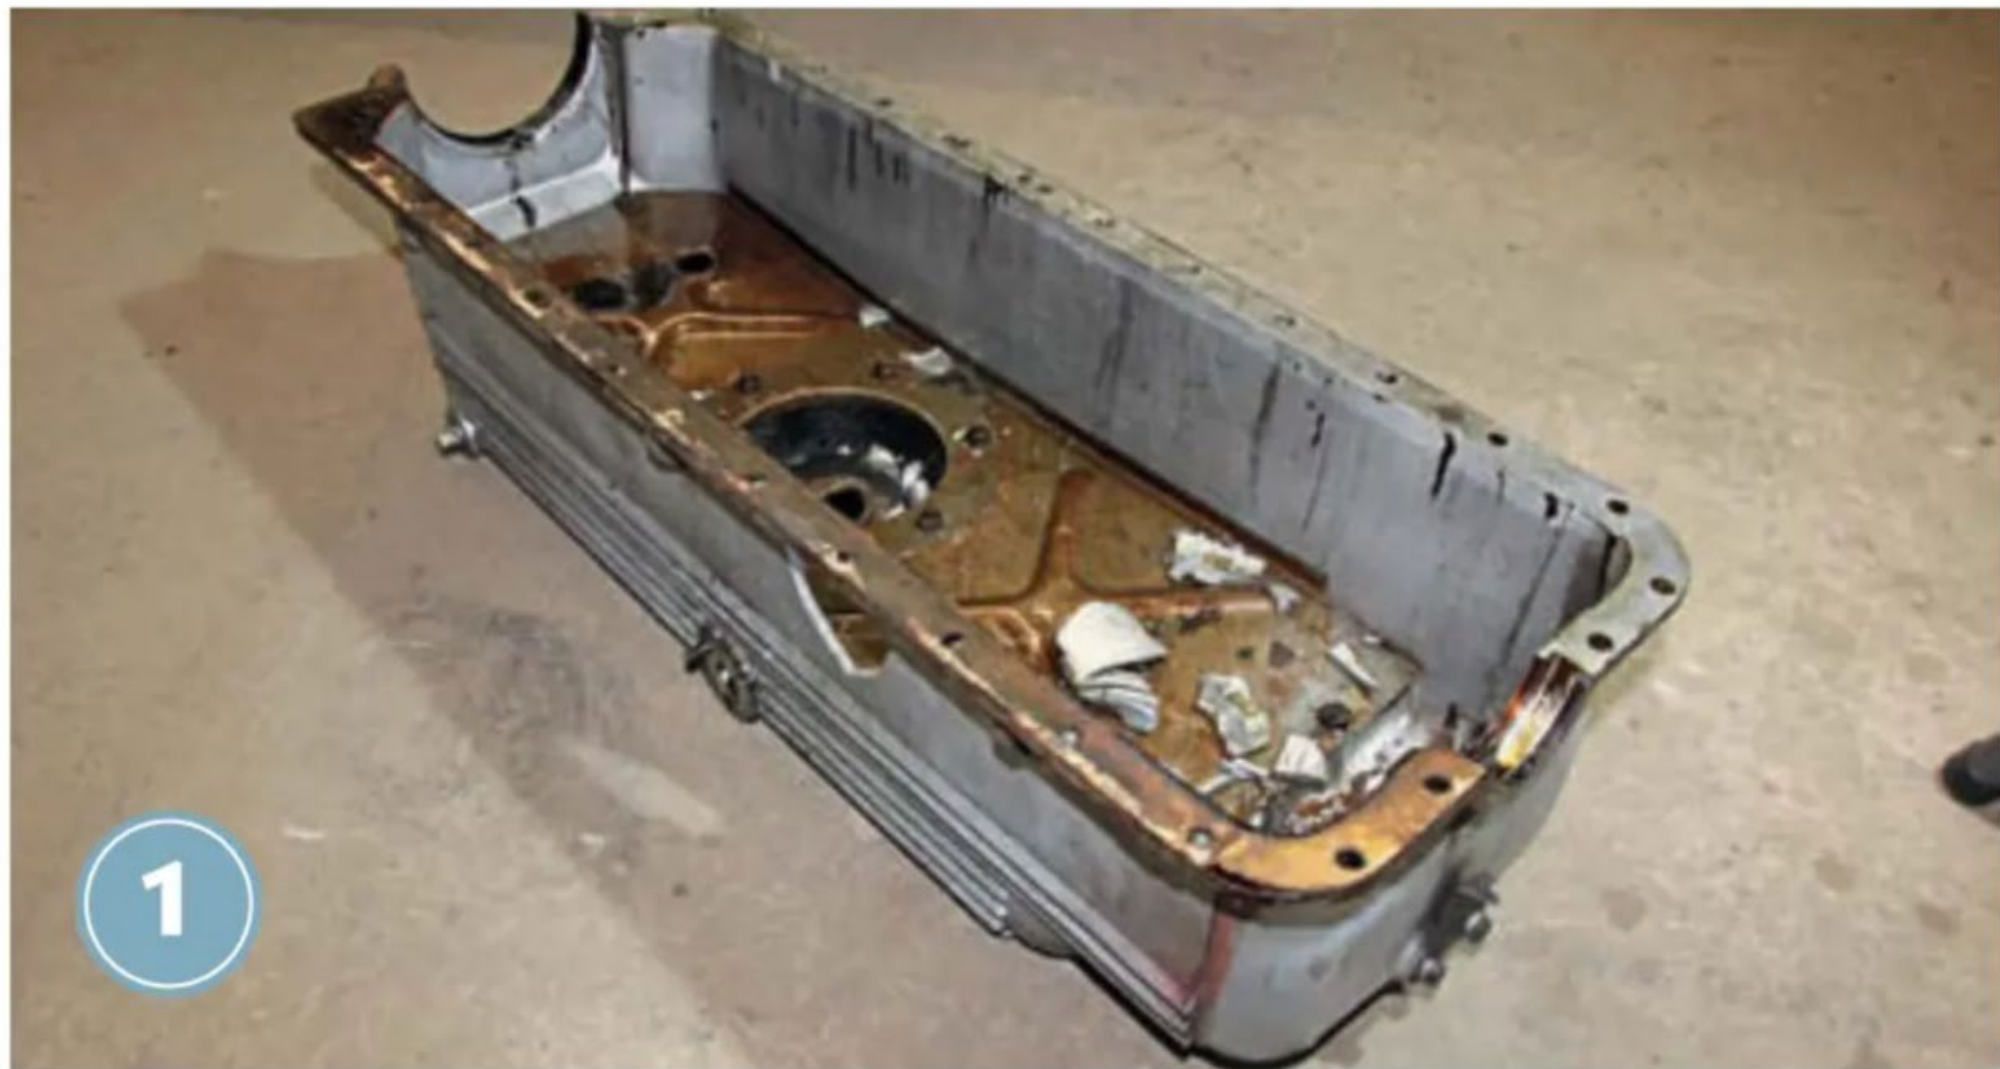
When we arrive at Ken Jenkins' workshop, the E-type is on the four-post lift and its sump has already been removed. It's hard to miss the hole in the side of it and the fragments of a piston

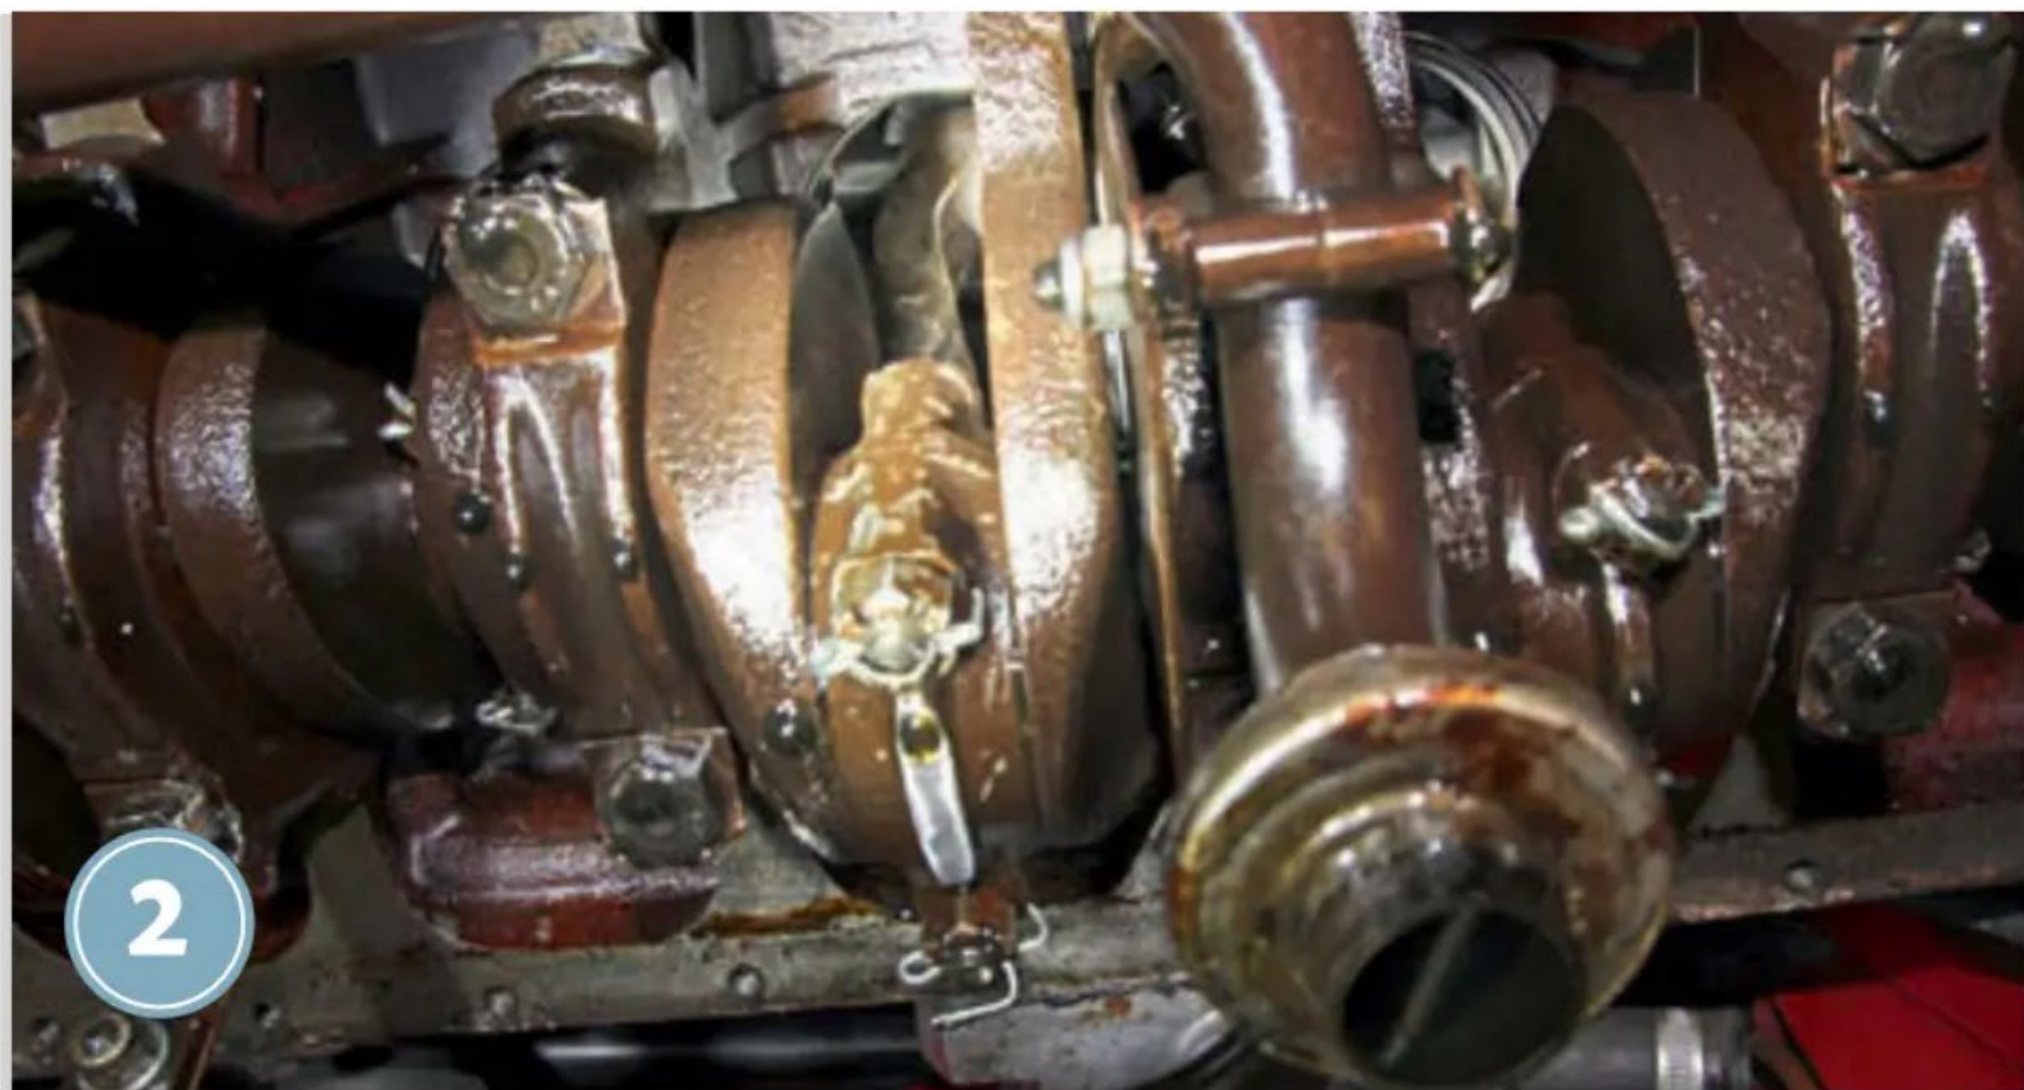
Looking up into the engine, we can see that piston number four is missing. All that's left is its gudgeon pin and a bent conrod. At this stage, we can't see all the remains of the piston

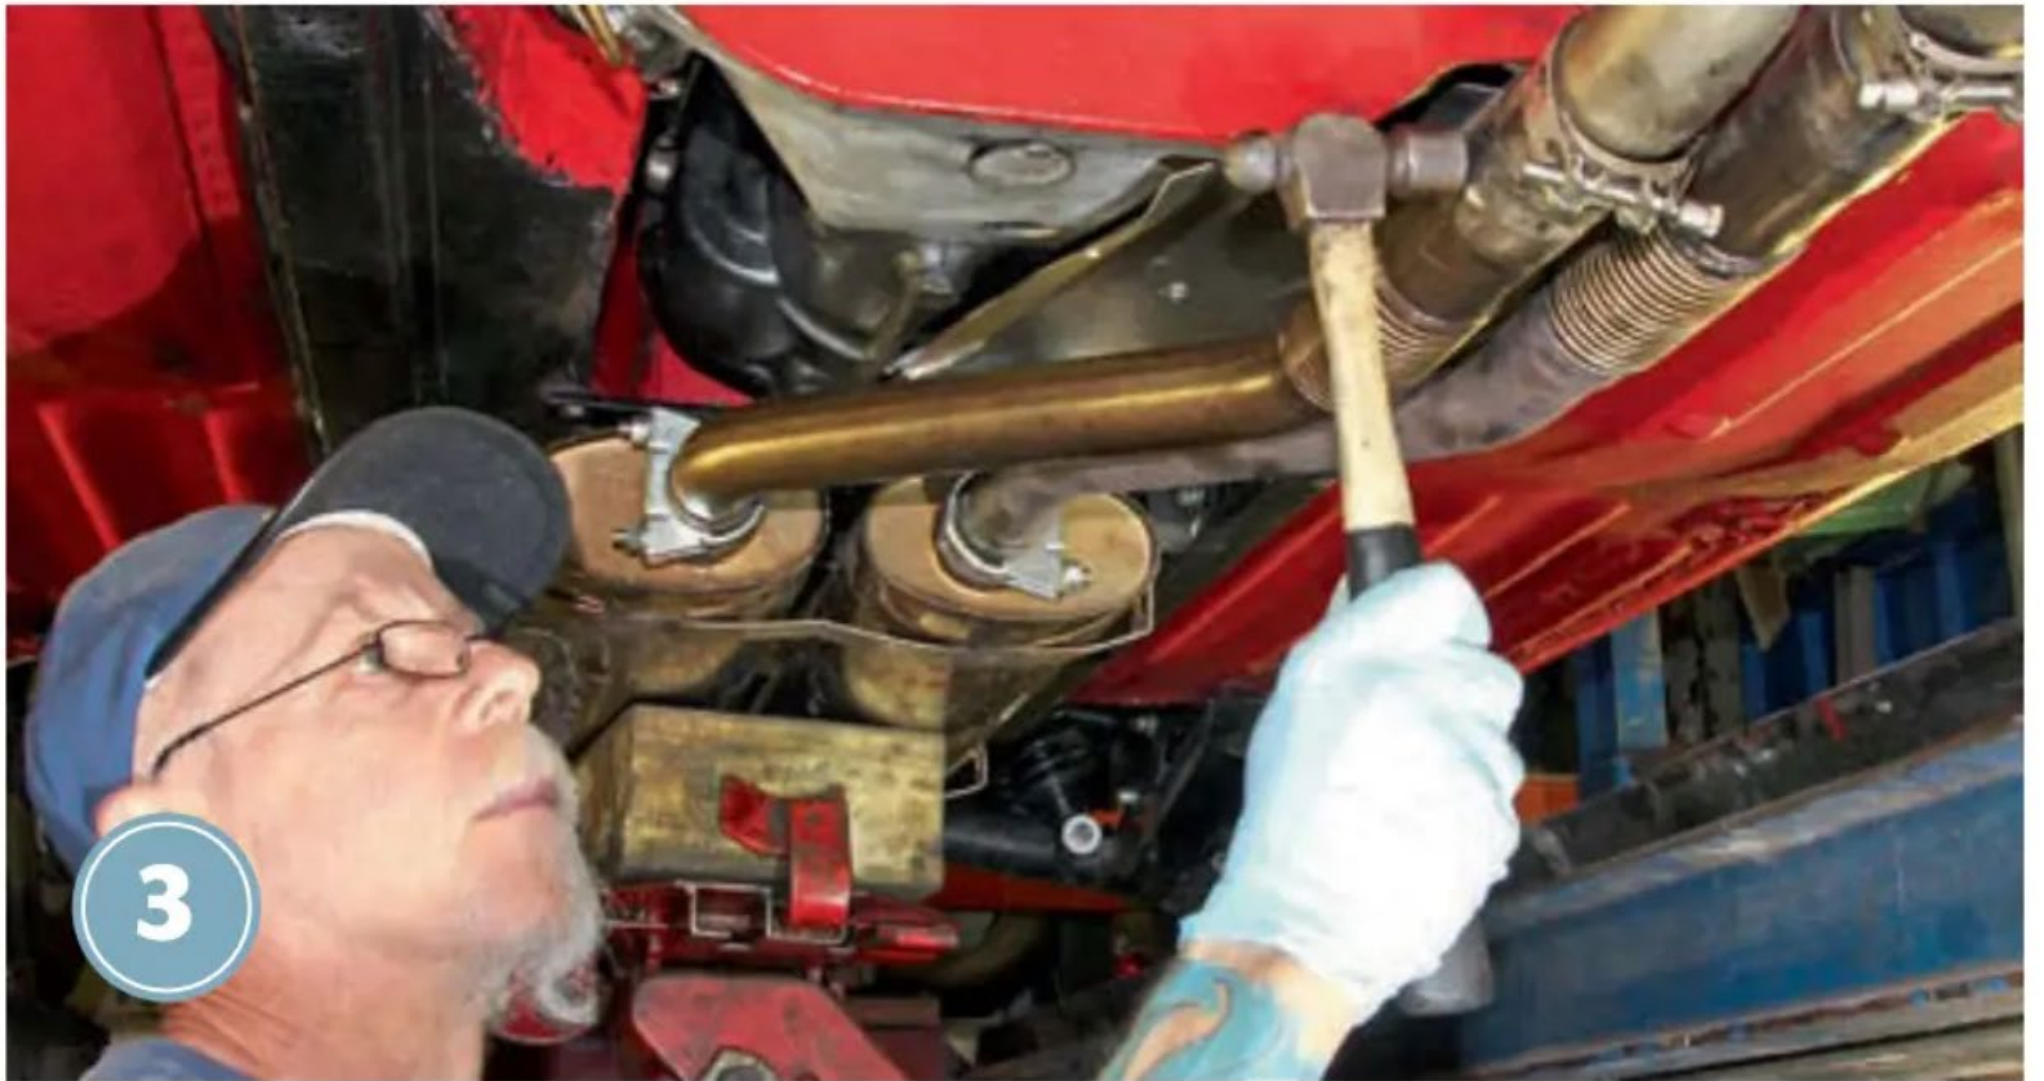
Mechanic Shaun makes a start on removing the engine and gearbox. First, he detaches the exhaust system from the downpipes. After loosening the clamps, he taps the joints with a hammer to release them

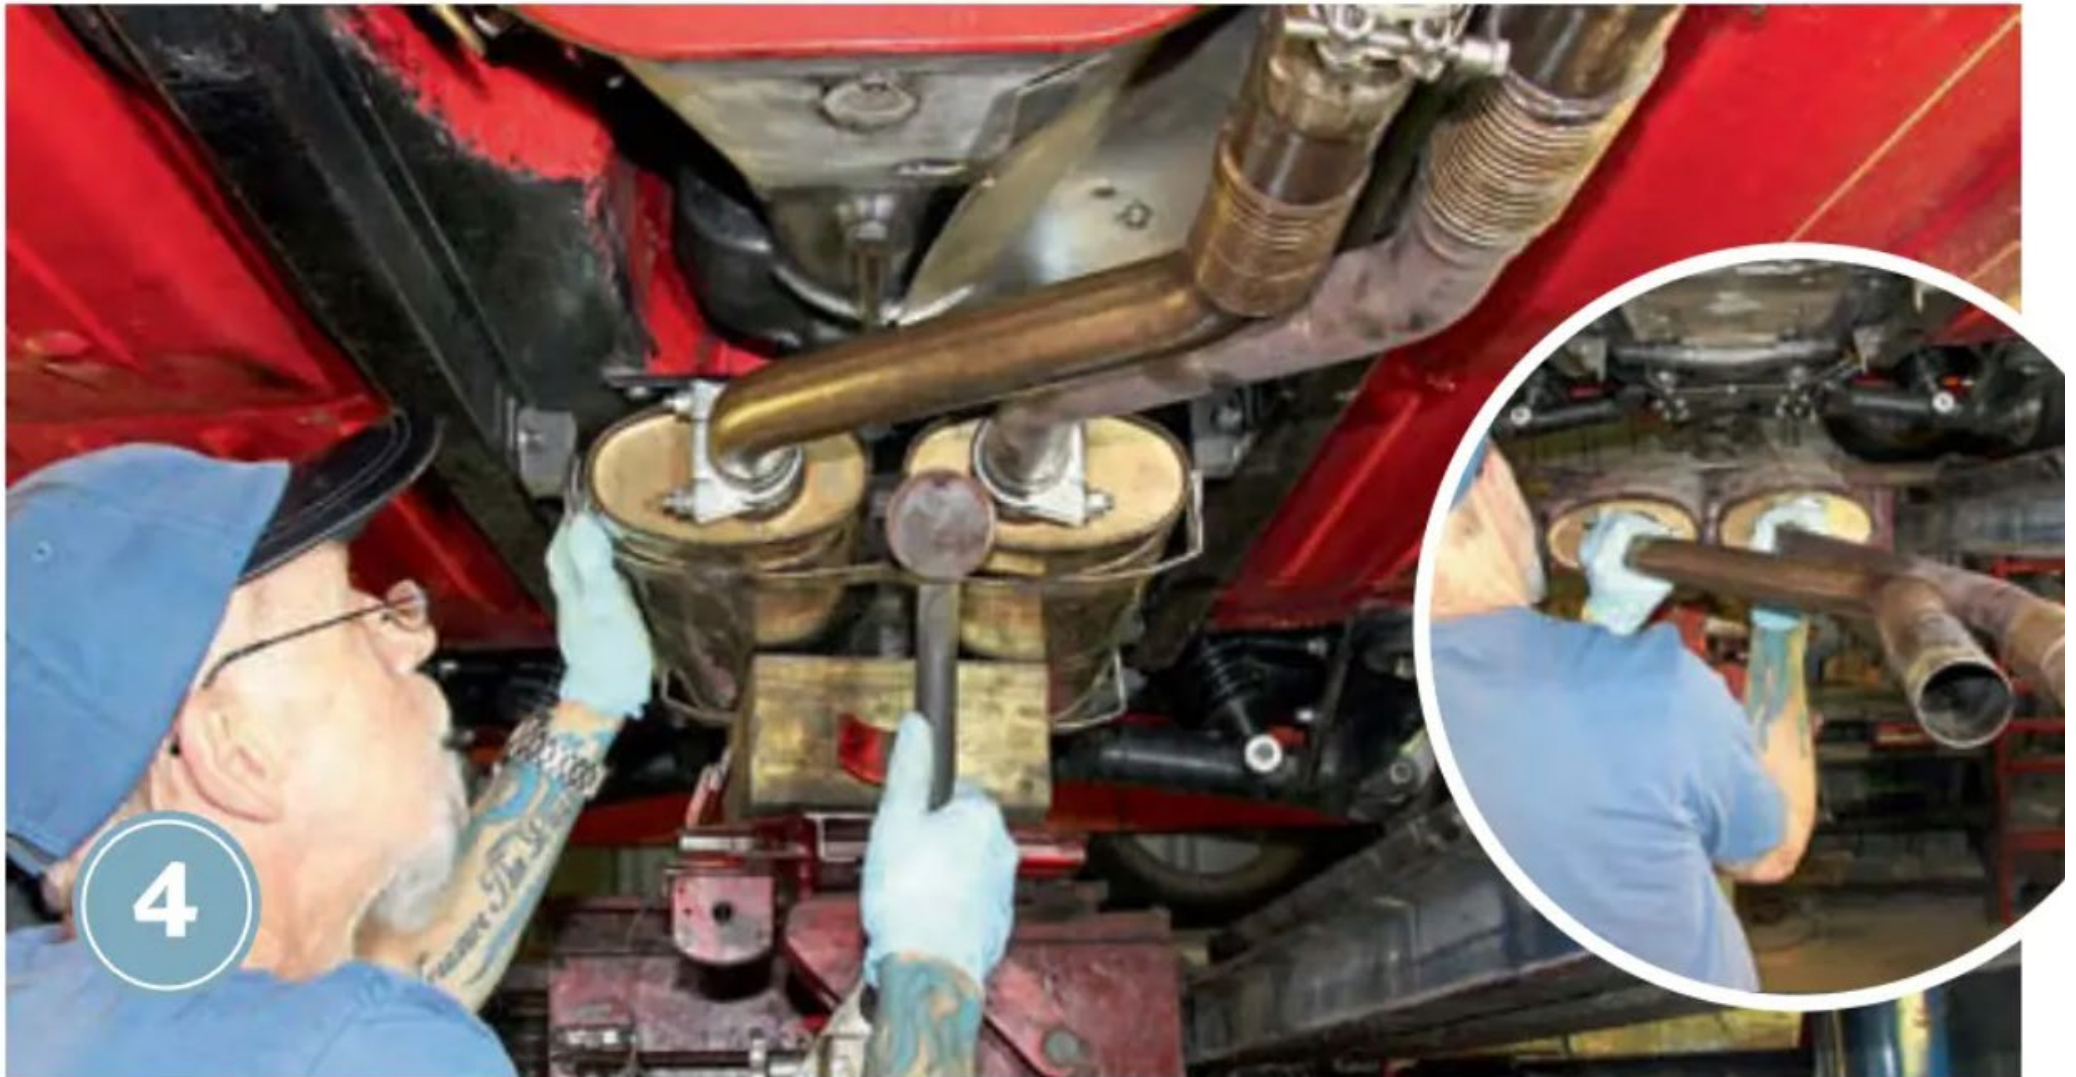
With the exhaust system supported by a transmission jack, he hits the front edge of the silencers with a mallet to detach the entire system and be able to carry it away

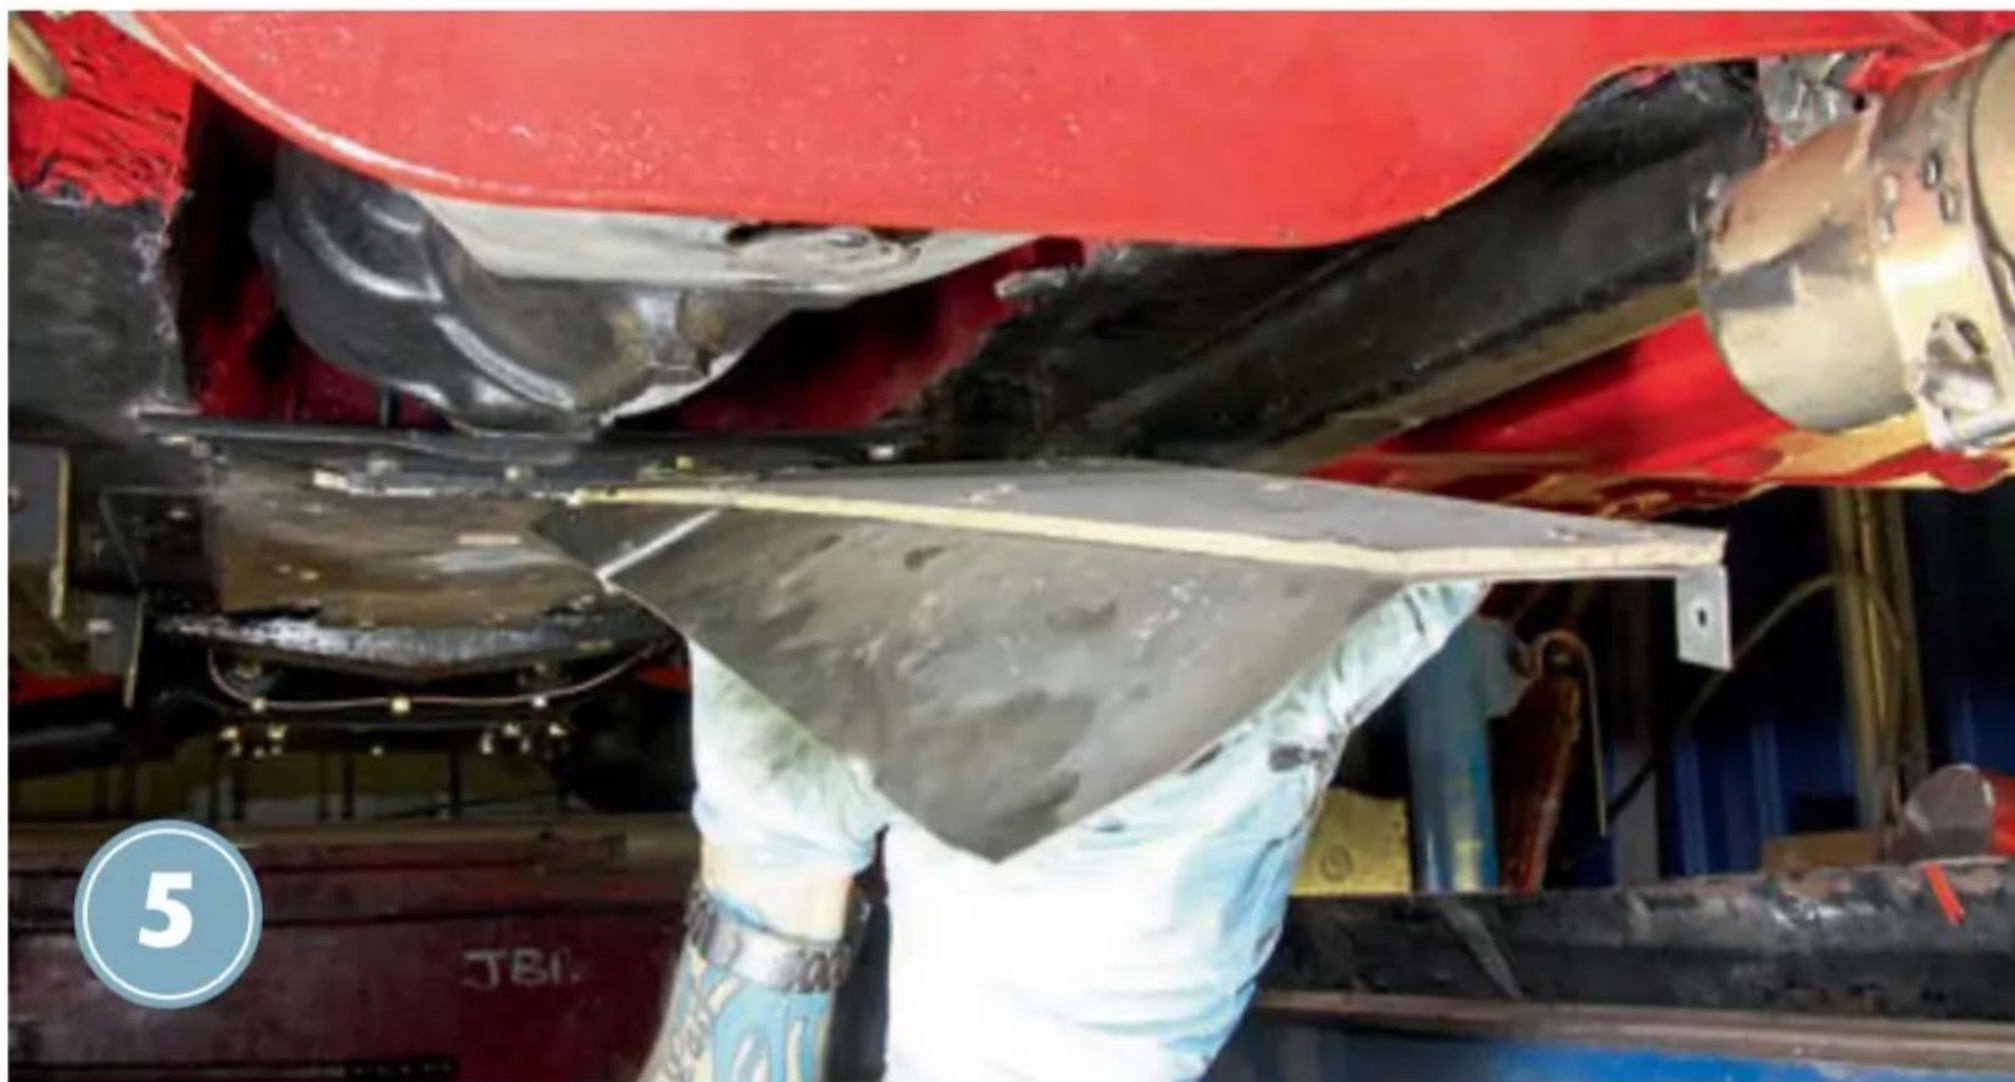
There's a metal plate attached to the underside of the vehicle, below the gearbox. Shaun removes all of its fastenings and lifts it off. This needs to be removed to lower the engine and gearbox

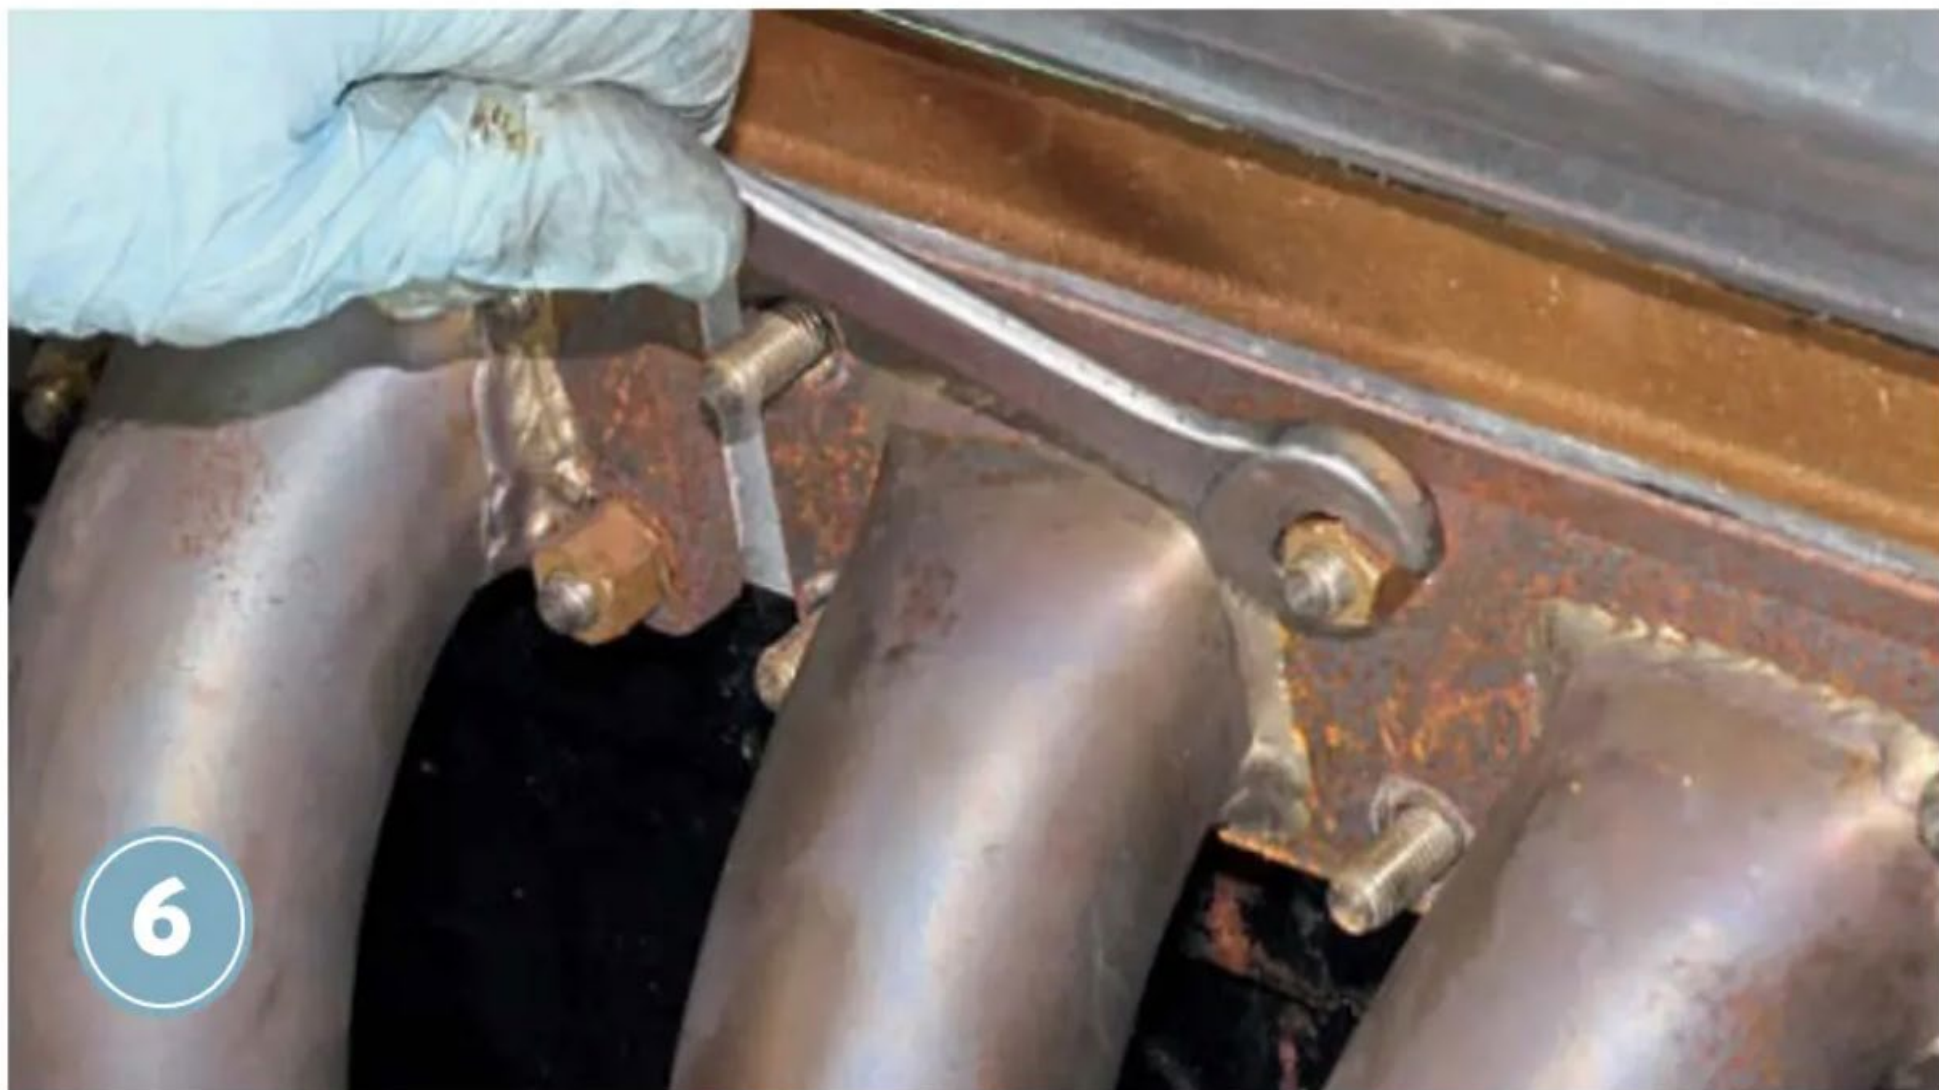
Moving to the top of the engine bay, the pair of tubular exhaust manifolds are removed. He starts with the rearmost, undoing eight 1/2in brass nuts. Brass is less prone to corrosion than steel

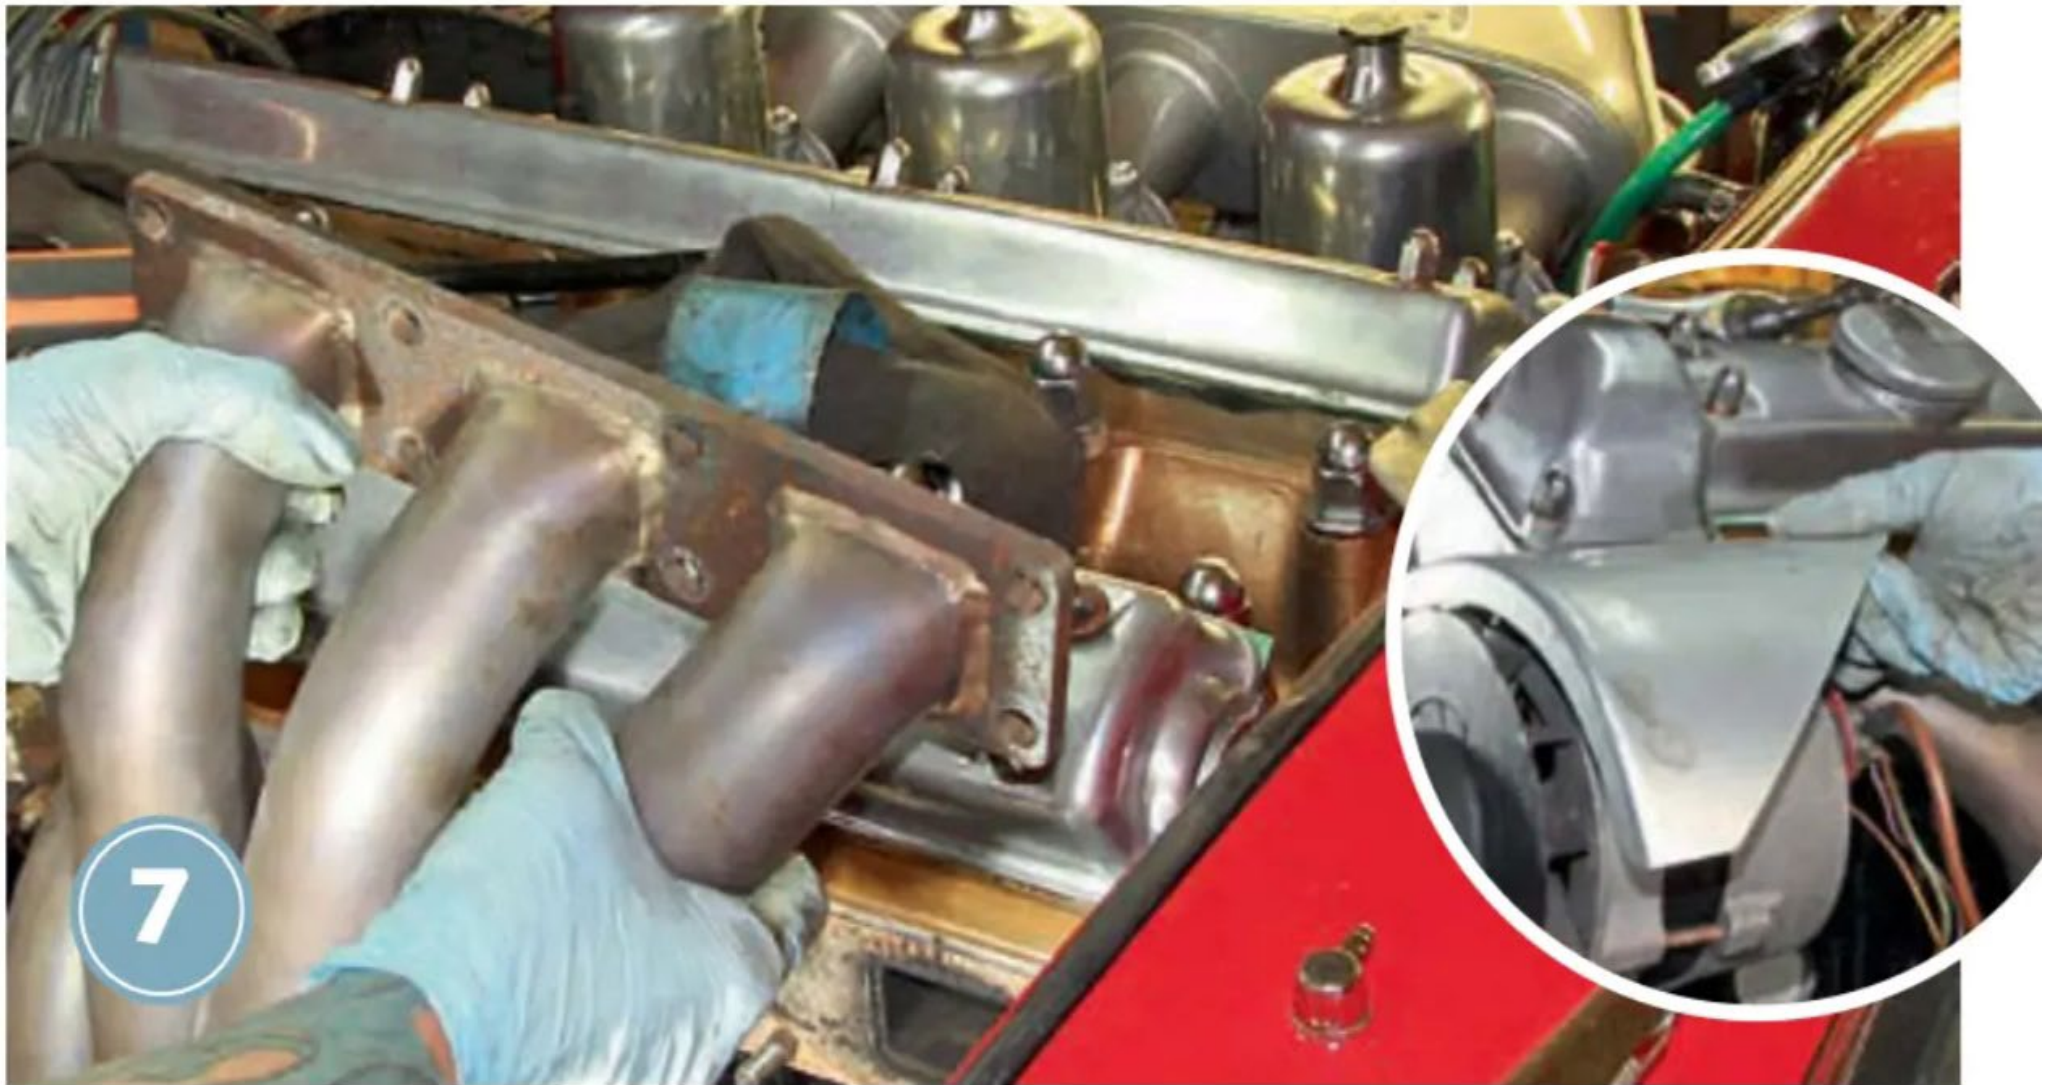
The rearmost exhaust manifold is straightforward to remove, whereas the frontmost is obstructed by a cover around the alternator, which needs removing first. Then the manifold can be removed

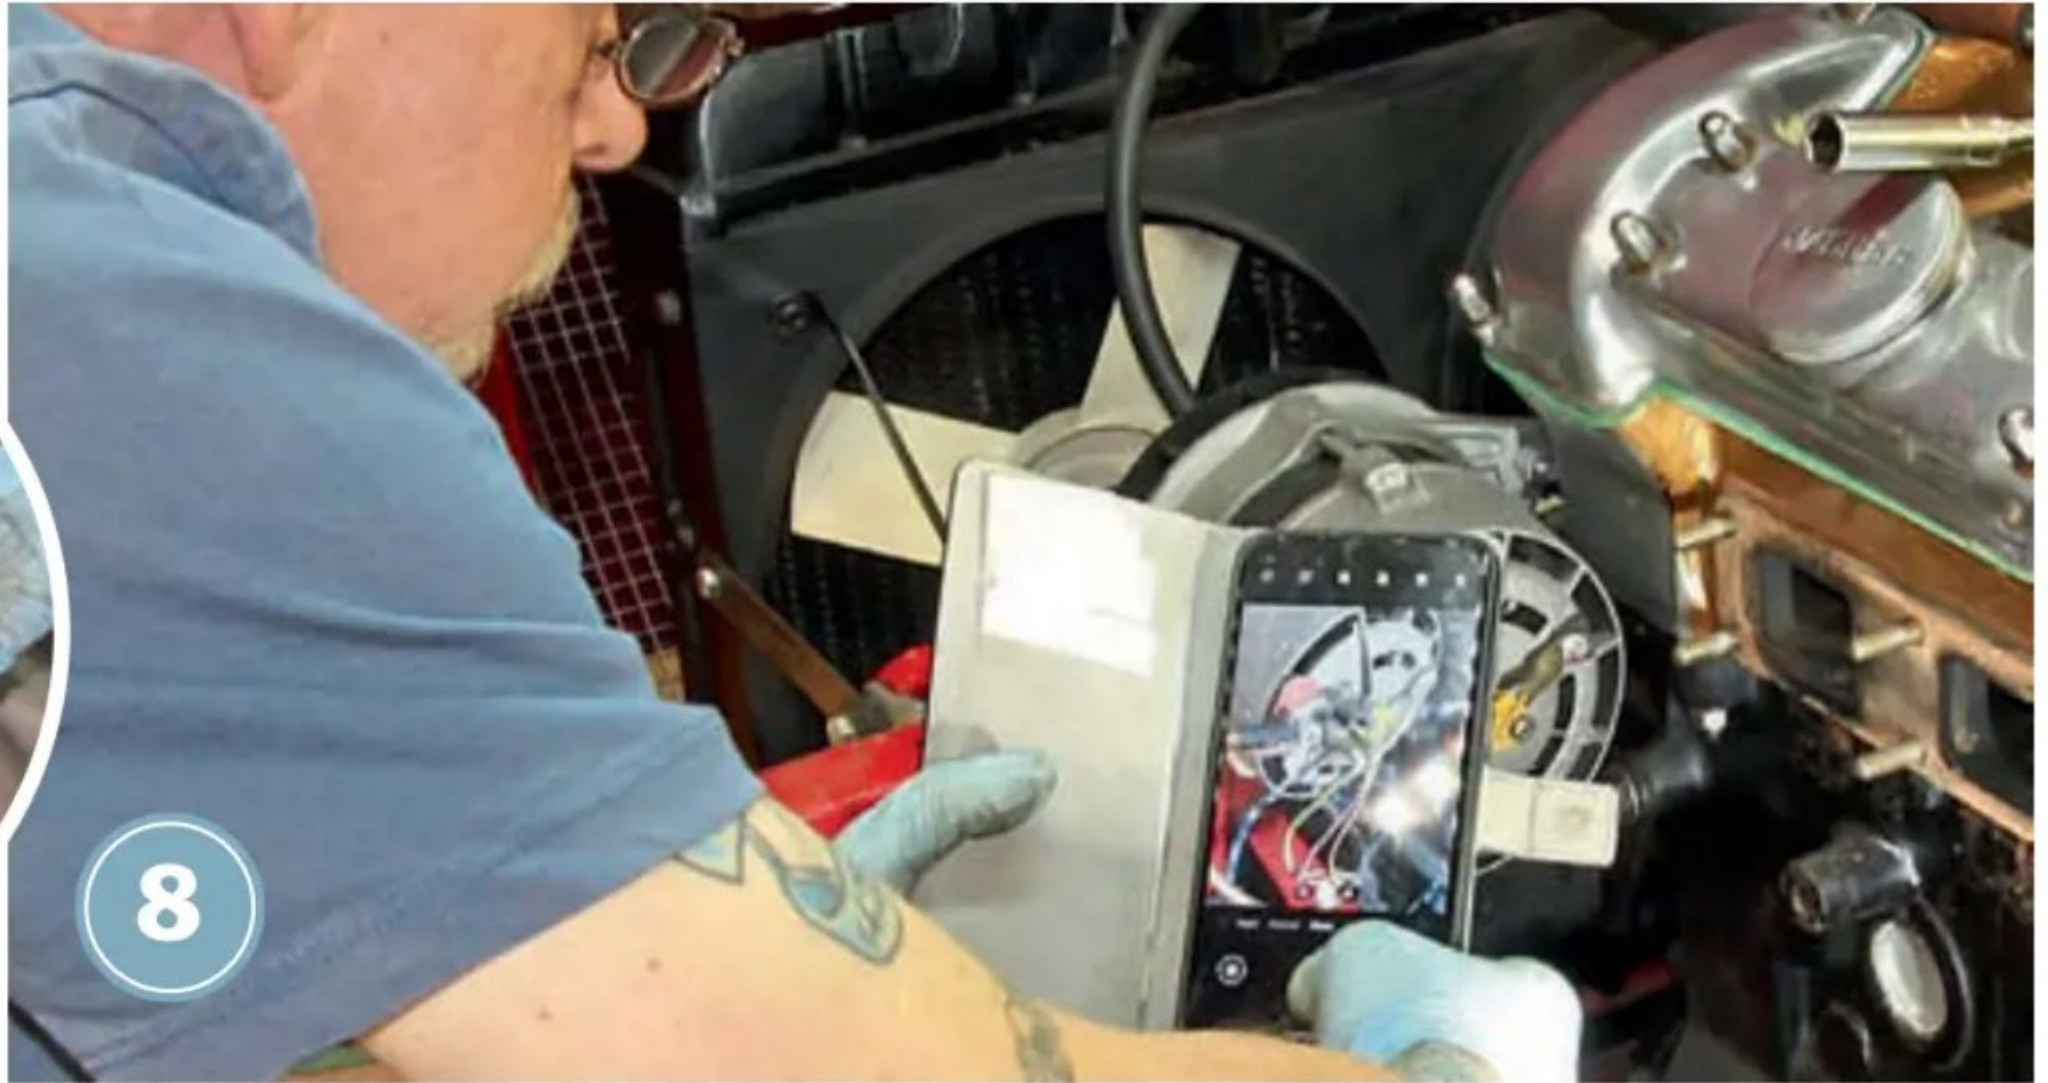
The alternator needs to be removed to create more space when lowering the engine and gearbox. Shaun wisely takes a photograph of the wiring attached to the back of it to ensure it's correctly refitted

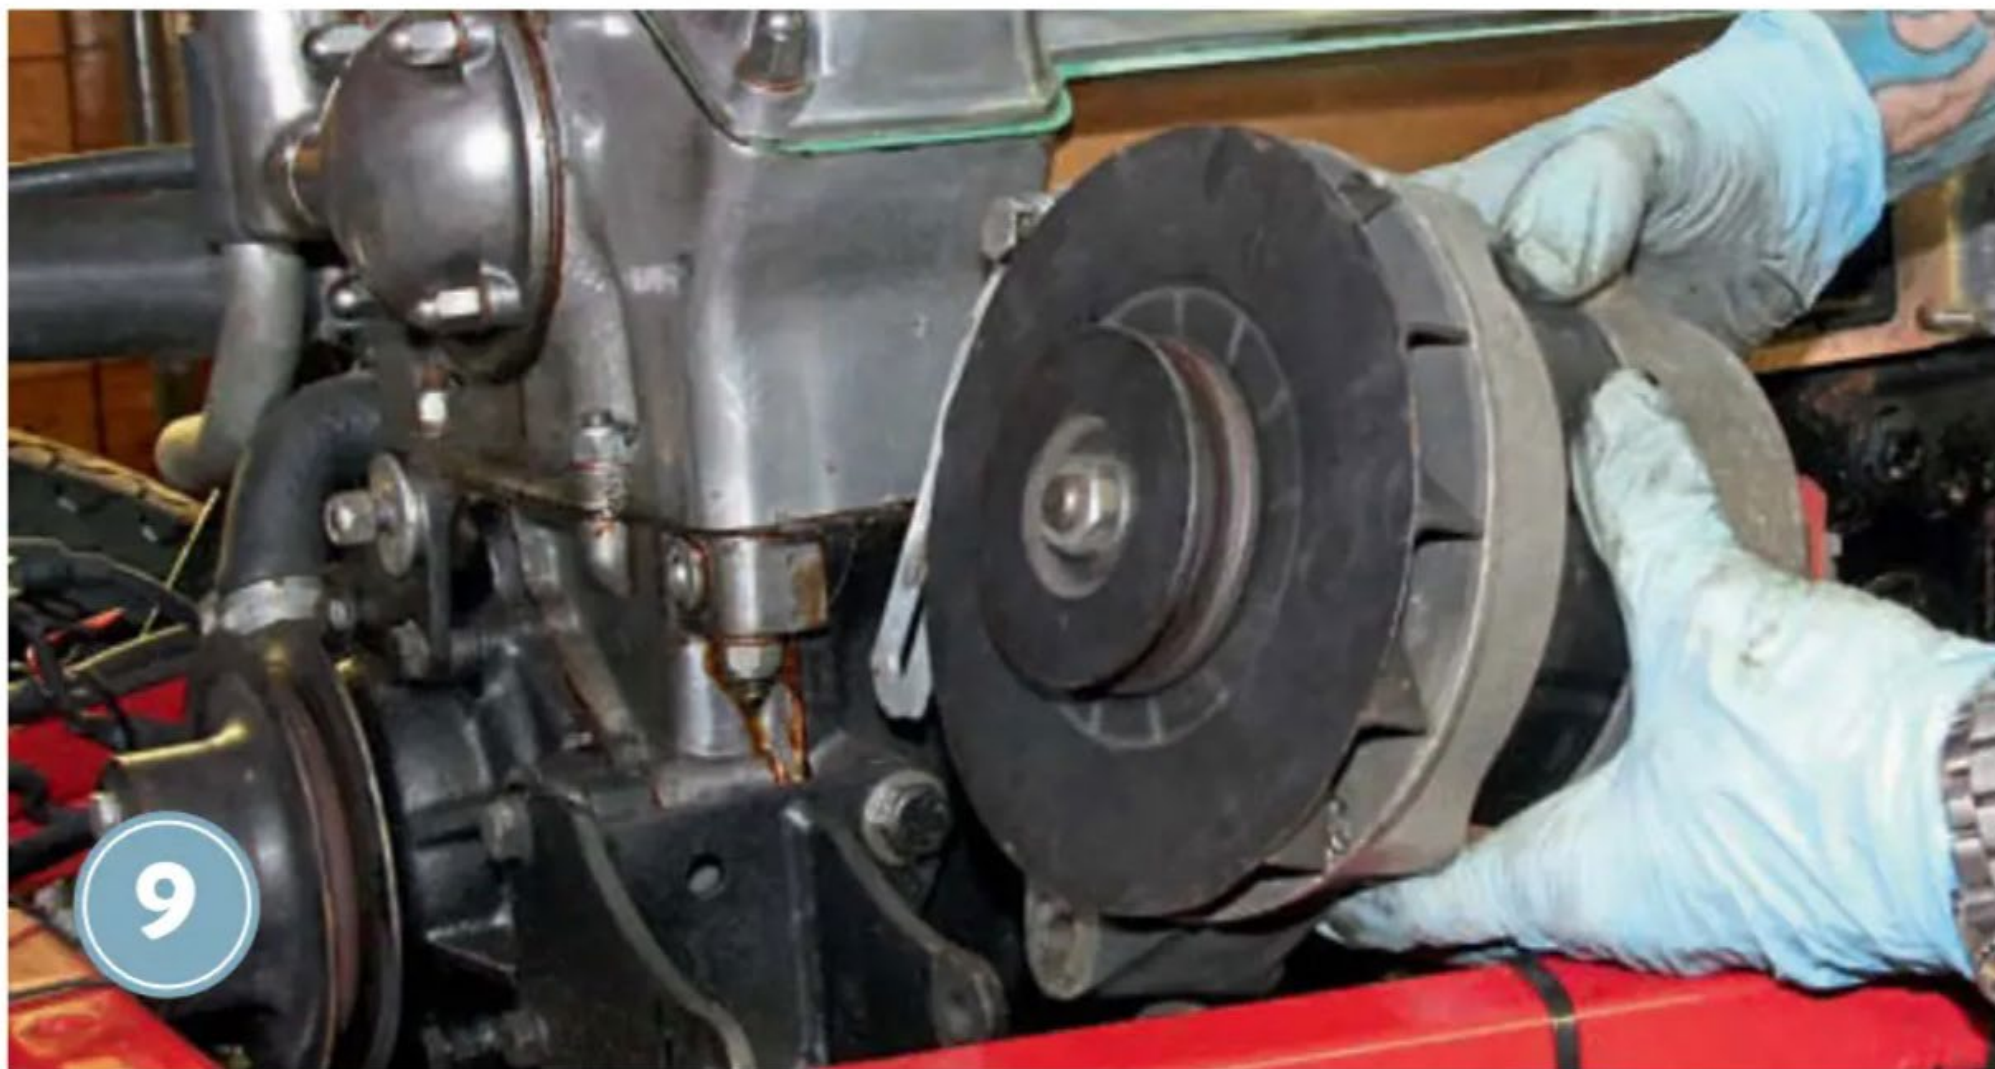
After undoing a 1/2in fastening for the alternator's adjuster (for the drive belt) and 9/16in nut and bolt for its mounting, it's removed. Its mounting bracket is then removed, secured with 9/16in and 5/8in fastenings

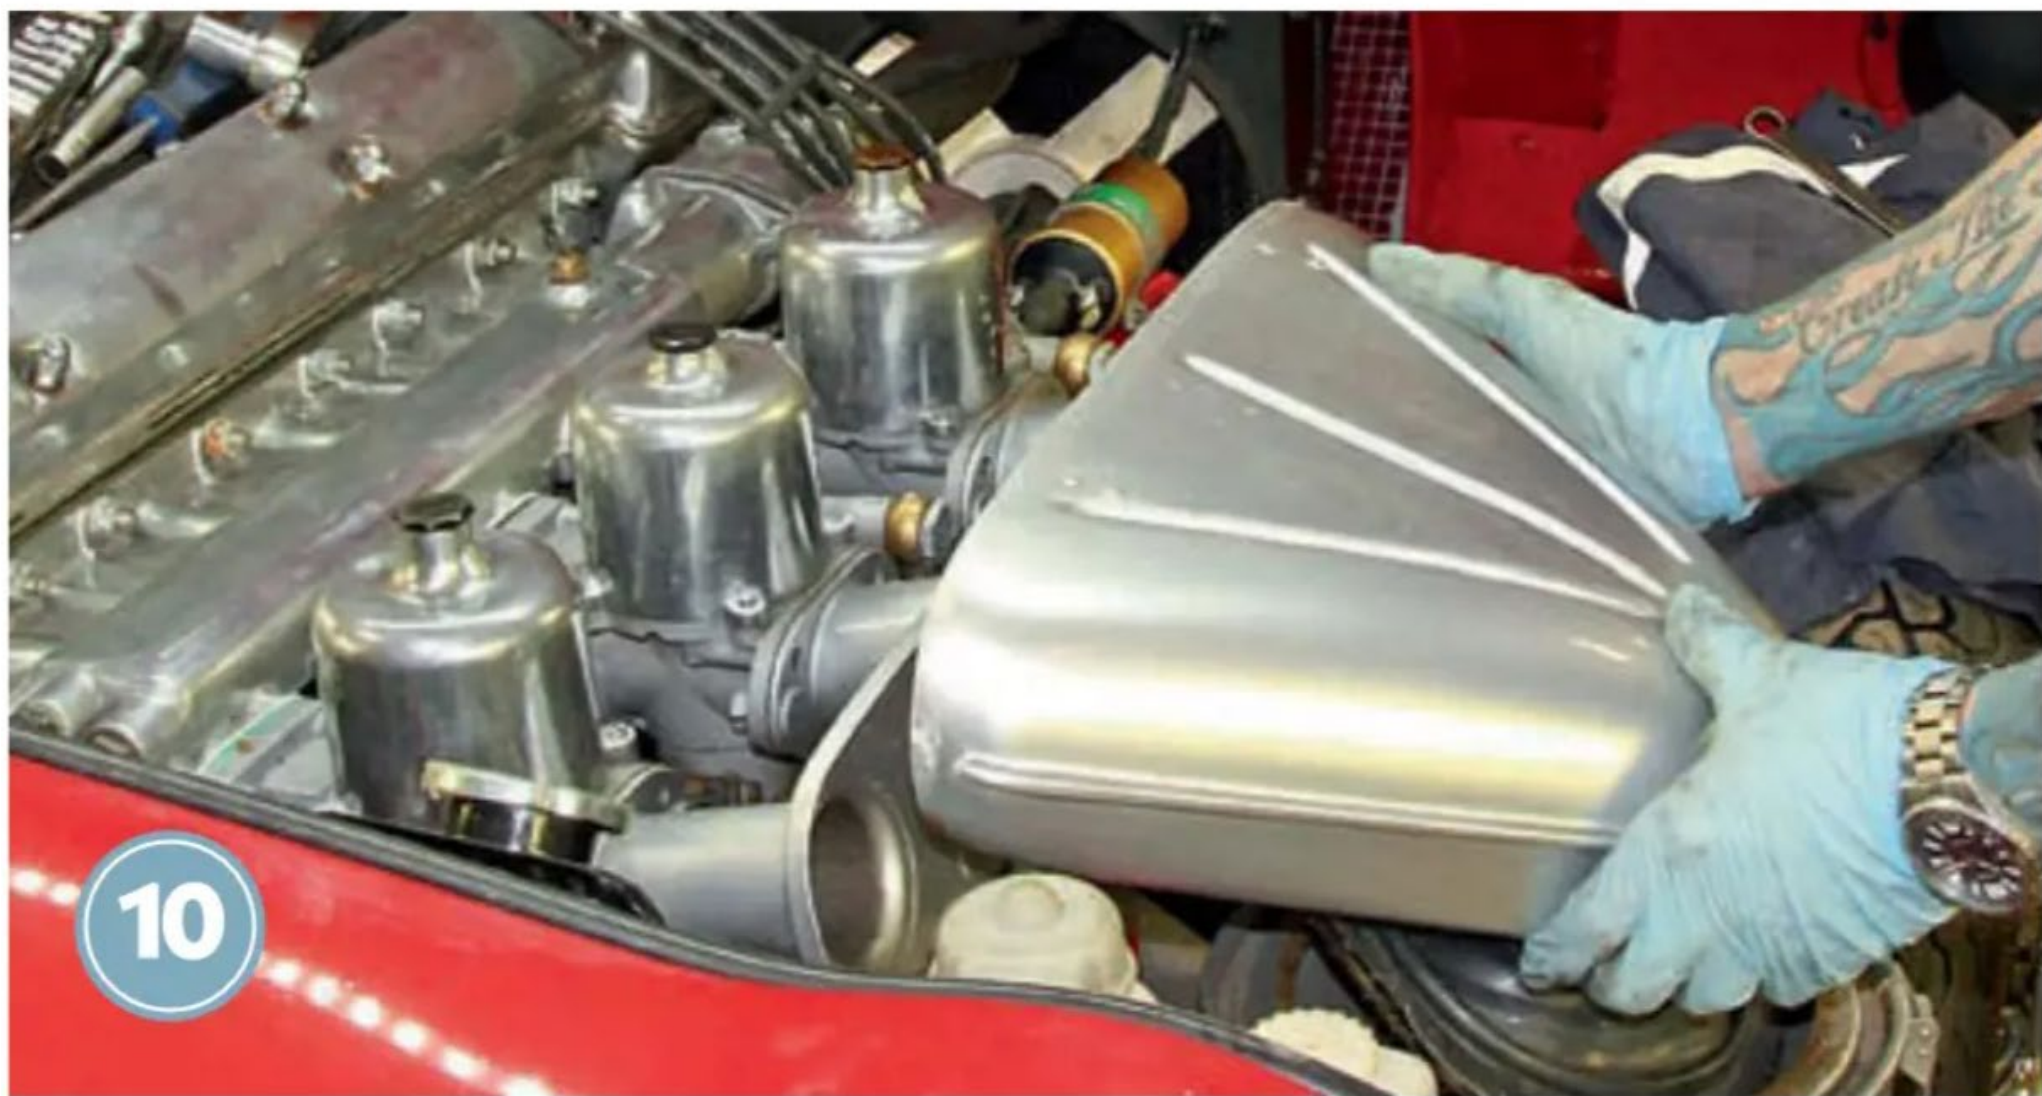
Moving to the offside, Shaun removes the air cleaner (air filter) housing. He starts with the large metal feed between the air filter and the three carburetors, usually secured with wing nuts
