E-type engine removal

PART ONE: In the first of a two-part series, we follow the preparation work required prior to removing the engine and gearbox from an E-type

PART TWO: In the final instalment, we follow the 4.2-litre XK engine and manual gearbox being removed from a Series I E-type

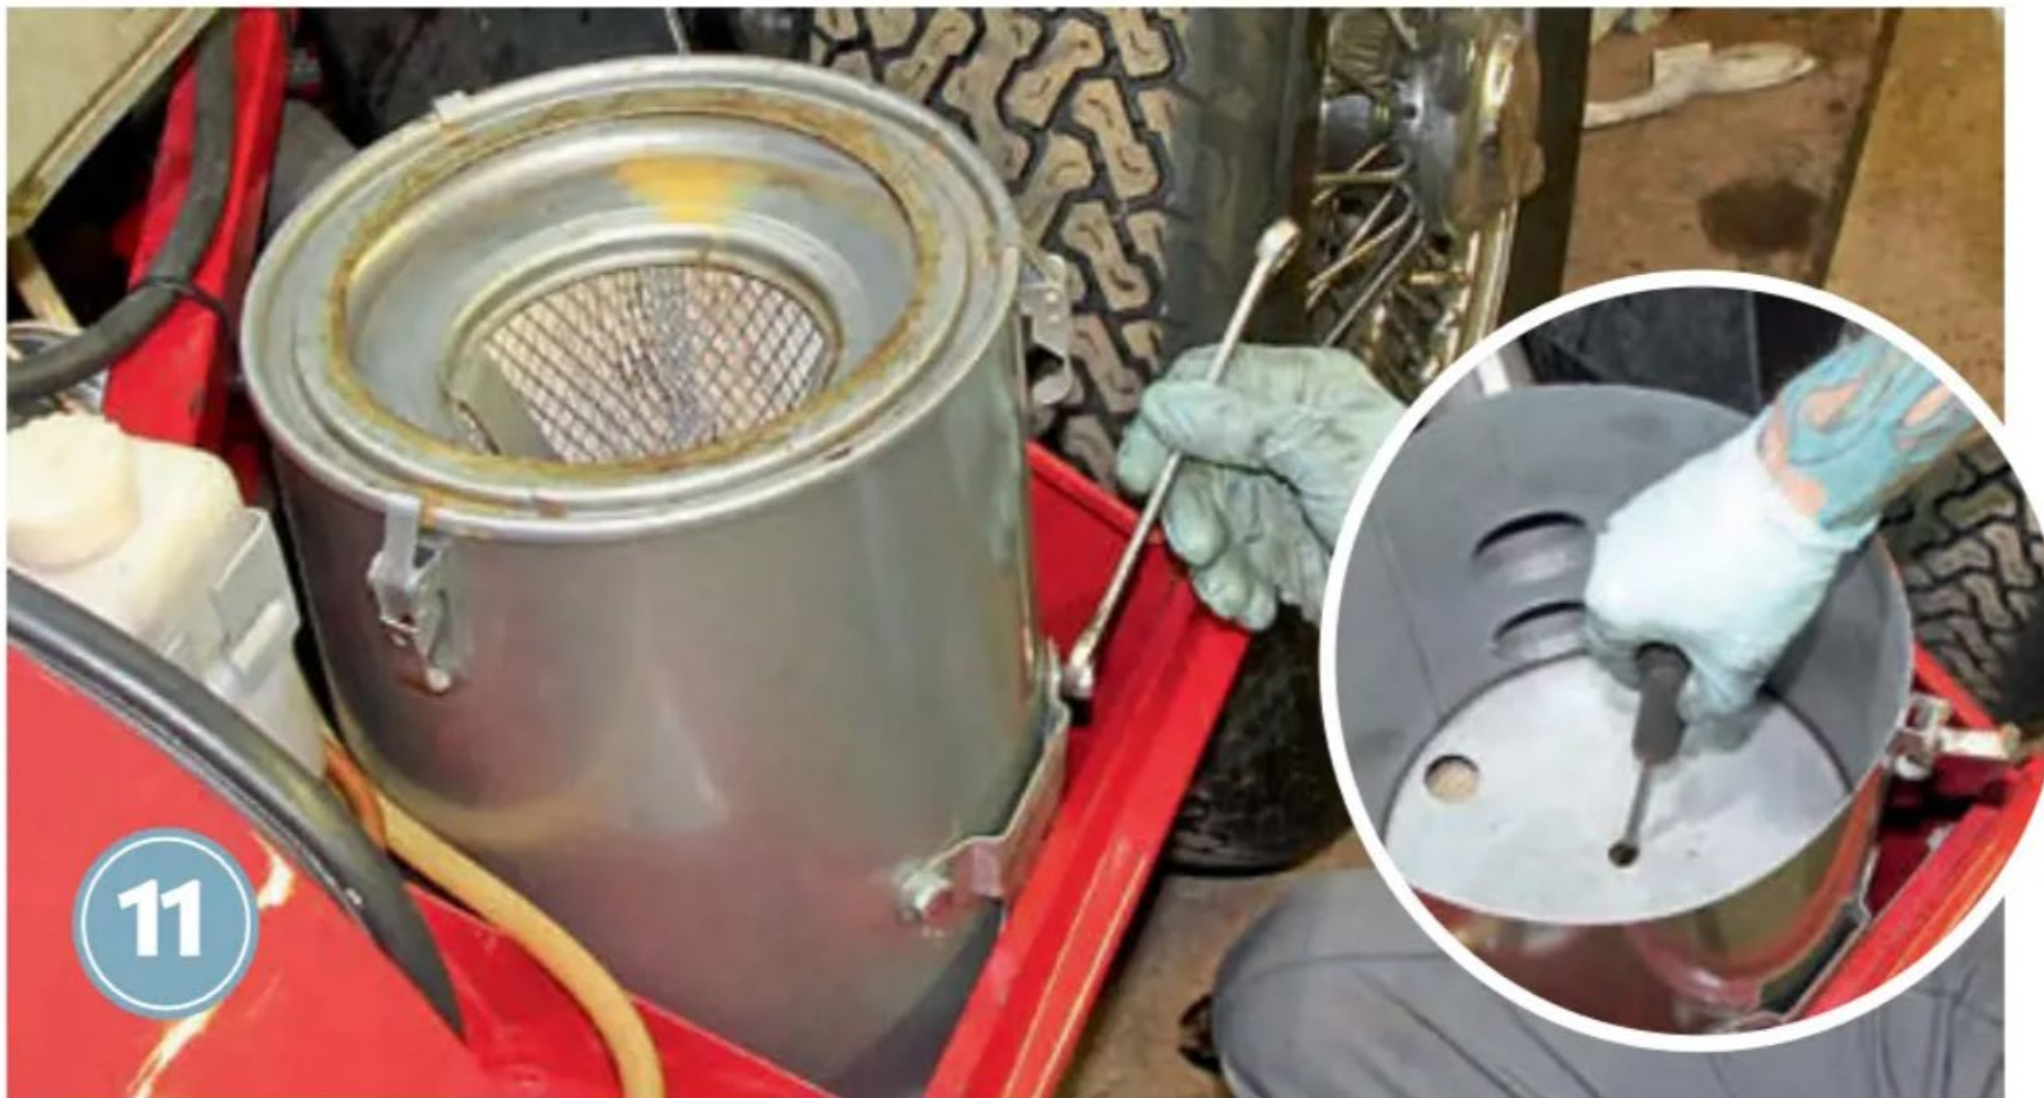
The air filter housing is secured with a couple of 1/2in nuts to a mounting bracket on the outside. The air filter is removed to reveal a single screw on the inside that needs to be undone

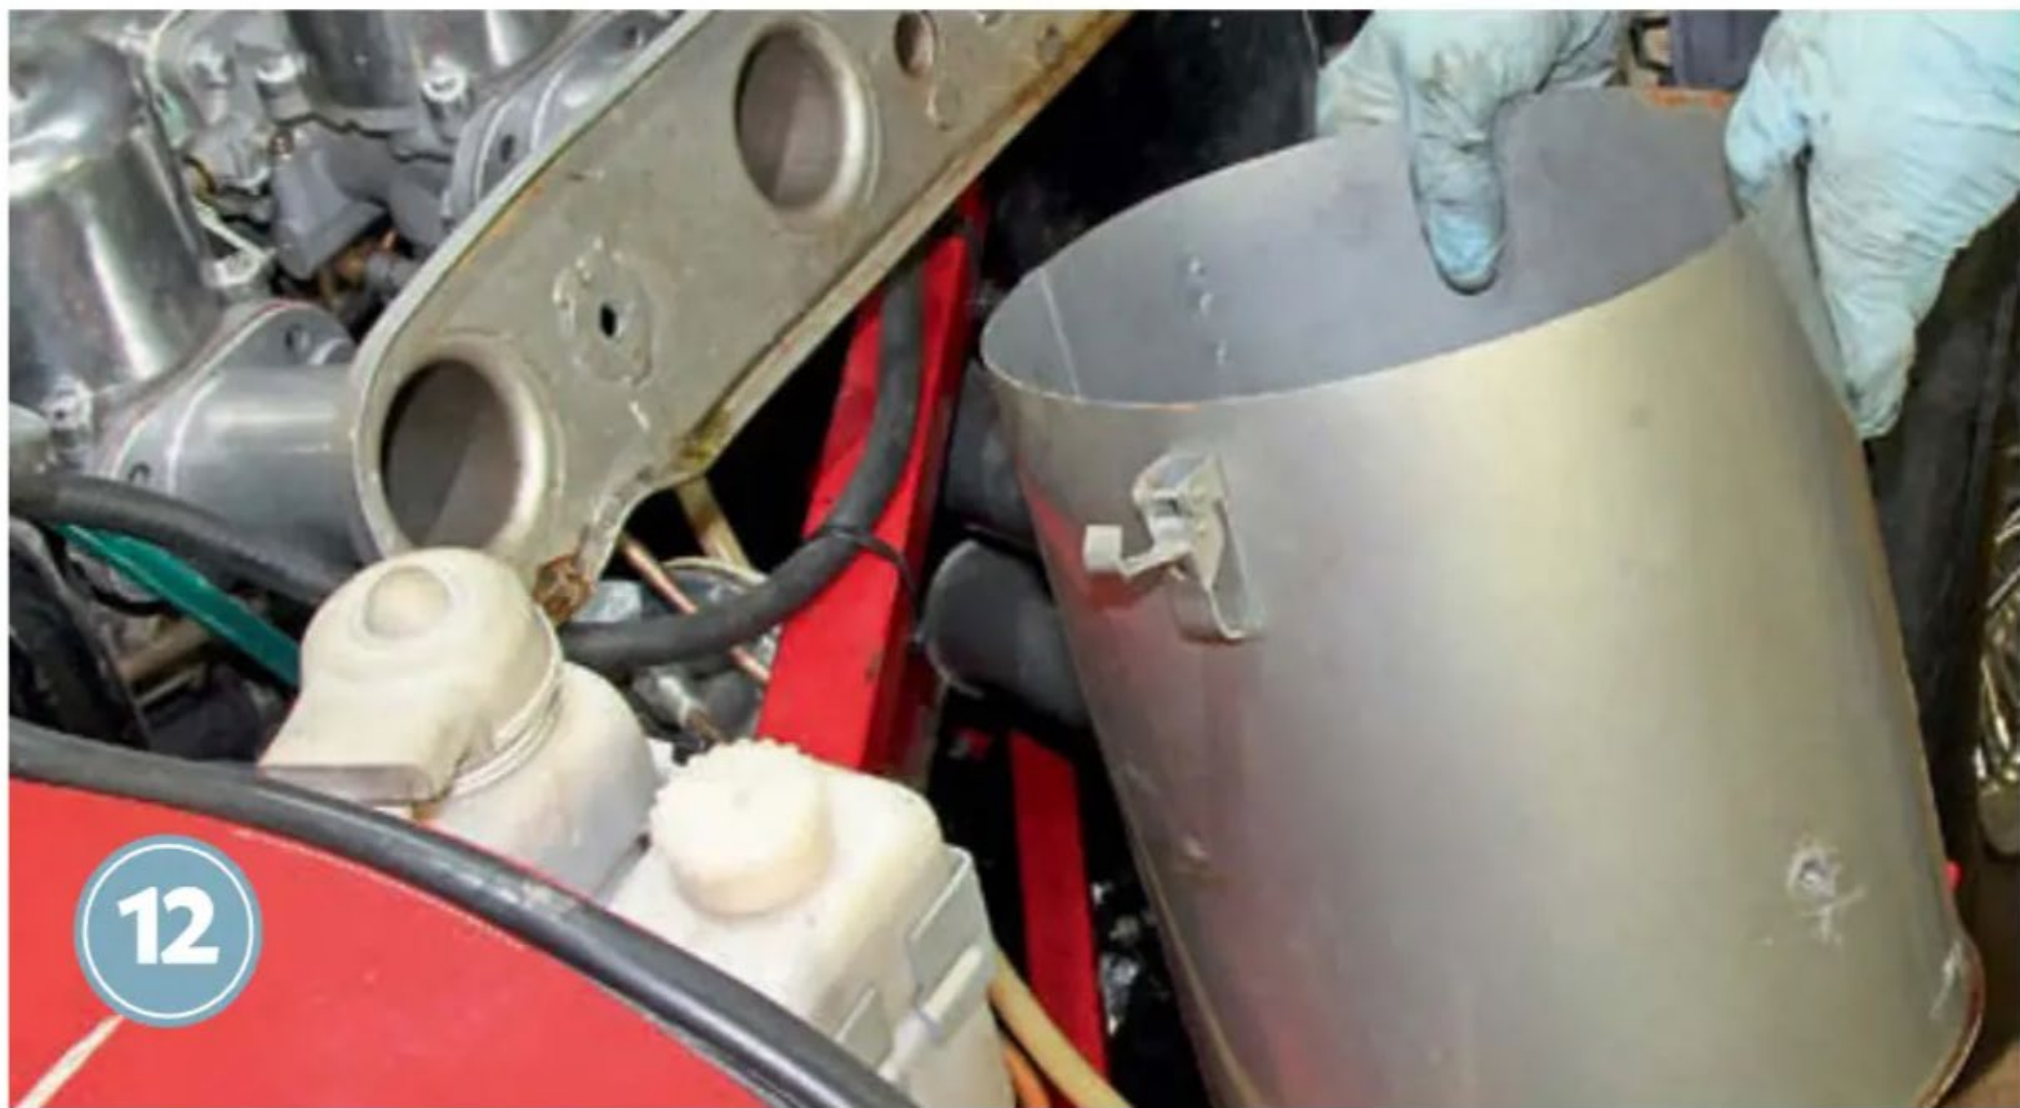
After carefully lifting the bucket-sized air filter housing out of the engine bay, Shaun spots a large lump of shiny metal sitting underneath it. At first, it's difficult to identify and looks like a rock, but...

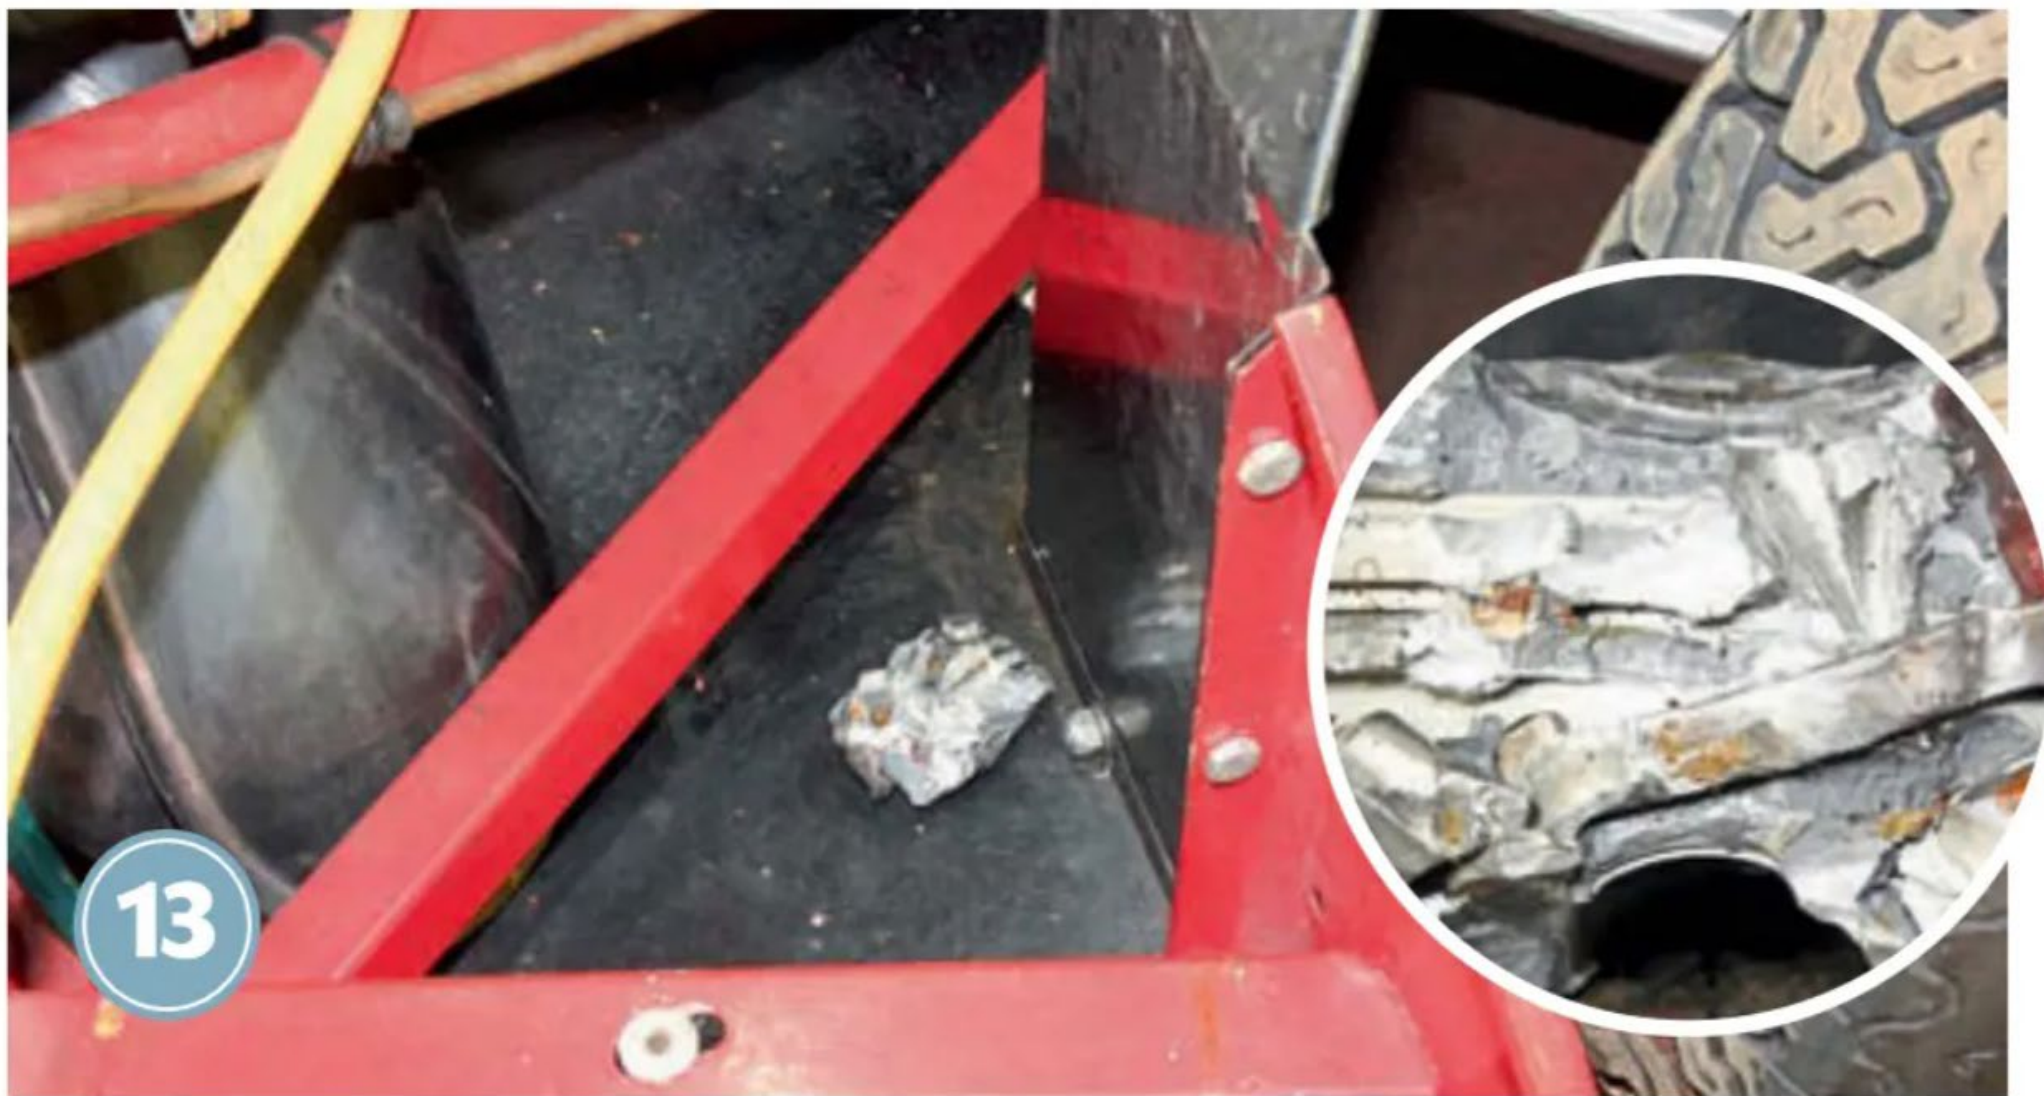
...upon closer inspection, it's the remains of the piston from cylinder number four, including a melted piston ring. We now realise that this is what created the hole in the side of the alloy sump

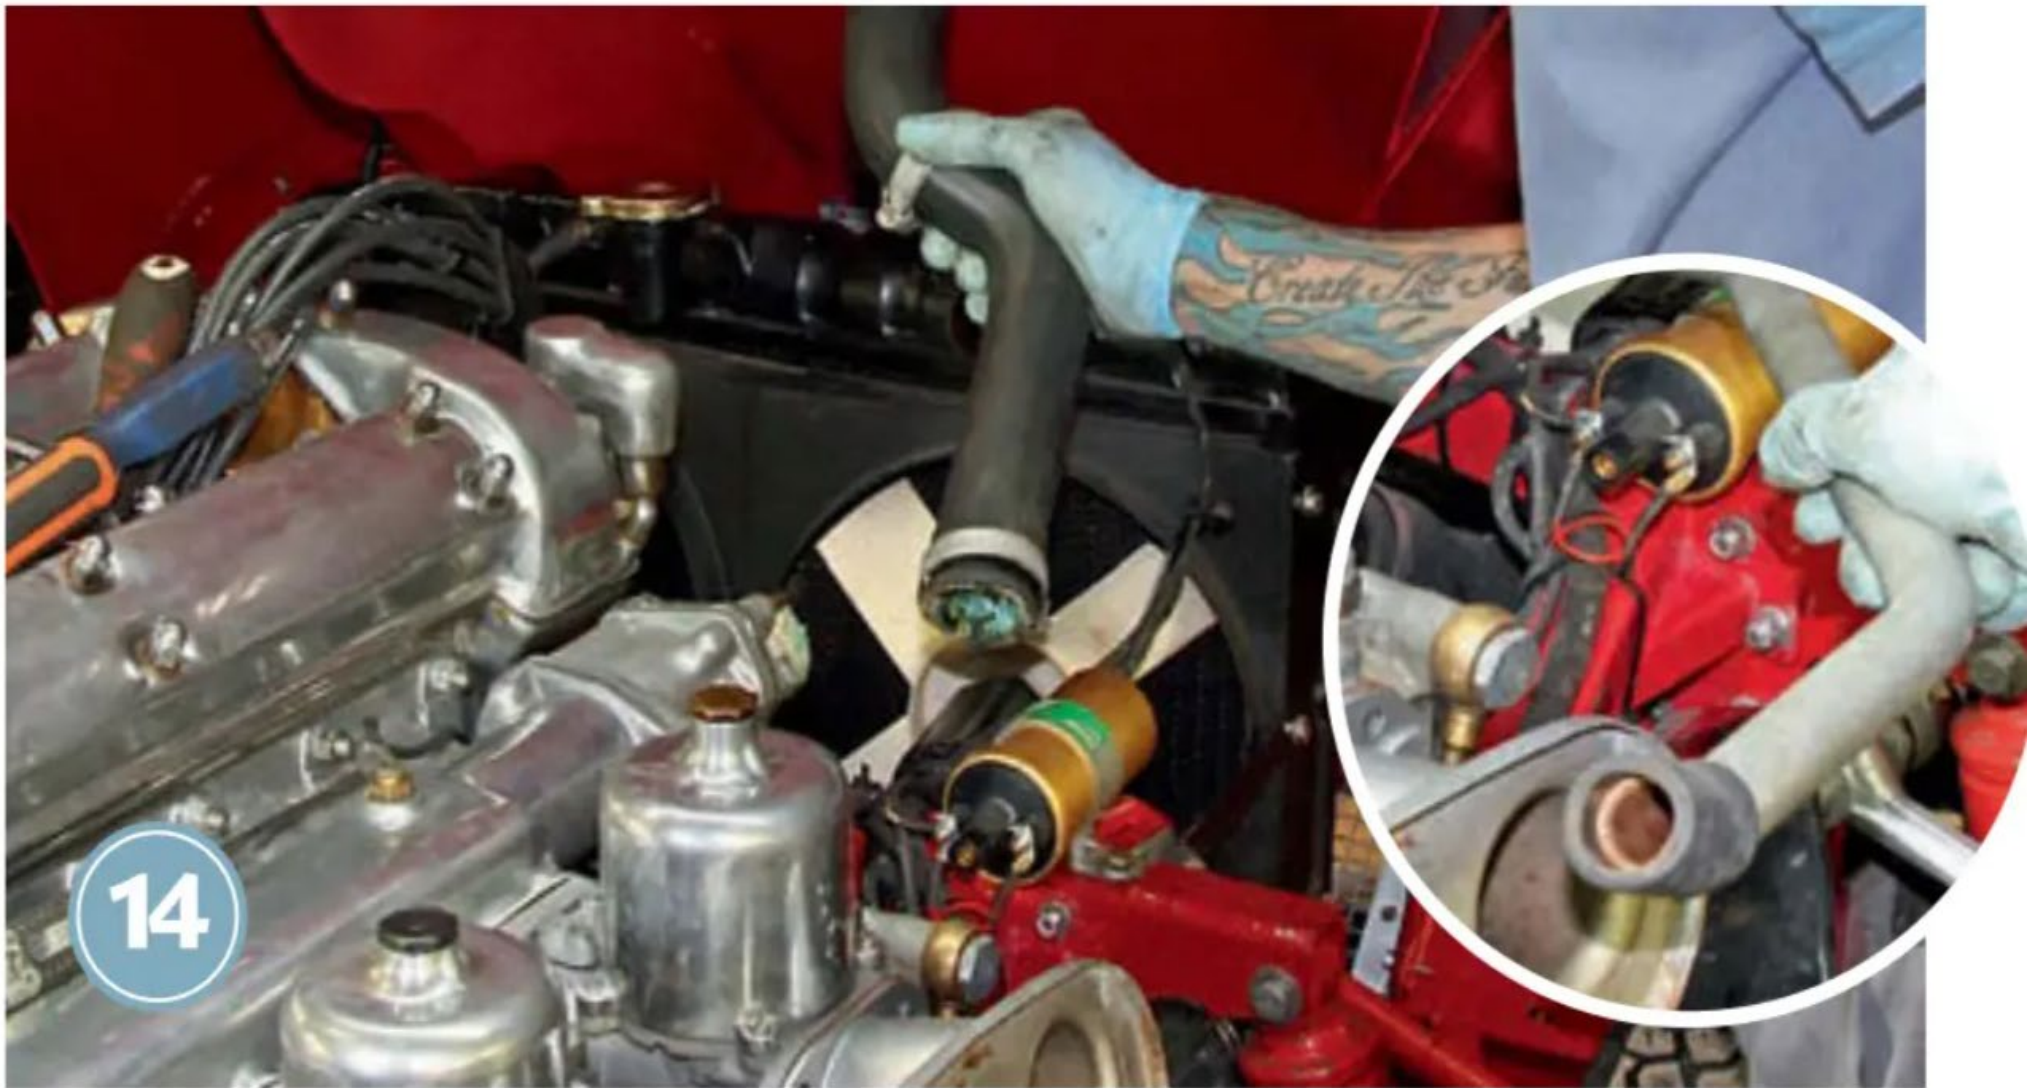
We continue to remove more components to help with lowering the engine and gearbox, including a breather hose between the carbs and the front of the engine and the top radiator hose

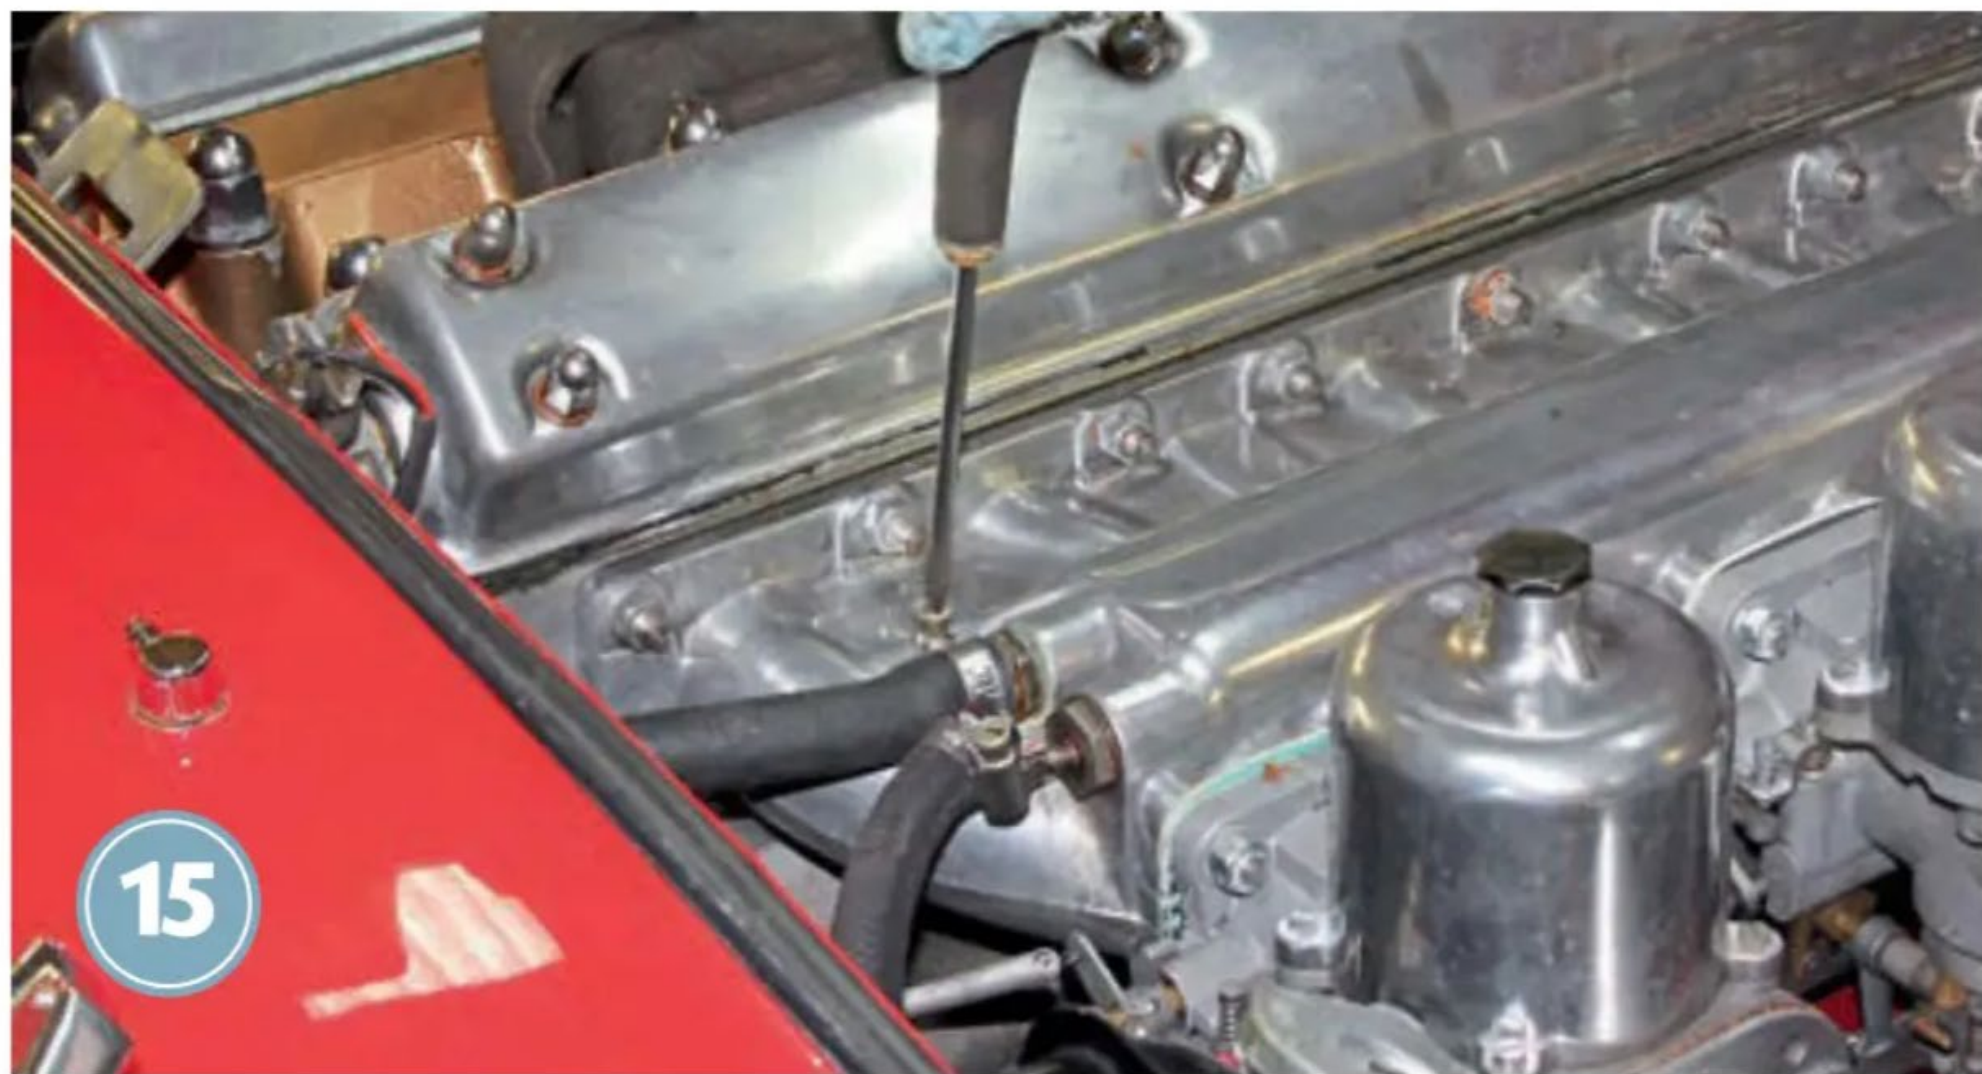
The inlet manifold, complete with carbs, needs to be removed, so a breather and a coolant hose are detached from this assembly. All of the engine coolant has already been drained

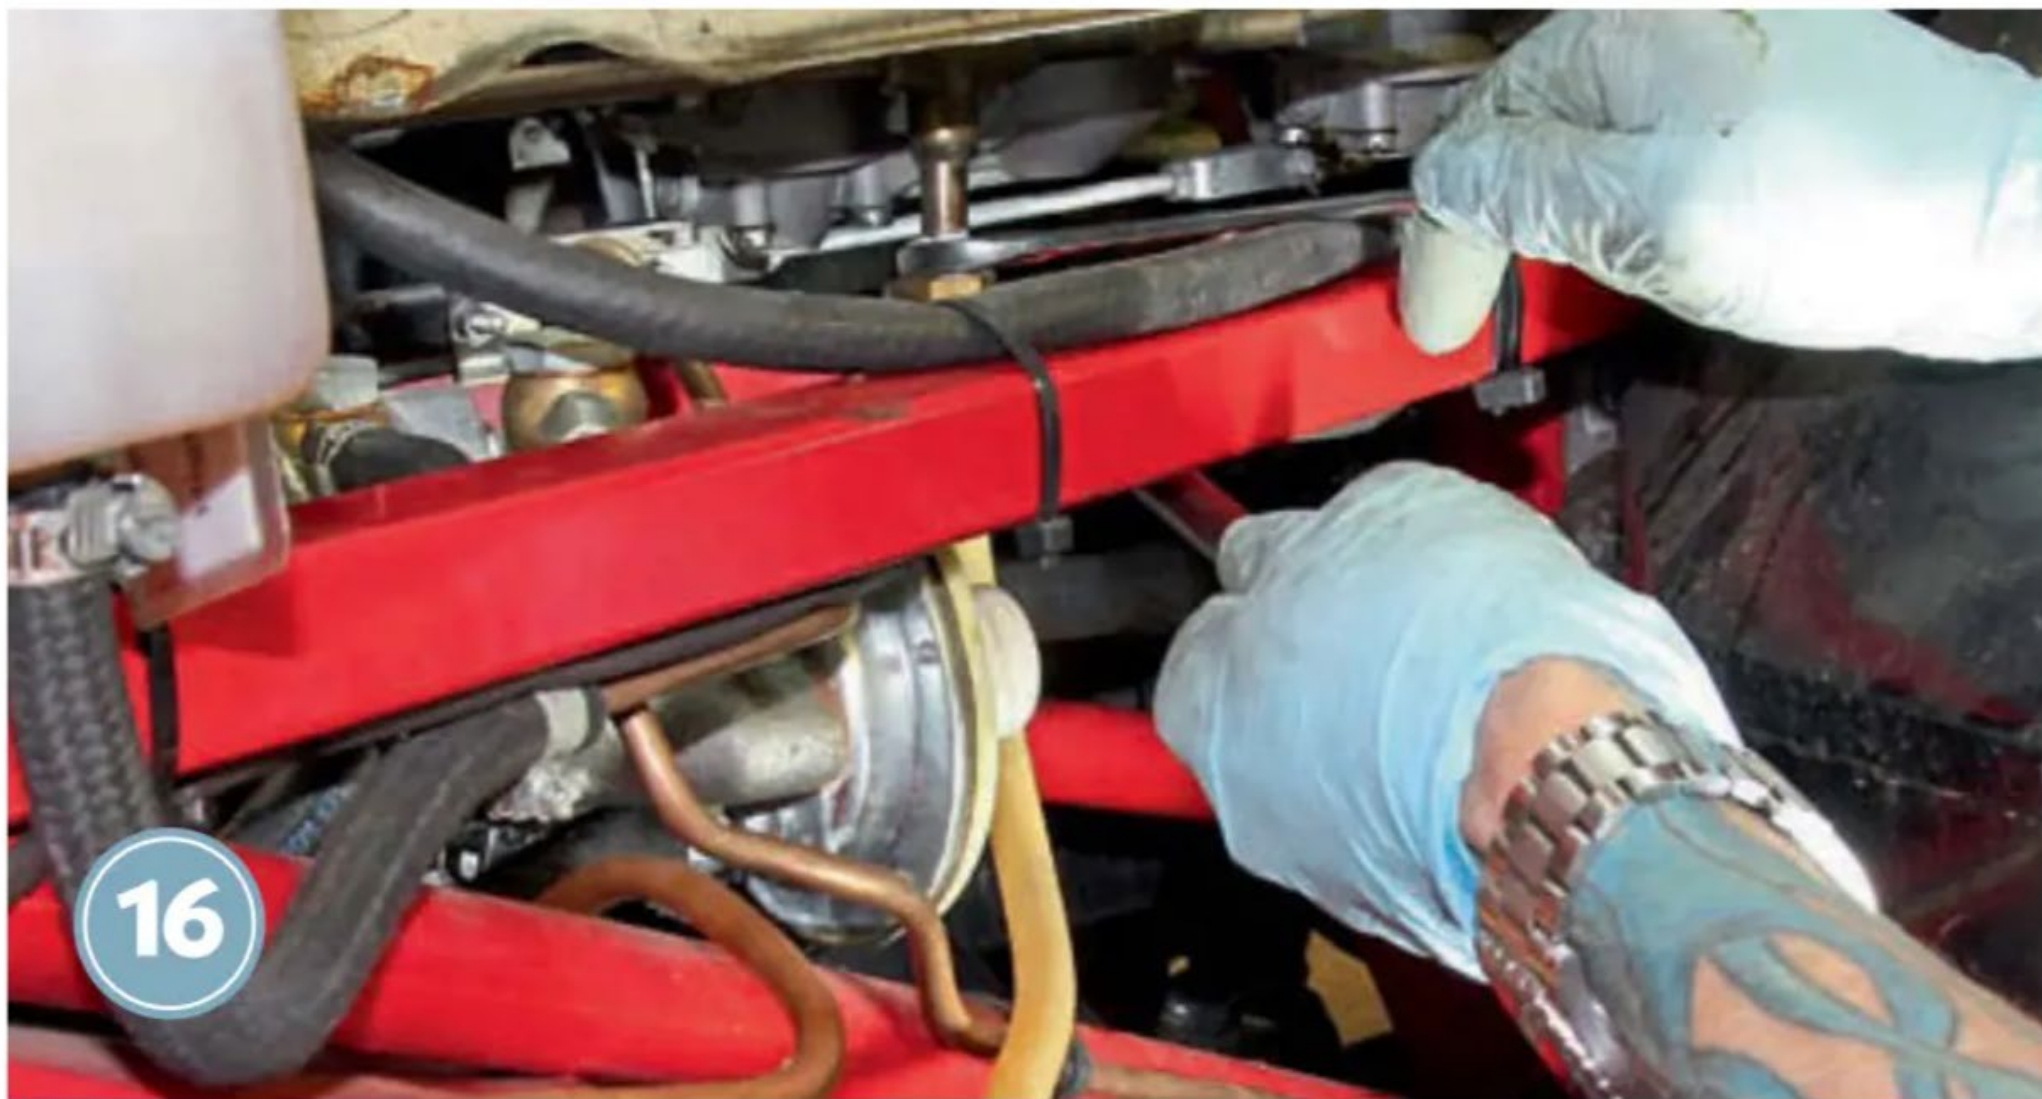
Shaun finds a couple of Whitworth spanners (3/8 and 5/16) to undo the fuel feed fastenings attached to the underside of the carburettor assembly. There are a few Whitworth fastenings on this E-type

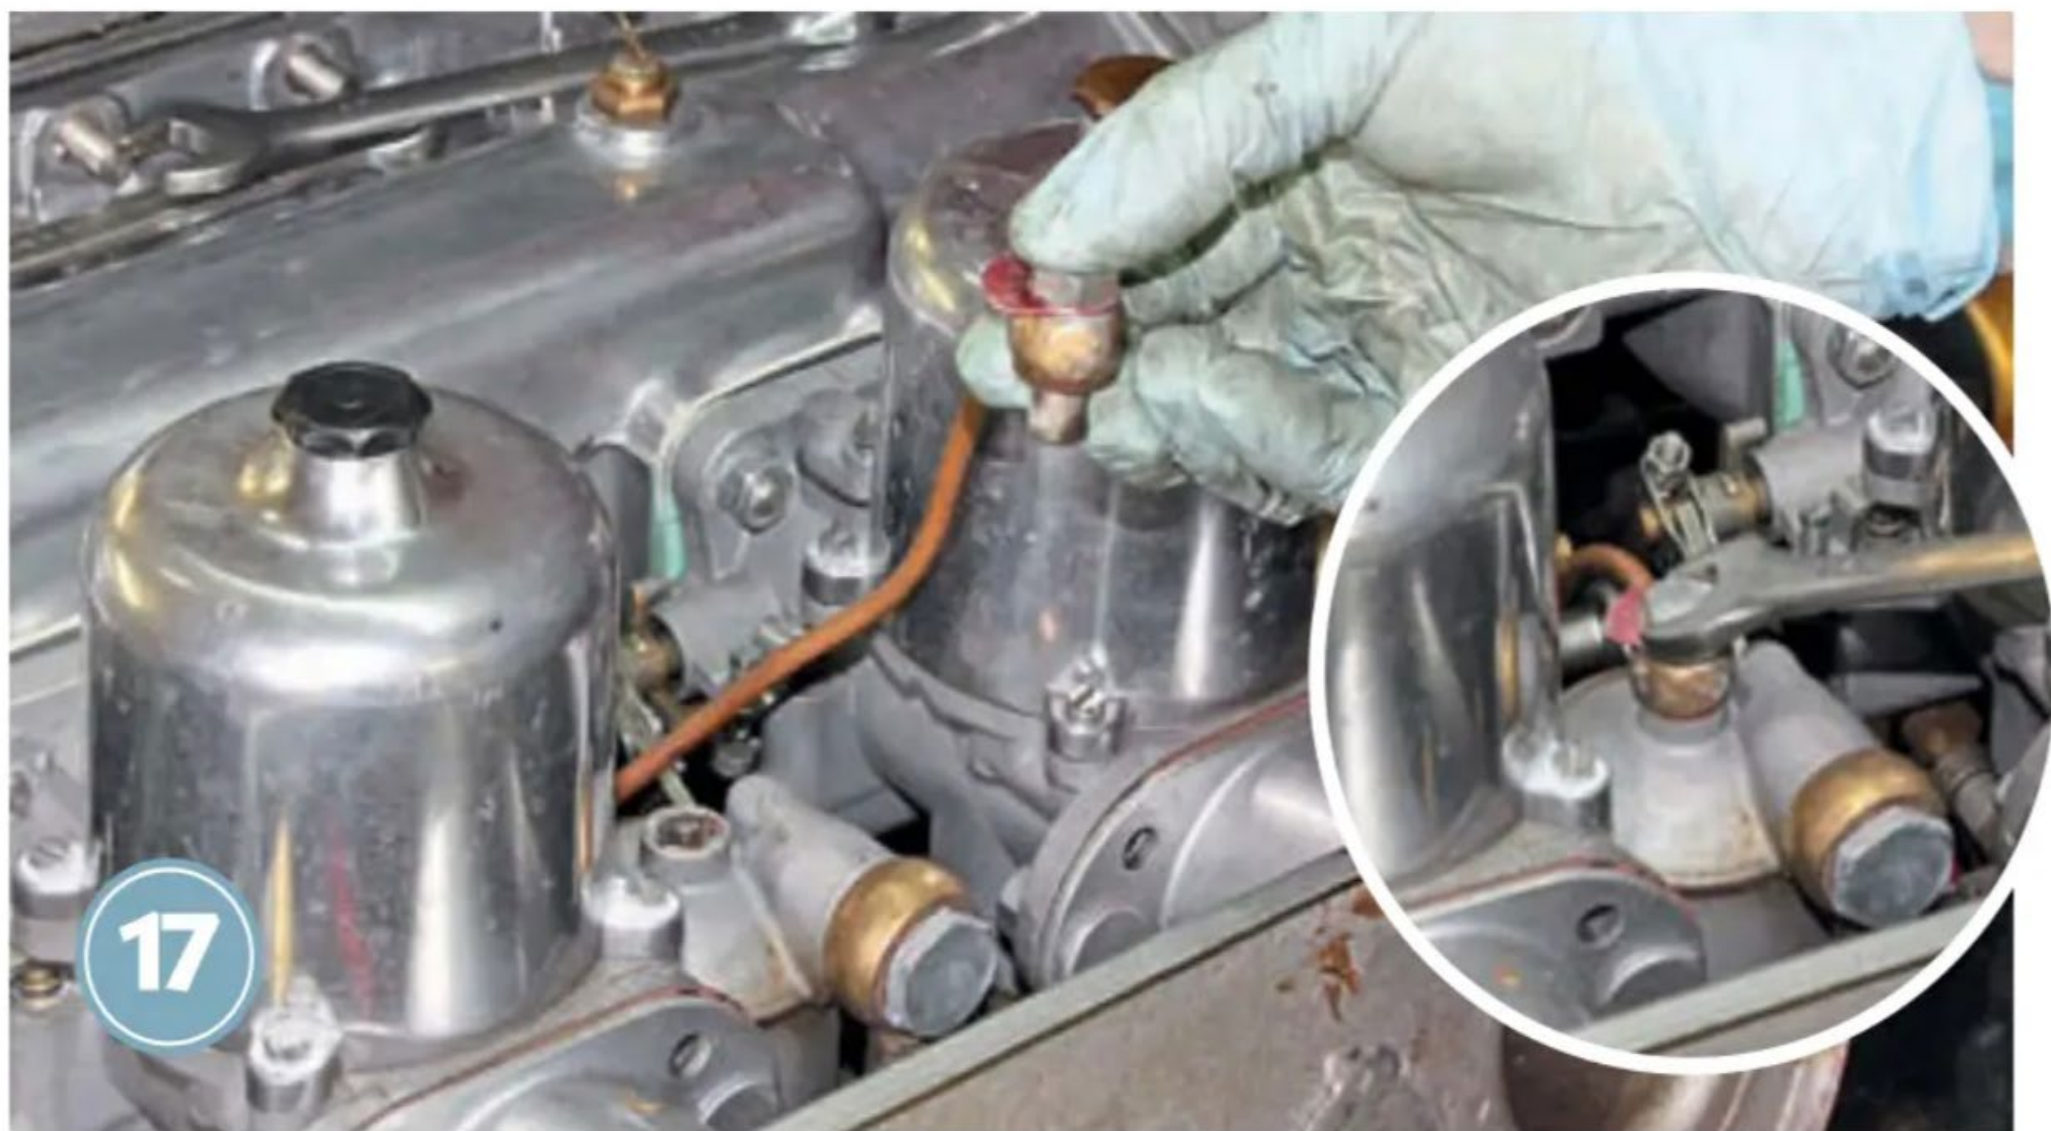
A 1/4 Whitworth spanner is used to undo the banjo bolt on the top of each carburettor for its breather pipe. Shaun says the pipes are originally made of steel, but these have been replaced with copper

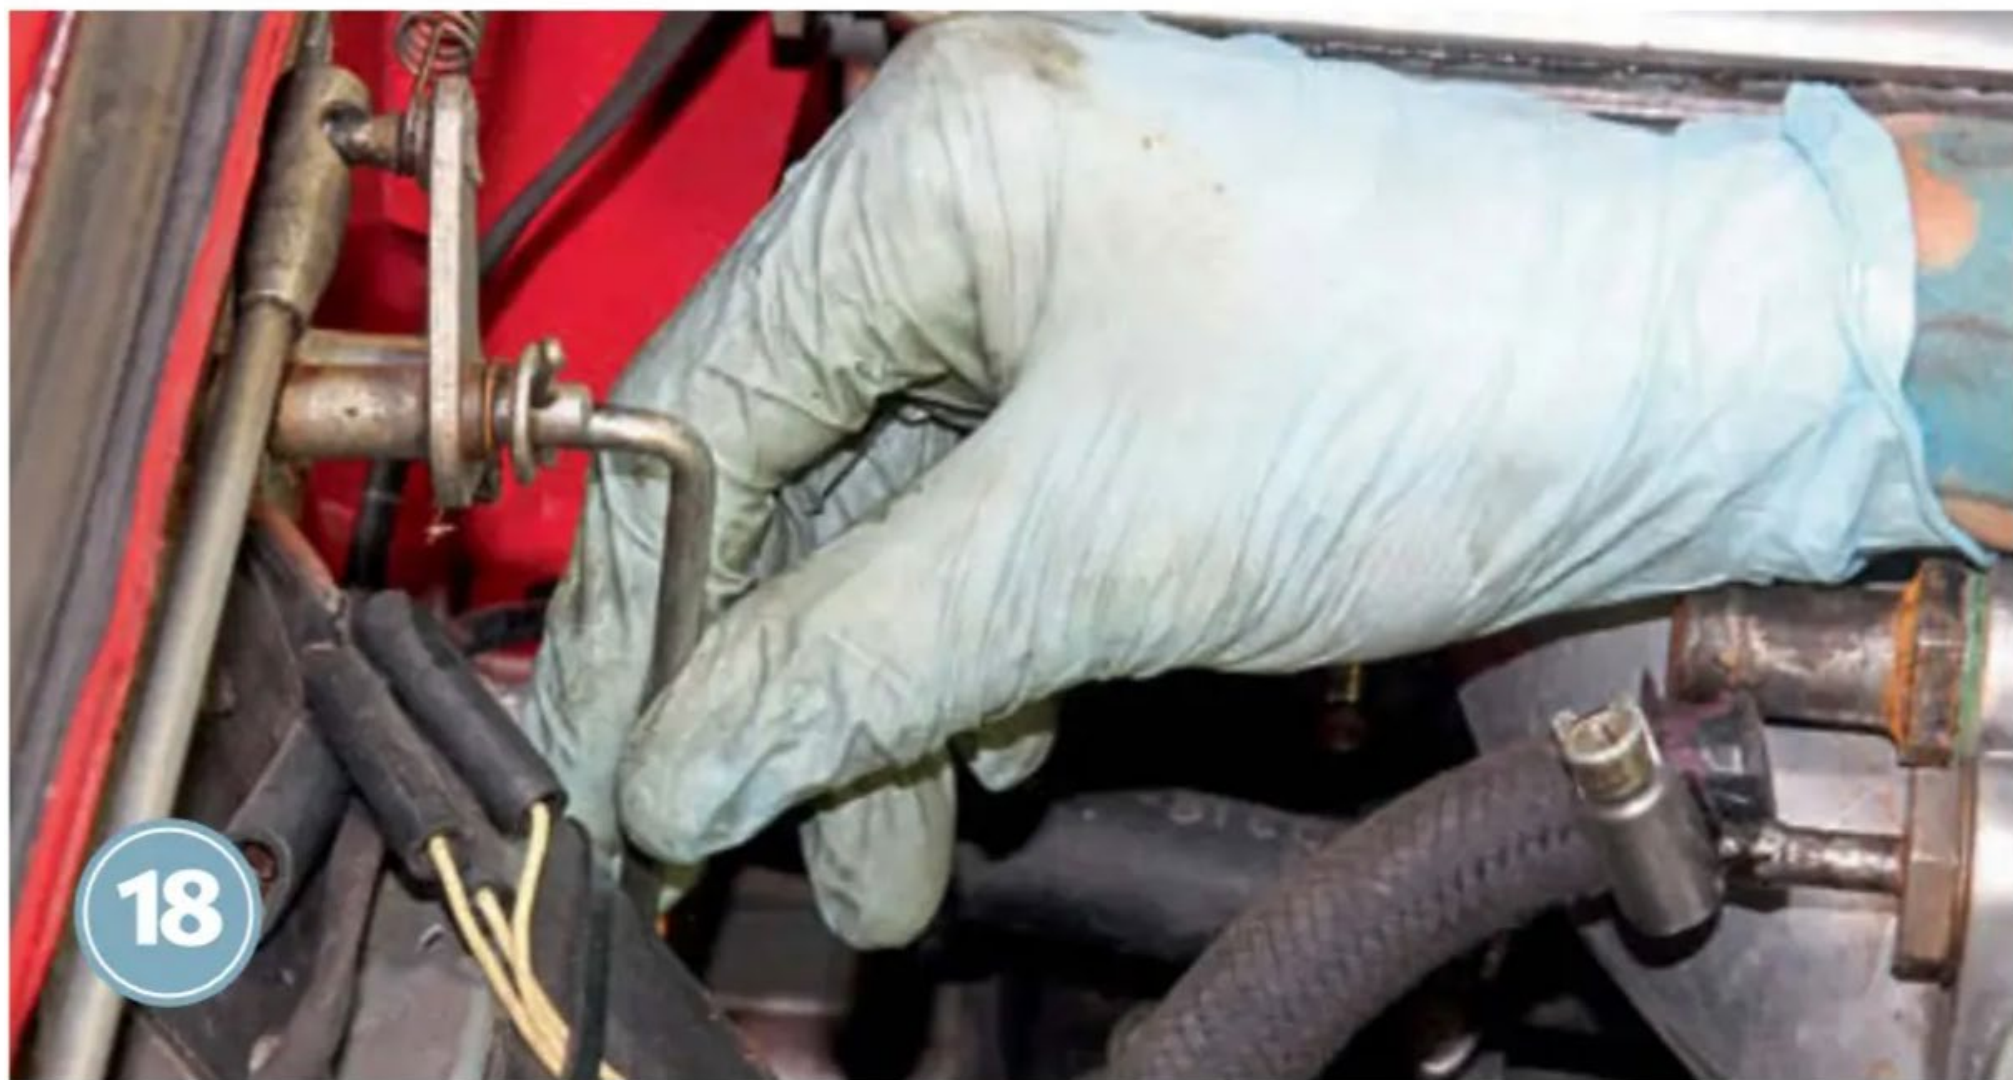
The throttle linkage needs to be detached. Shaun decides to disconnect it at the pivot arm on the bulkhead, extracting a small securing clip before releasing a metal rod

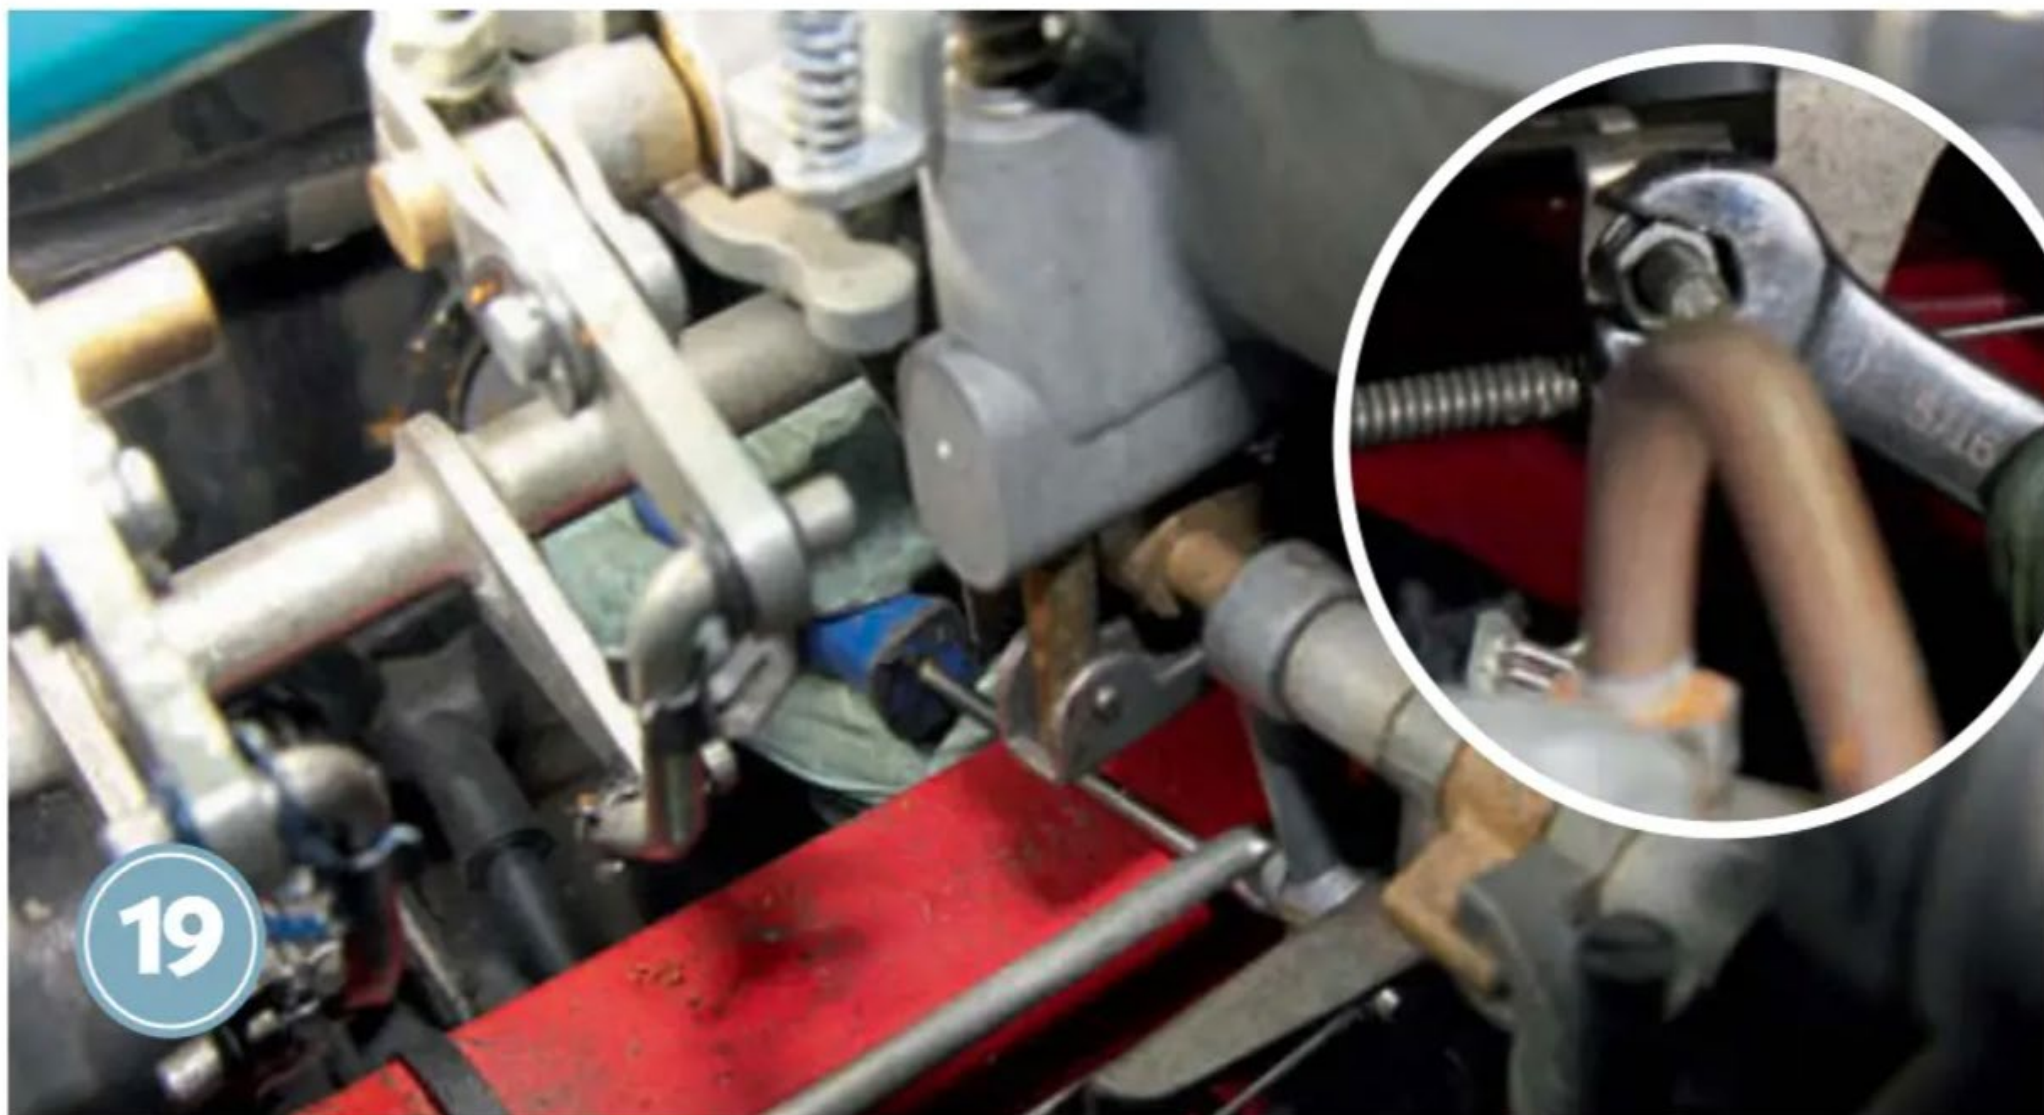
The choke cable also needs to be detached. Underneath the carbs, Shaun undoes a nut for a mount, then uses a small screwdriver to undo a screw that secures the end of the choke cable

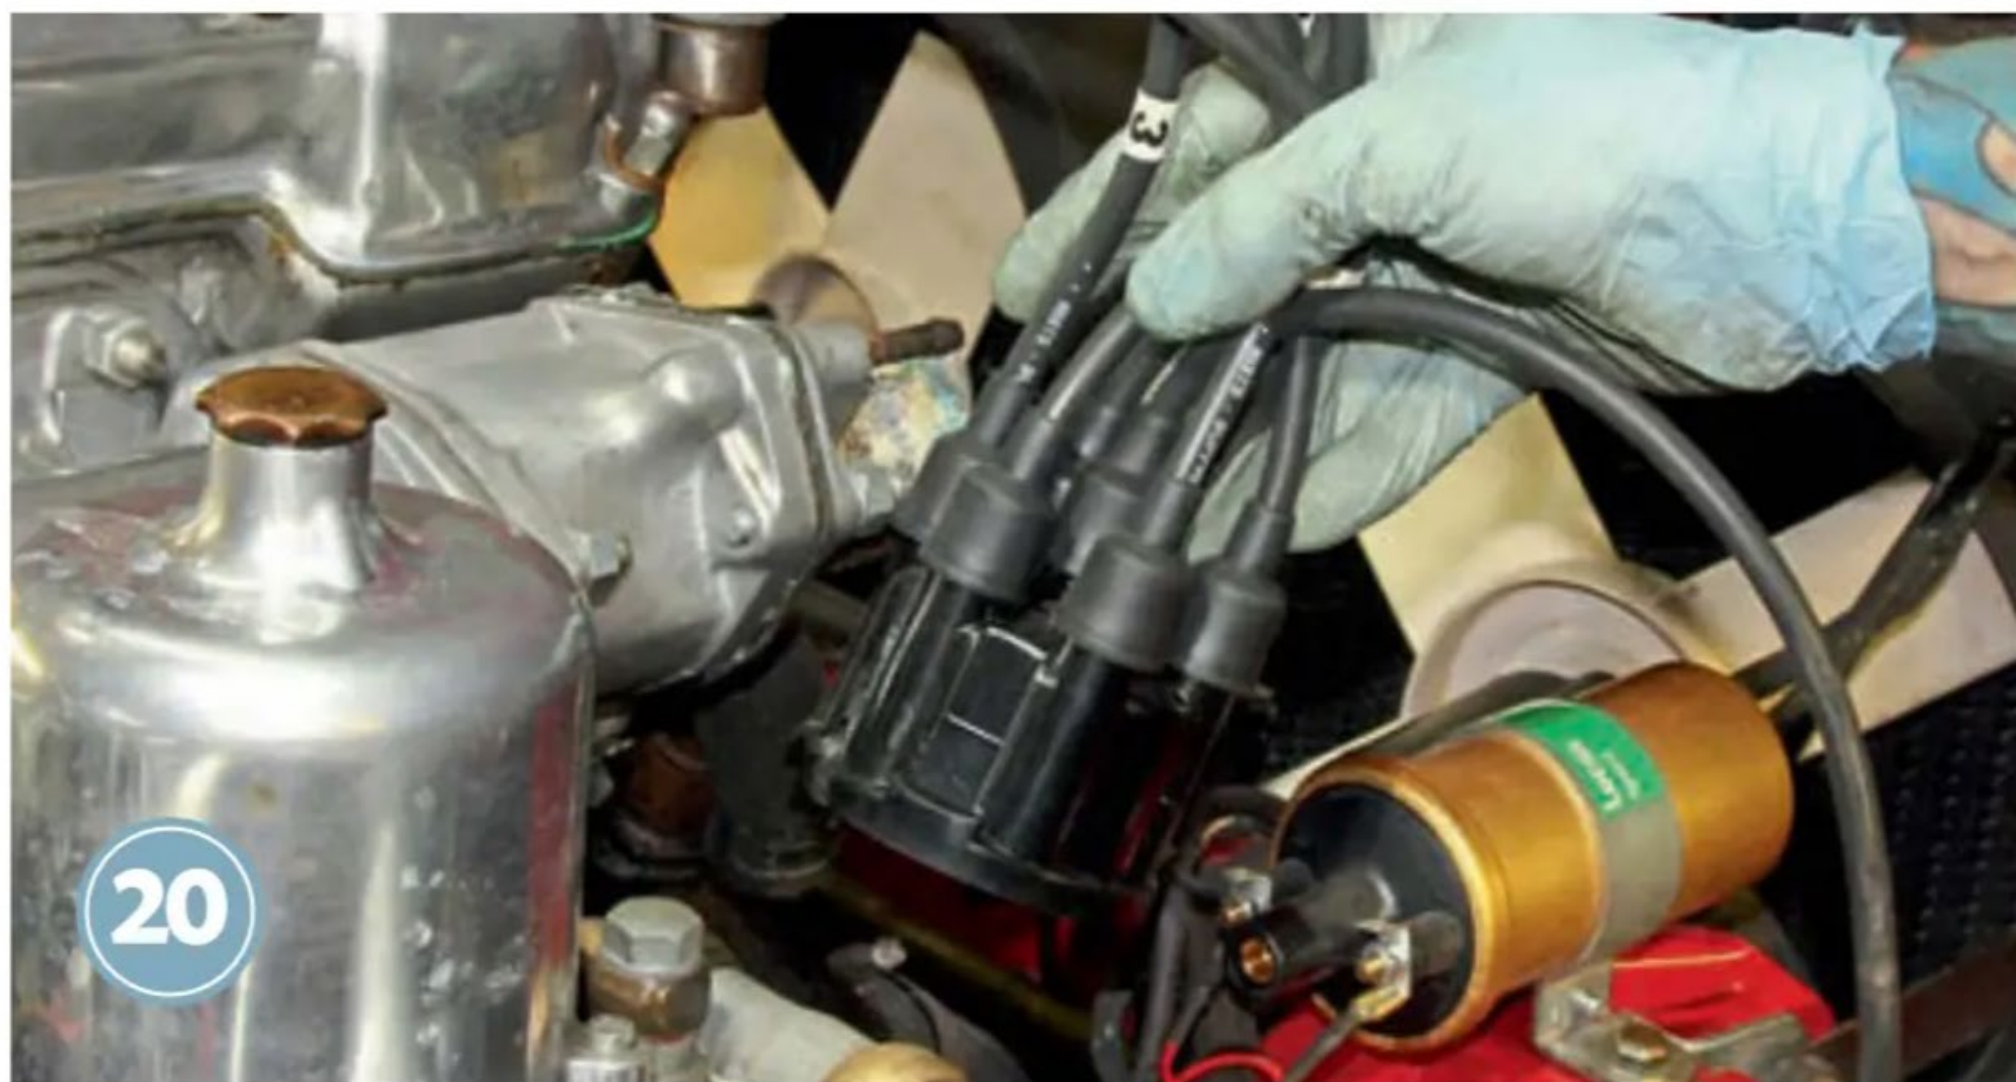
Shaun's almost ready to undo all of the inlet manifold nuts and remove the complete assembly. He removes the distributor cap to improve access to one of those manifold nuts
