E-type engine removal

PART ONE: In the first of a two-part series, we follow the preparation work required prior to removing the engine and gearbox from an E-type

PART TWO: In the final instalment, we follow the 4.2-litre XK engine and manual gearbox being removed from a Series I E-type

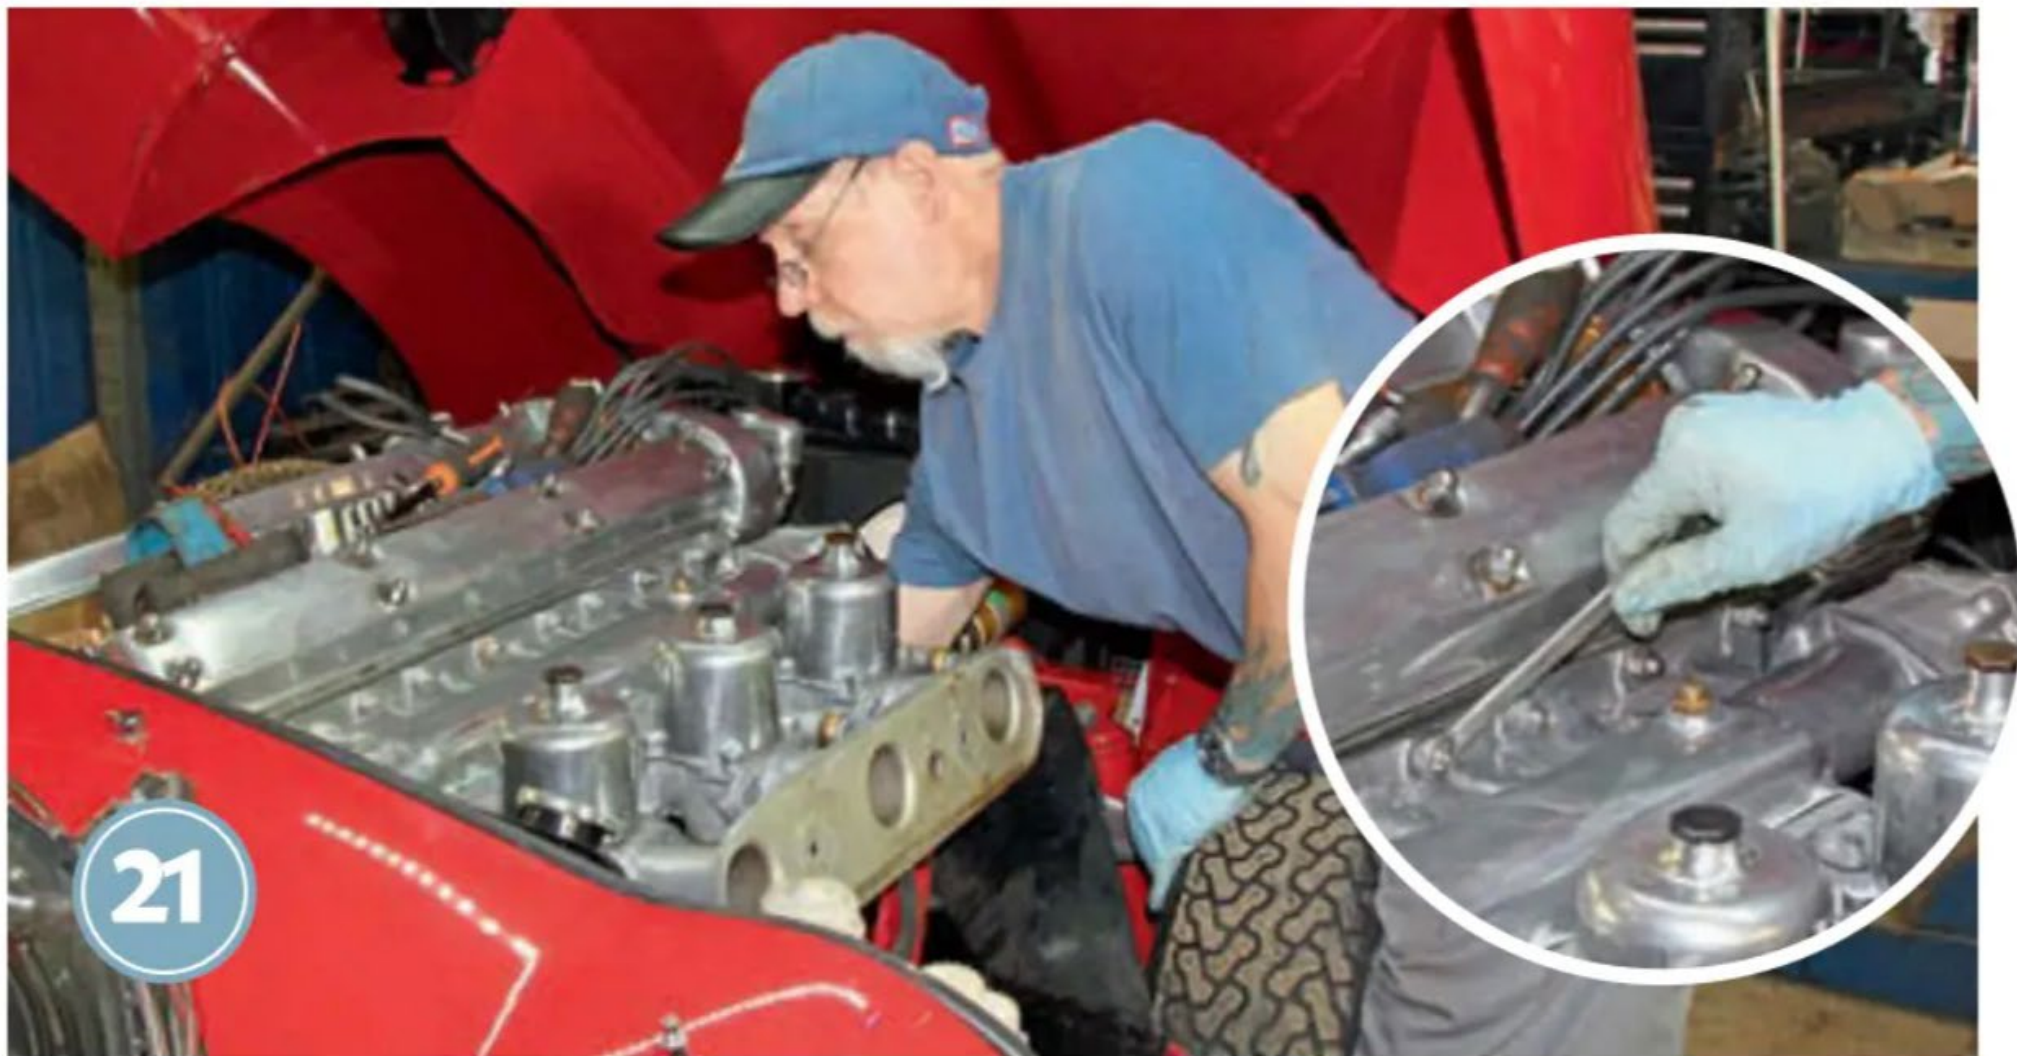
21

There is a total of 18 ½in nuts to undo for the inlet manifold. Shaun can clearly do this blindfolded and uses various spanners and sockets to reach around the manifold and undo them

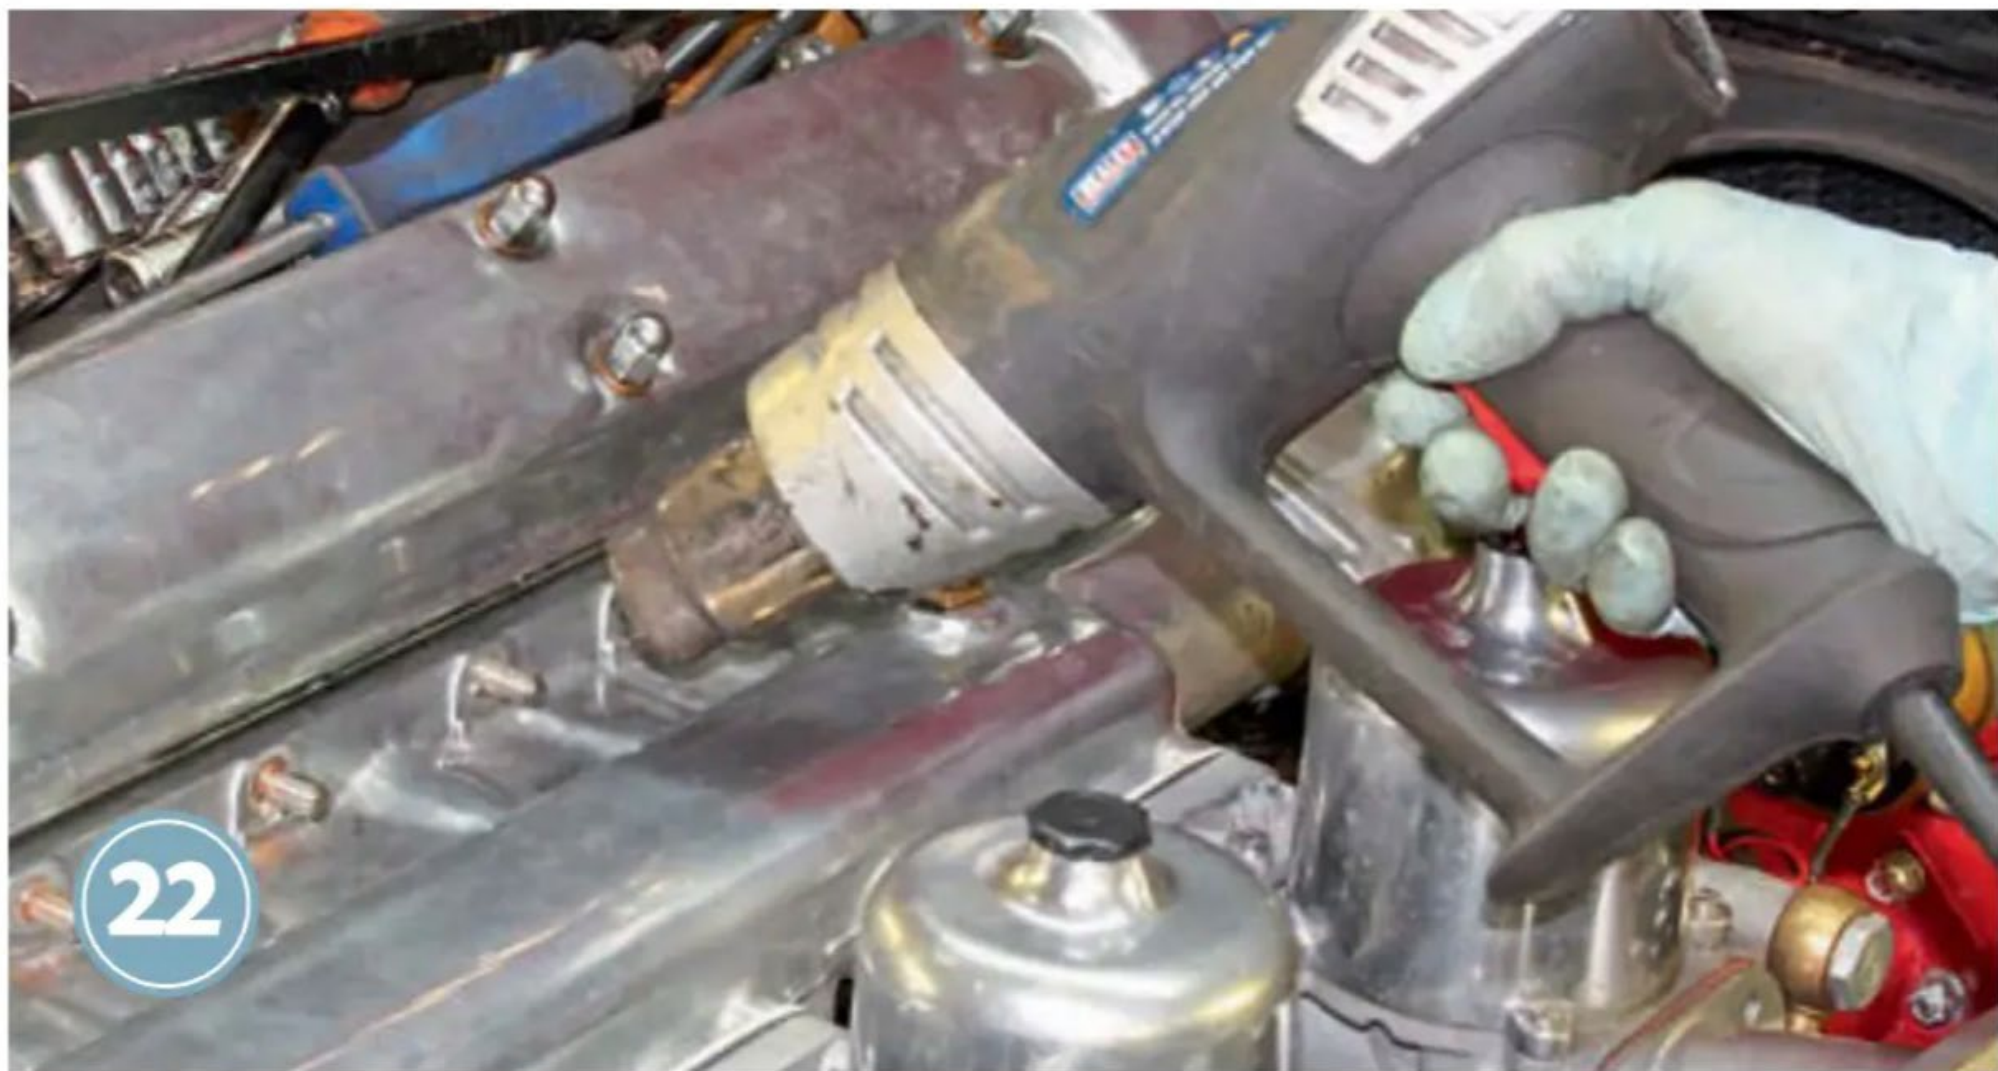
Typically, the inlet manifold initially refuses to budge once all of its nuts have been undone. Shaun carefully levers against it with a pry bar, but it's still stuck. Then he applies heat with a heat gun

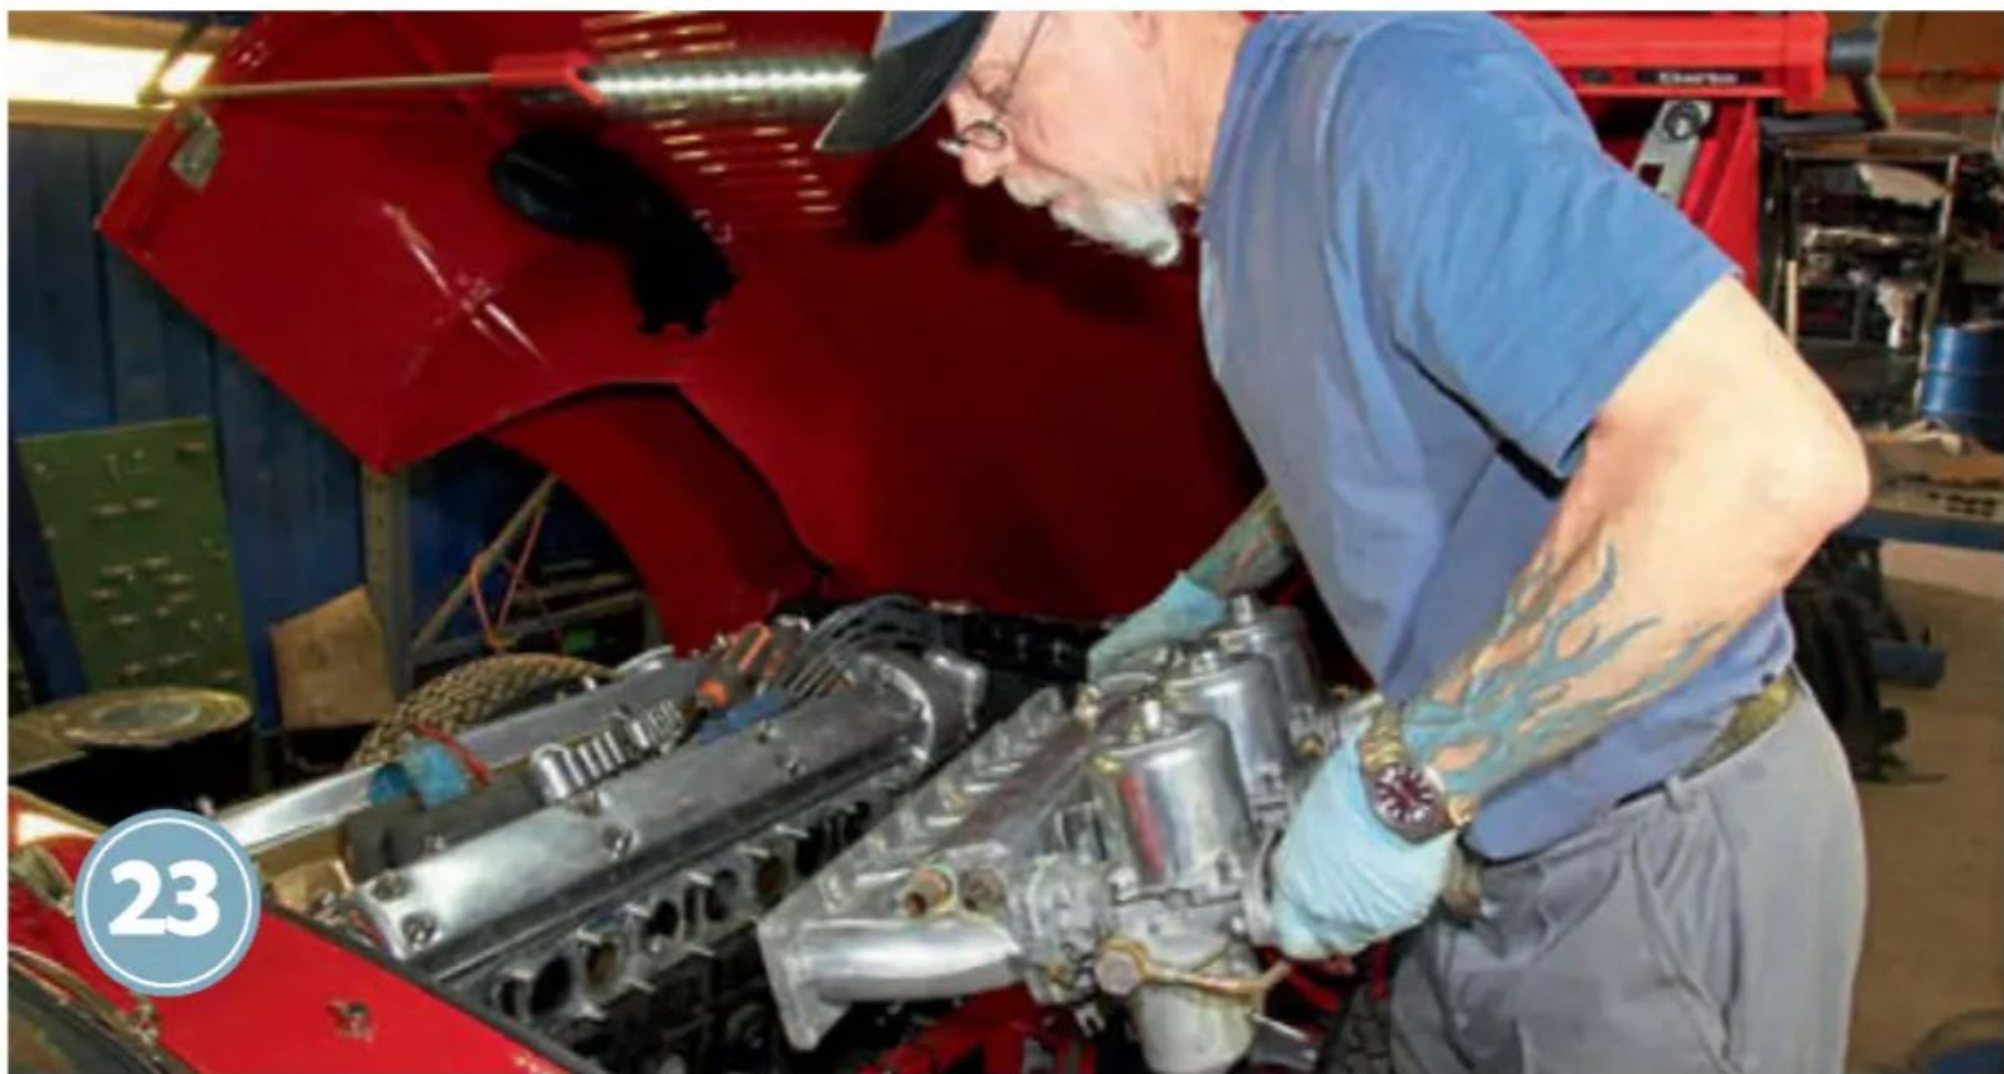
23

Eventually, there's the reassuring sound of the inlet manifold releasing itself from the cylinder head and we all breathe a sigh of relief – we didn't want to risk fracturing it

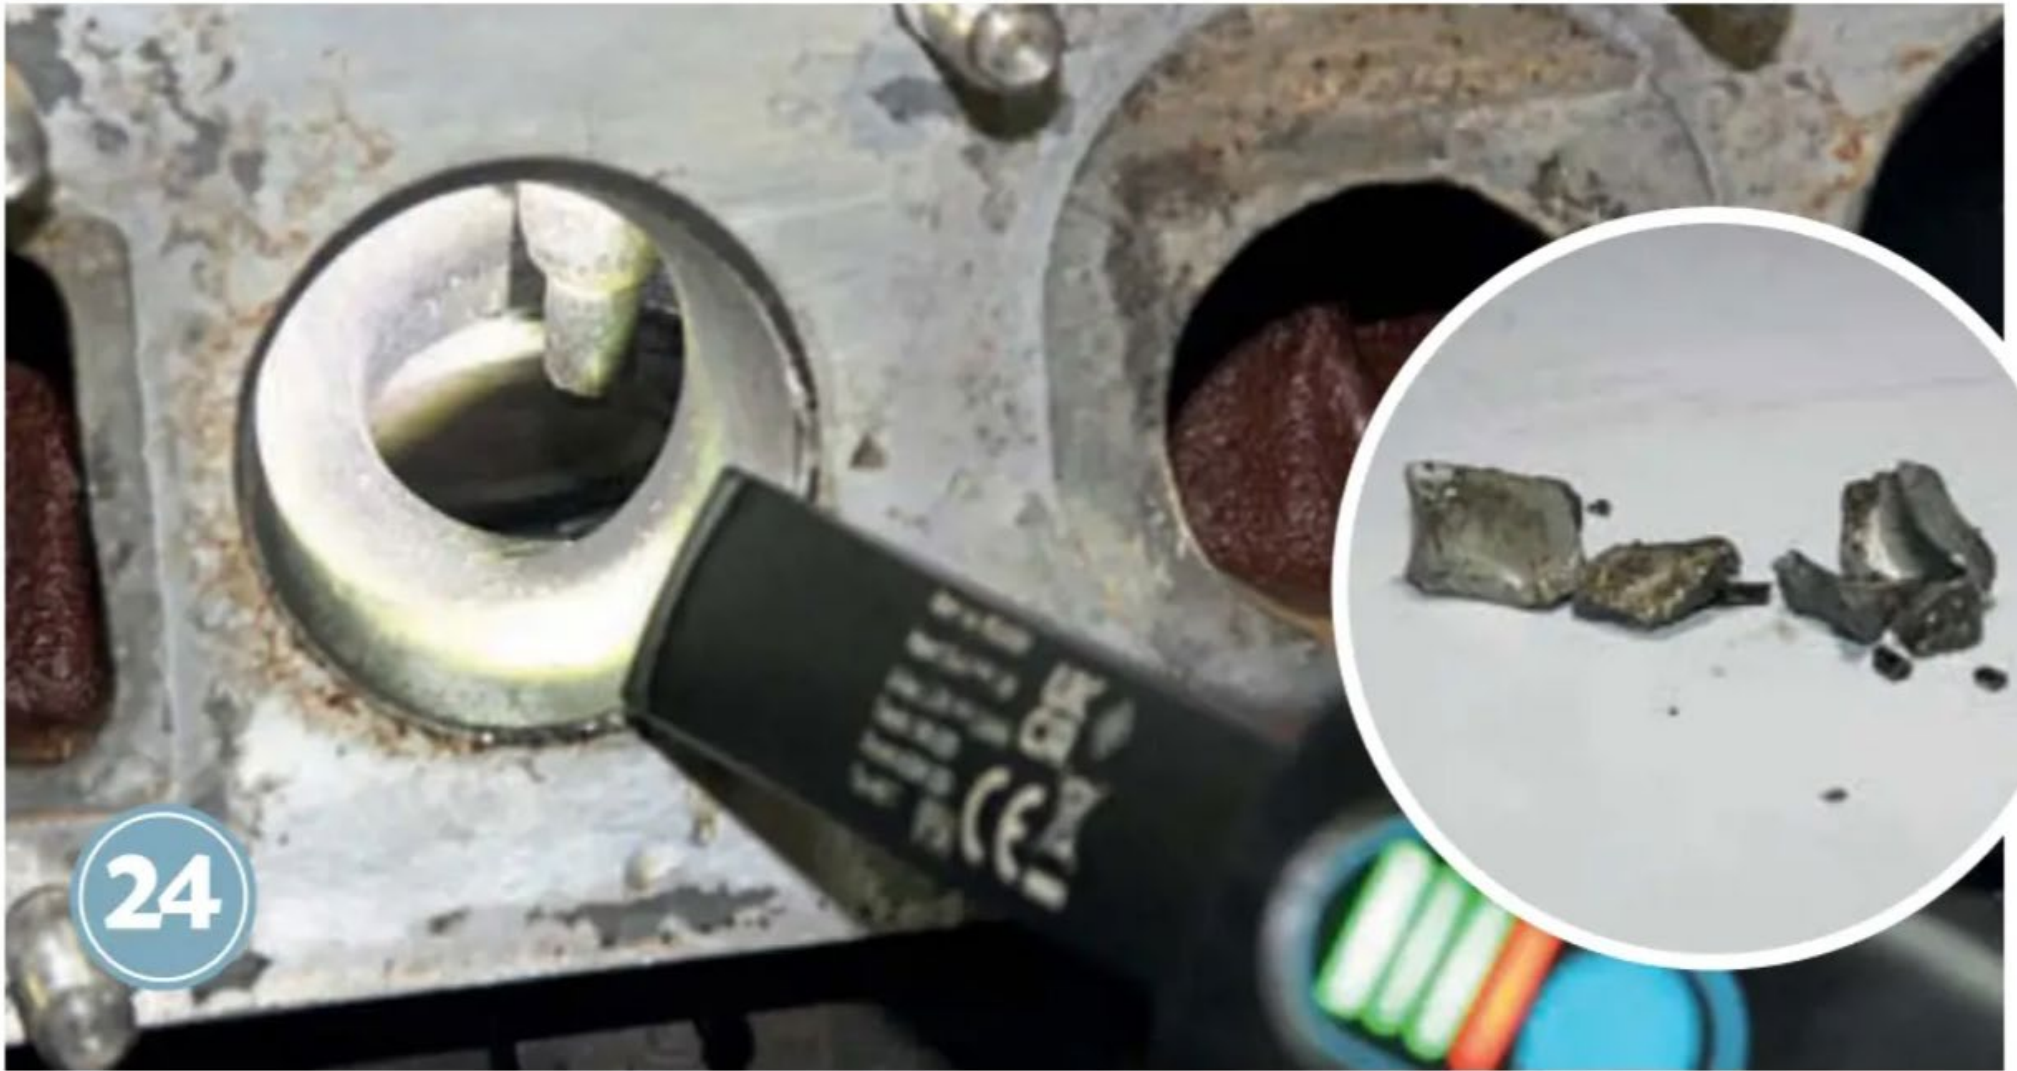
Looking inside the inlet port for cylinder number four, there's no valve. There's more piston debris inside inlet port number three. Has it been forced out of cylinder four and sucked into here?

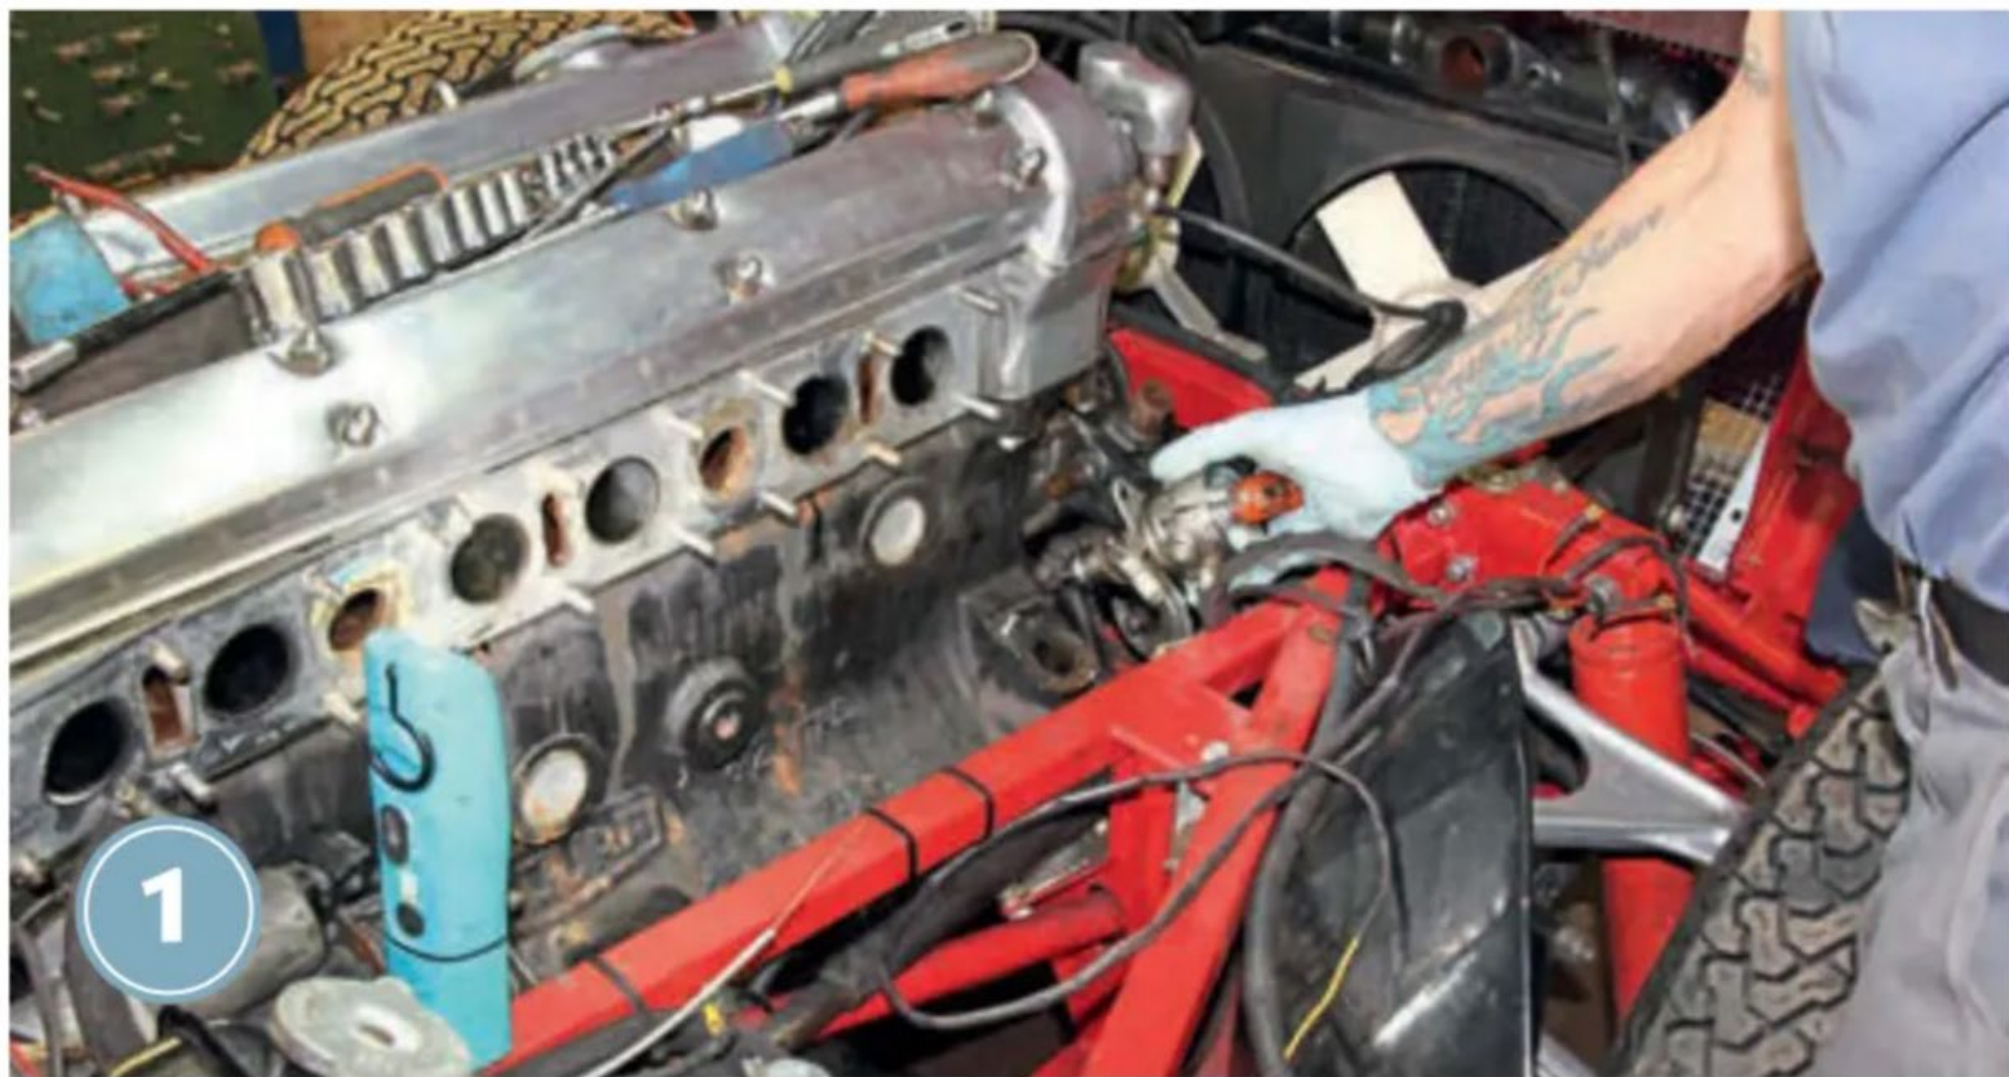
Having removed the inlet manifold and carbs, Shaun extracts the distributor, which in this case is a 123 Ignition unit. The engine cannot be reused, so there's no point in timing it up with the distributor

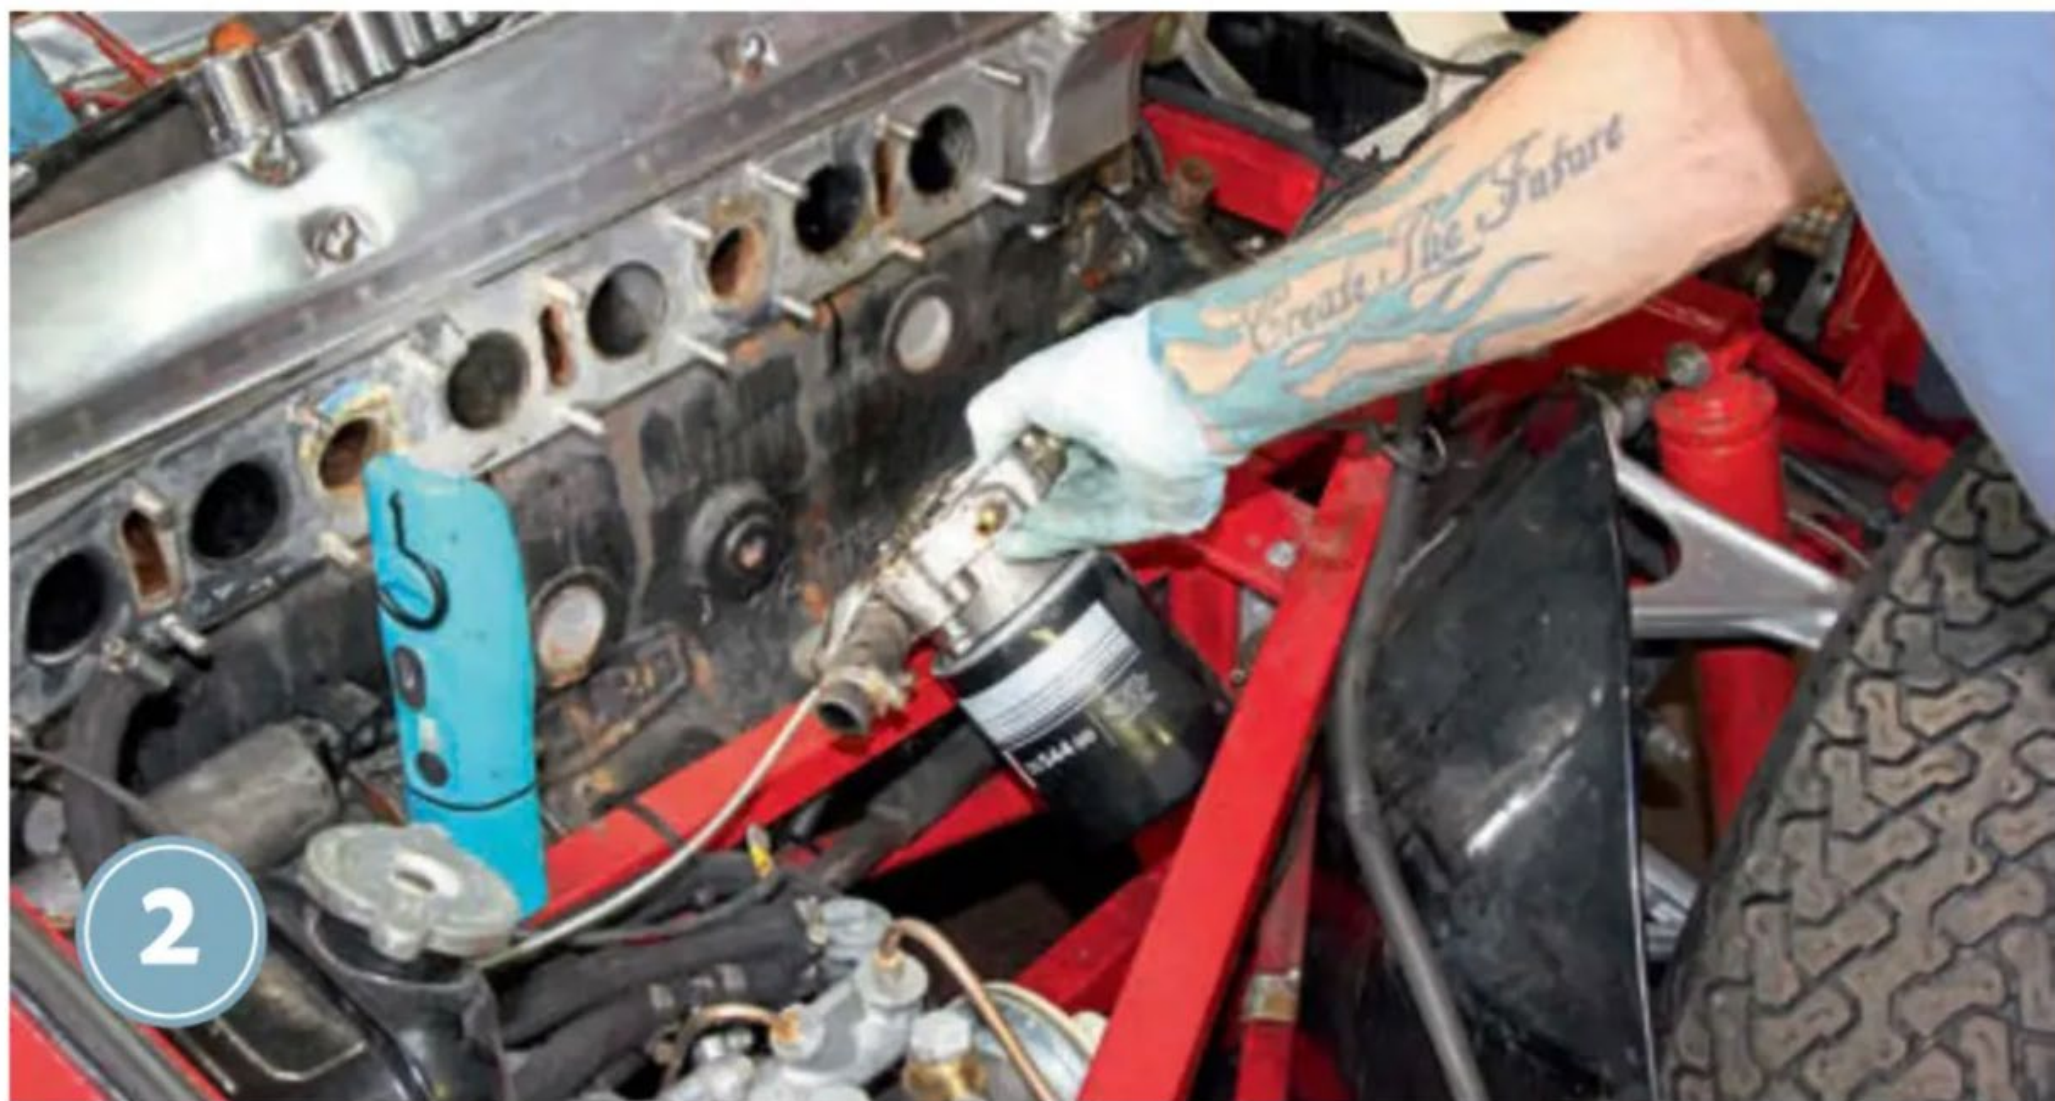
There's also a spin-on oil filter instead of the original canister. The oil has already been drained, so the entire oil filter housing is removed, along with a feed for the oil pressure gauge

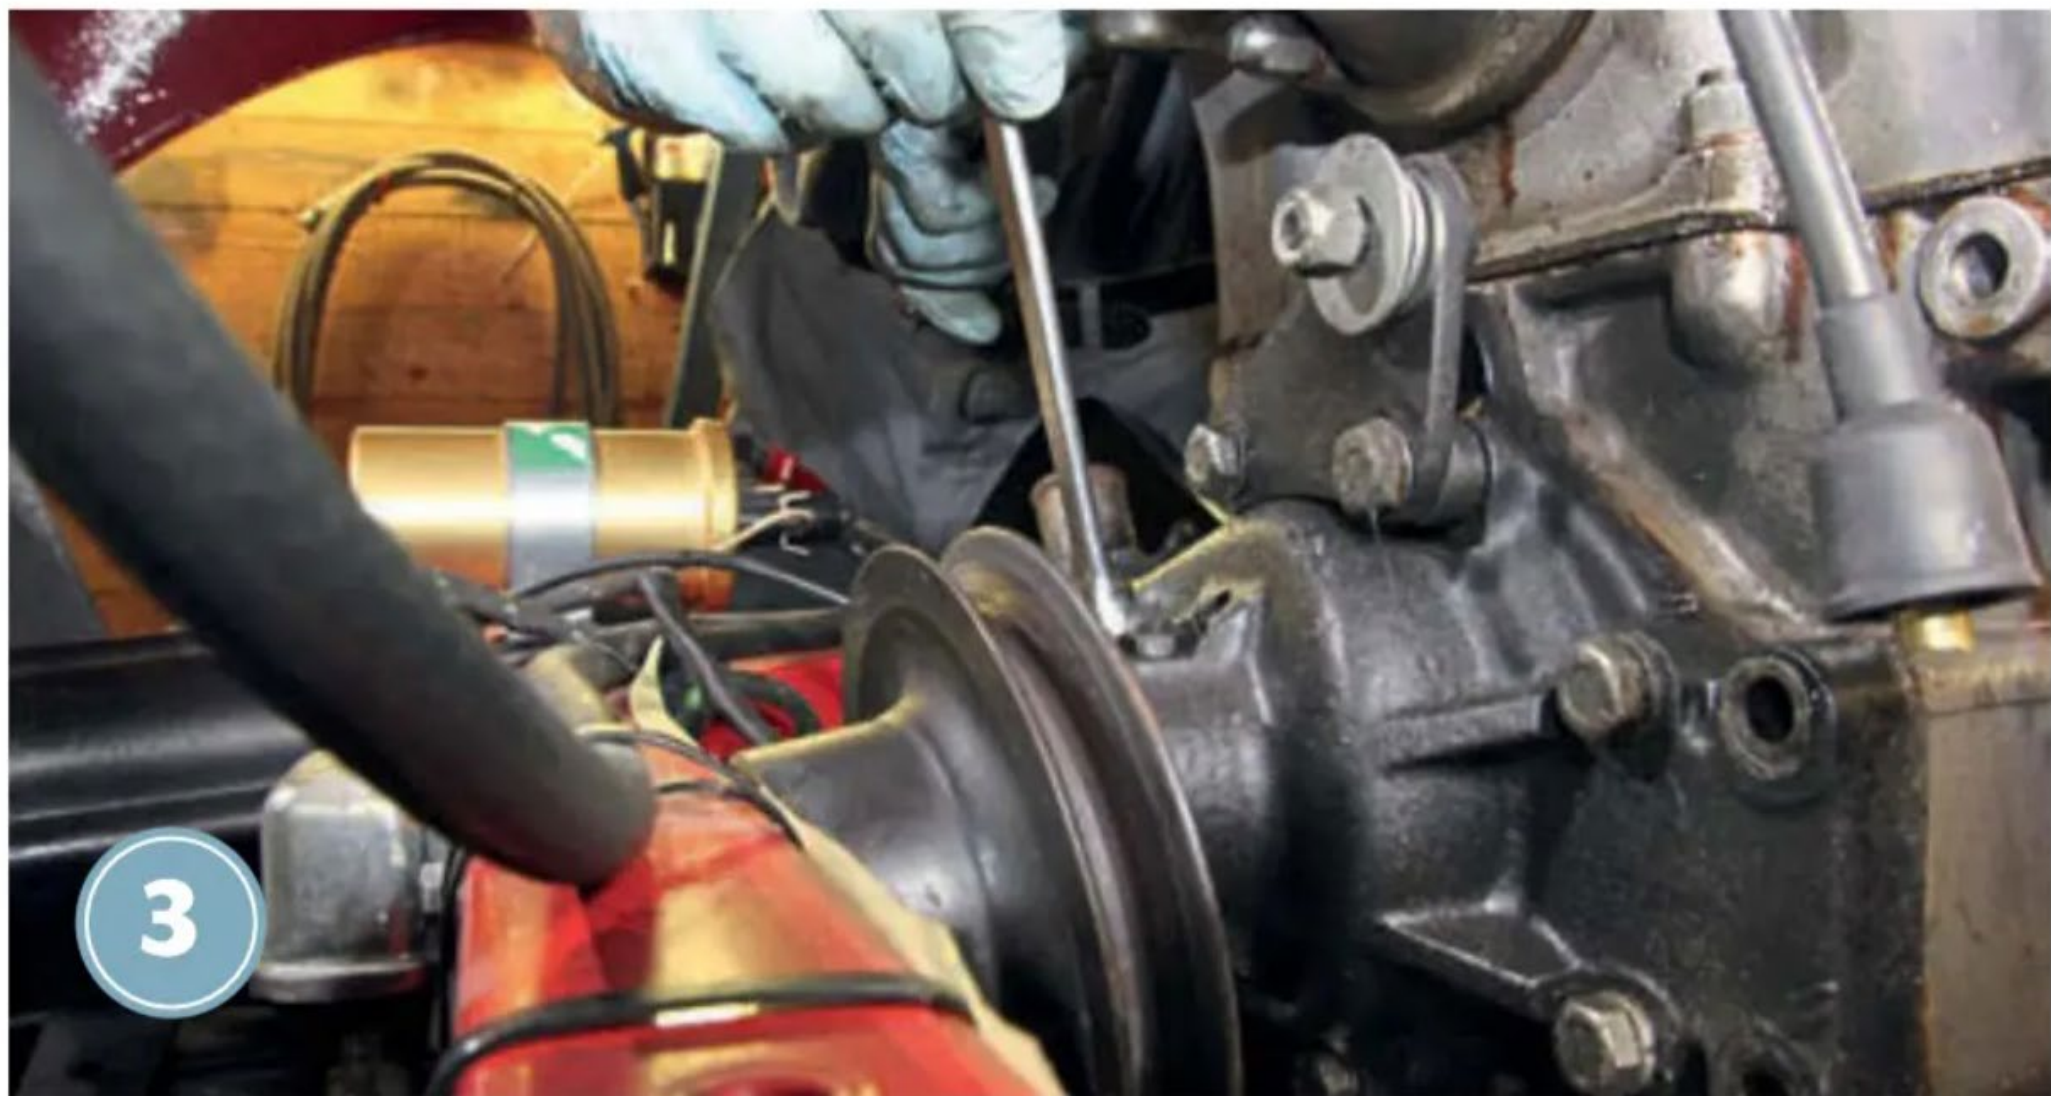
The water pump can foul the framework when lowering the engine and gearbox, so it's removed. The pulley is detached (four 7/16in bolts) to access one of the pump's mounting bolts

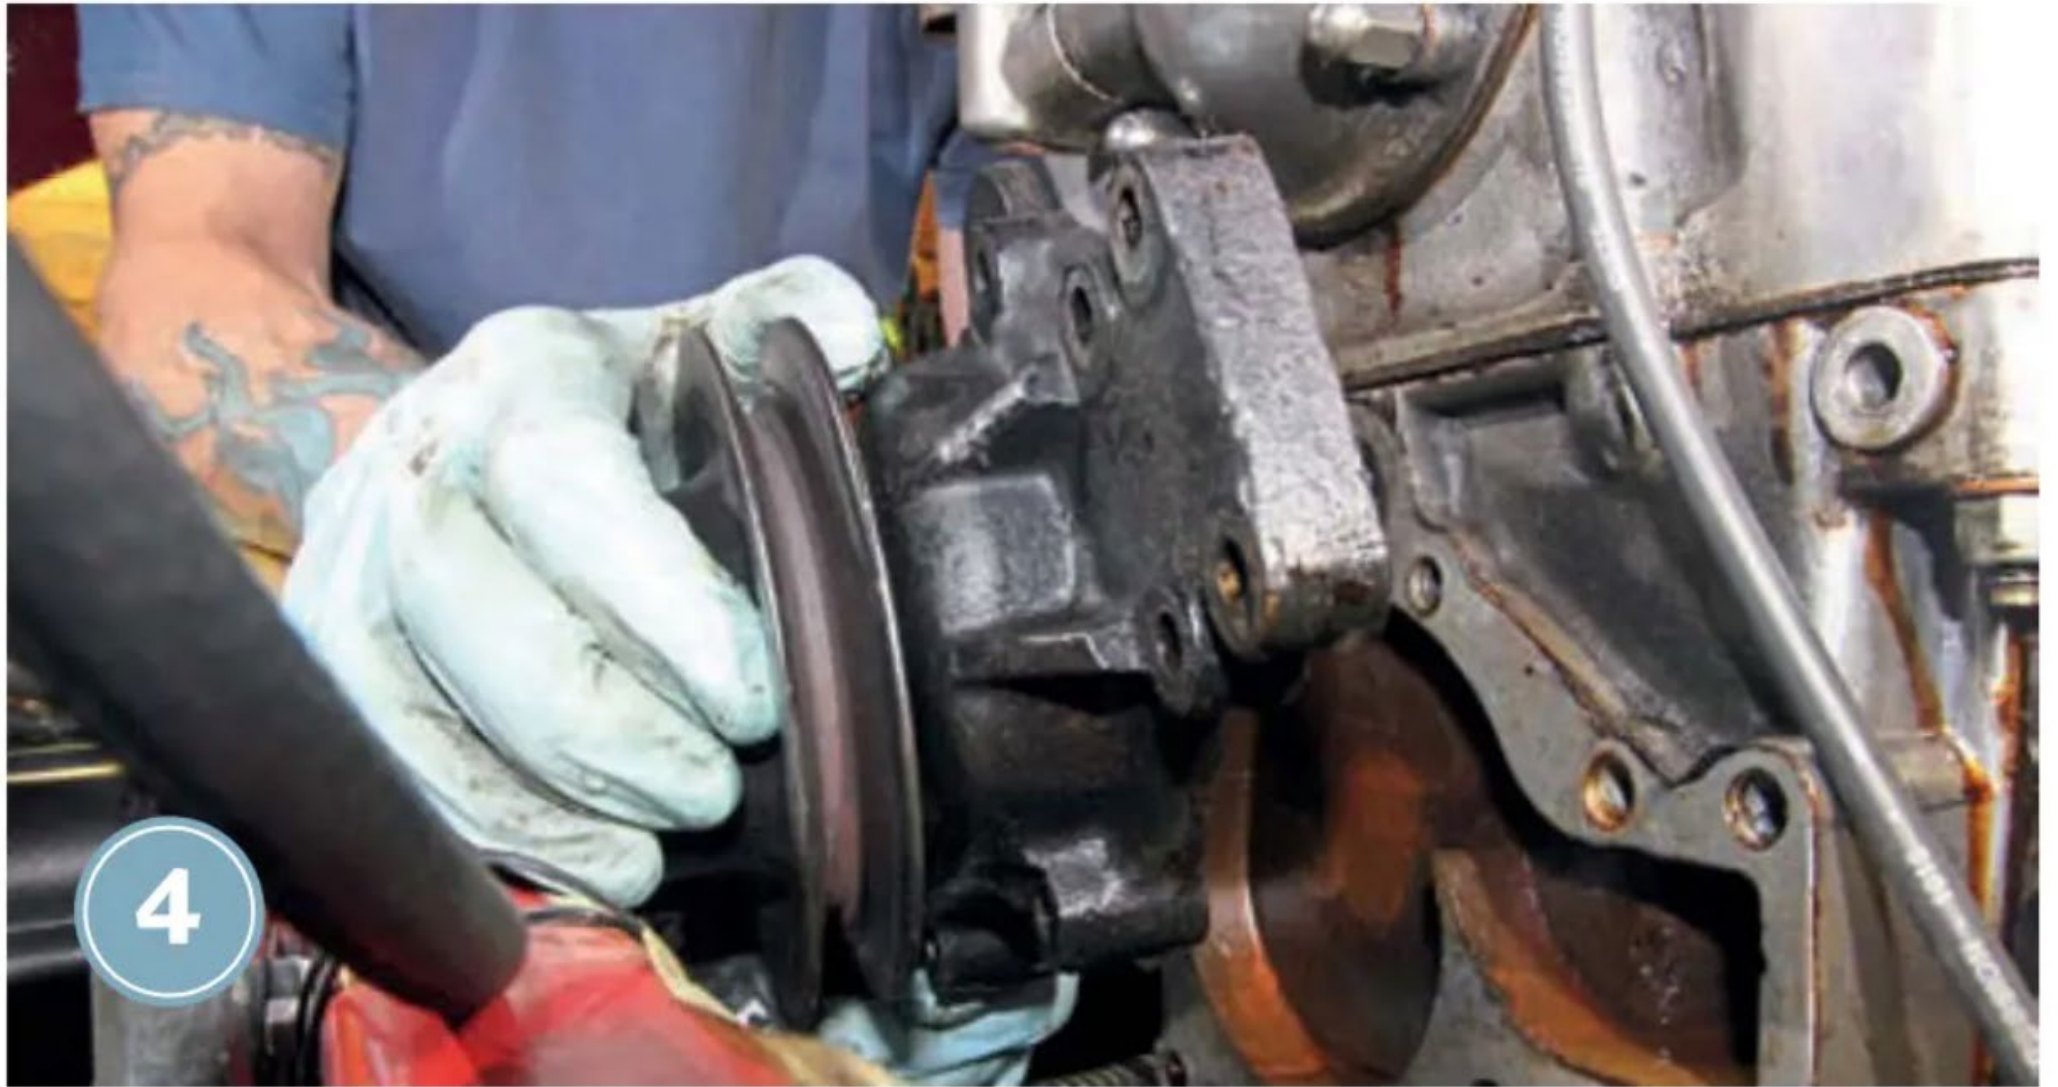
With insufficient room to fully remove the water pump pulley, it has to be removed with the pump after undoing nine 1/2in mounting bolts. The coolant has already been drained

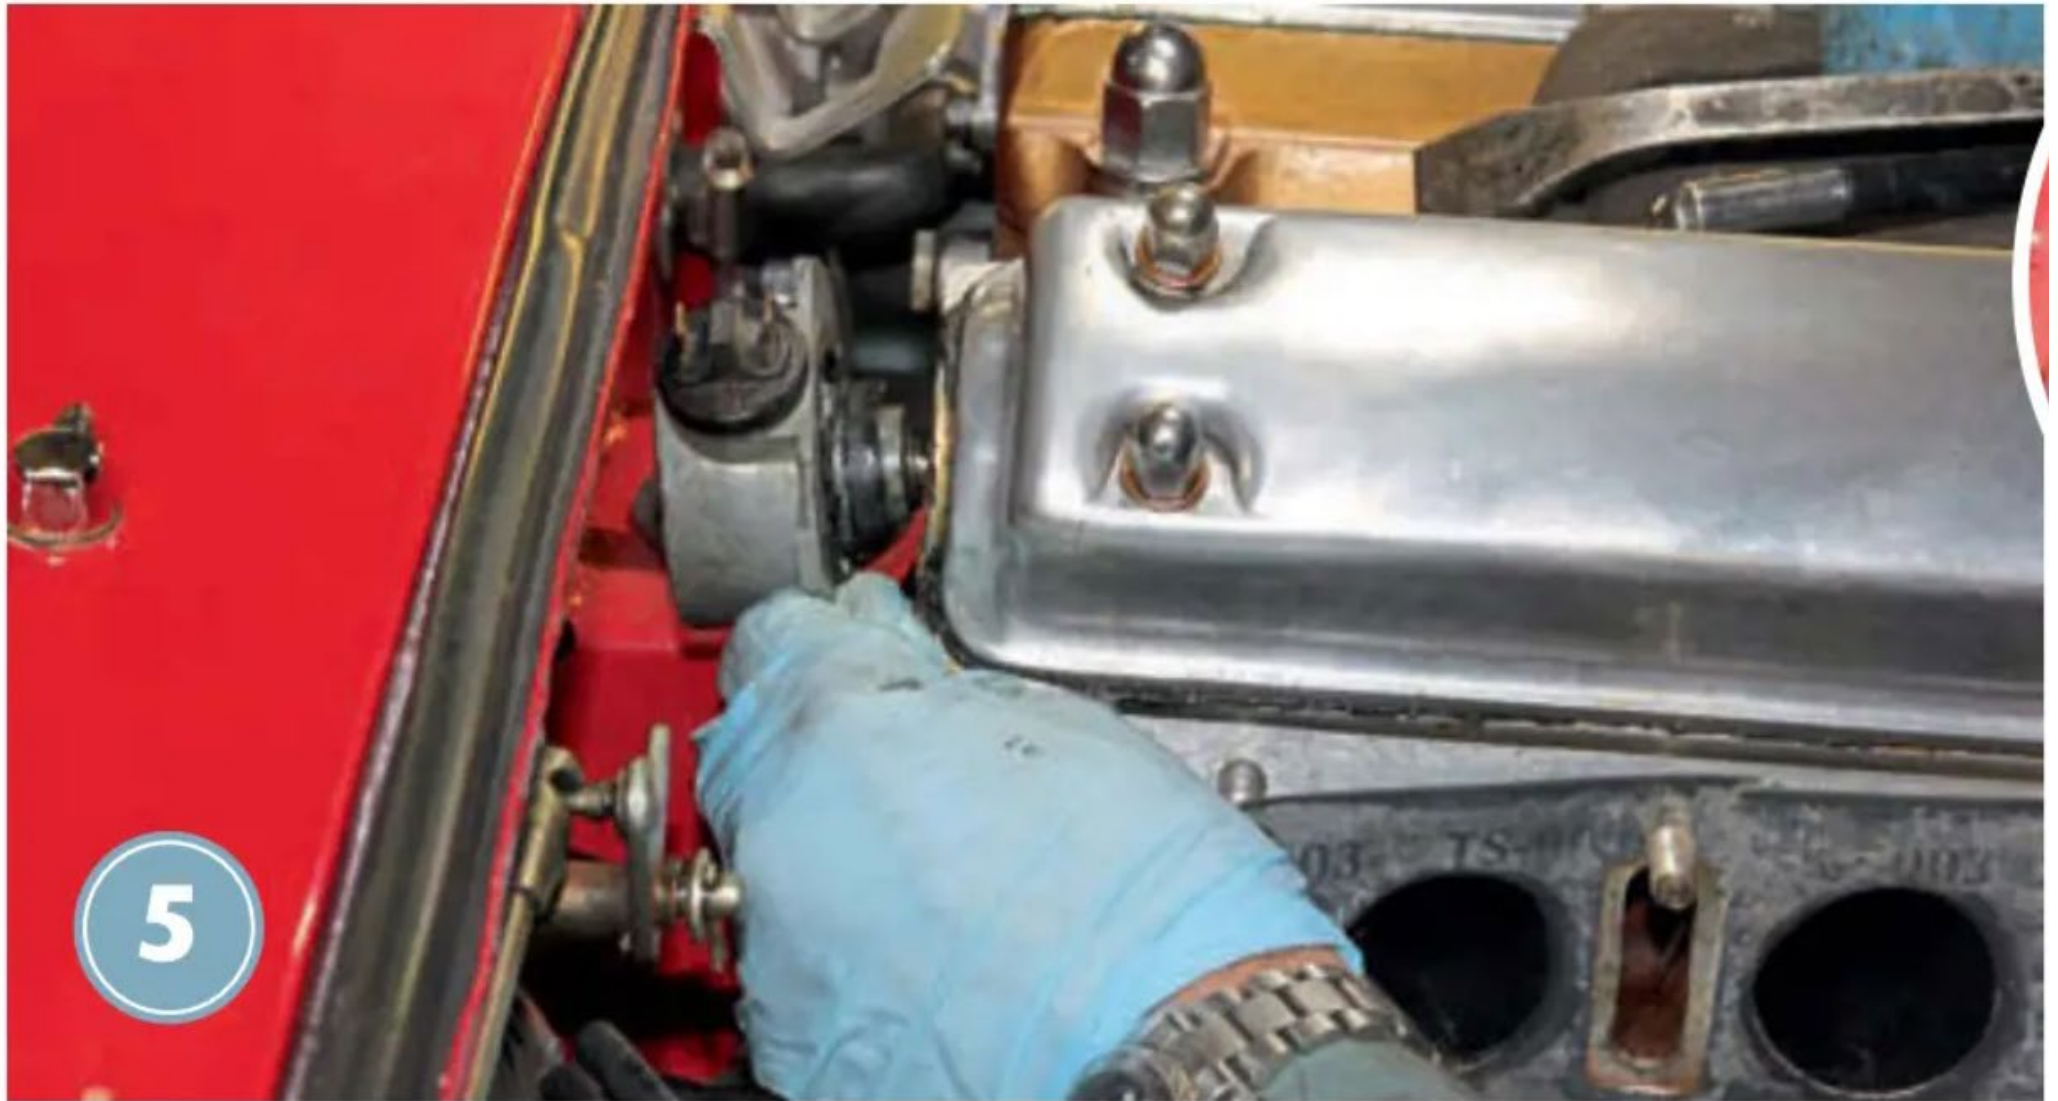
The tachometer drive attached to the back of the cylinder head (inlet side) is removed to avoid damaging it. Three 3/16in hex mounting screws are undone before it can be removed

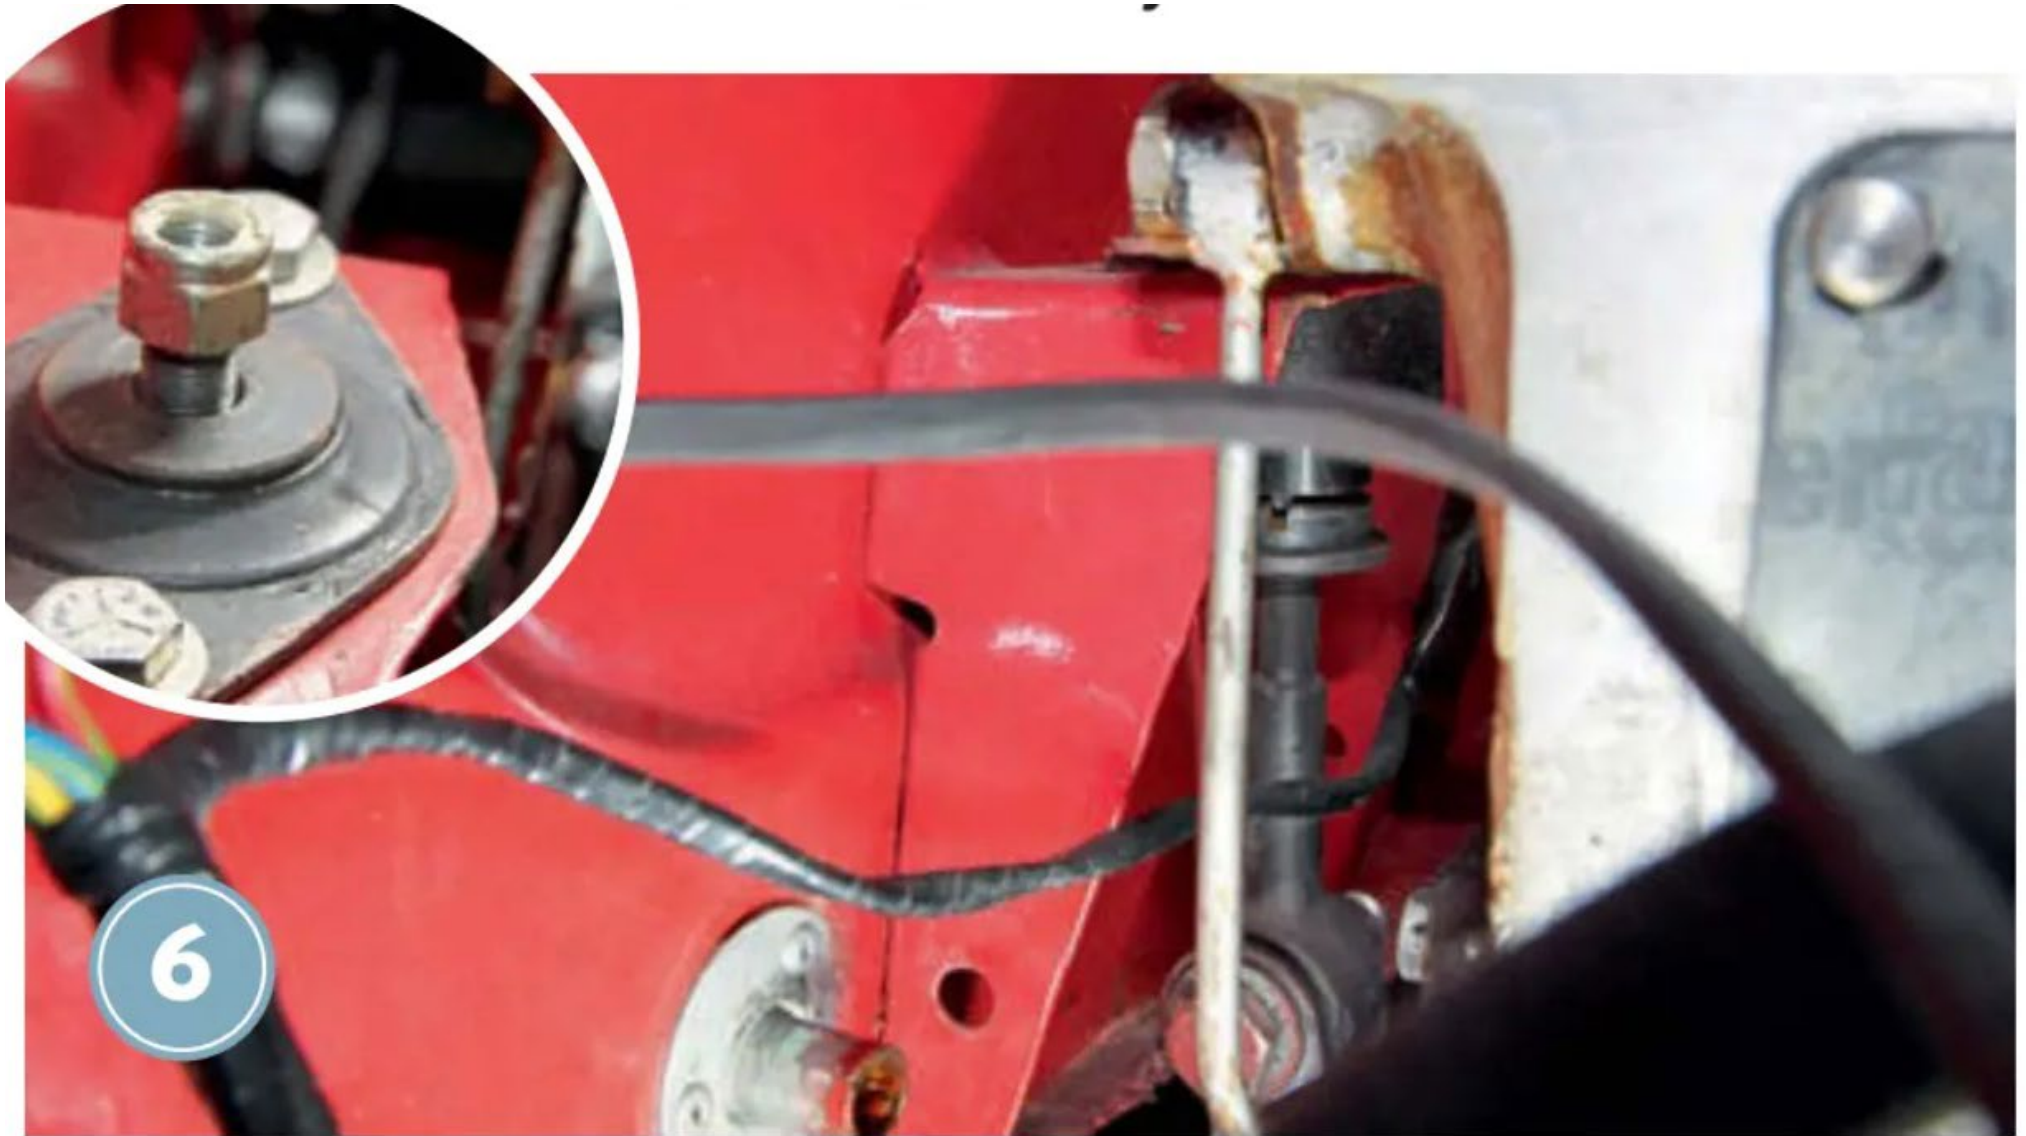
Shaun had already slackened the engine stabiliser, which is attached to the bulkhead, when he removed the sump. He now removes the 9/16in nut and uses a special tool to fully unwind it
