E-type engine removal

PART ONE: In the first of a two-part series, we follow the preparation work required prior to removing the engine and gearbox from an E-type

PART TWO: In the final instalment, we follow the 4.2-litre XK engine and manual gearbox being removed from a Series I E-type

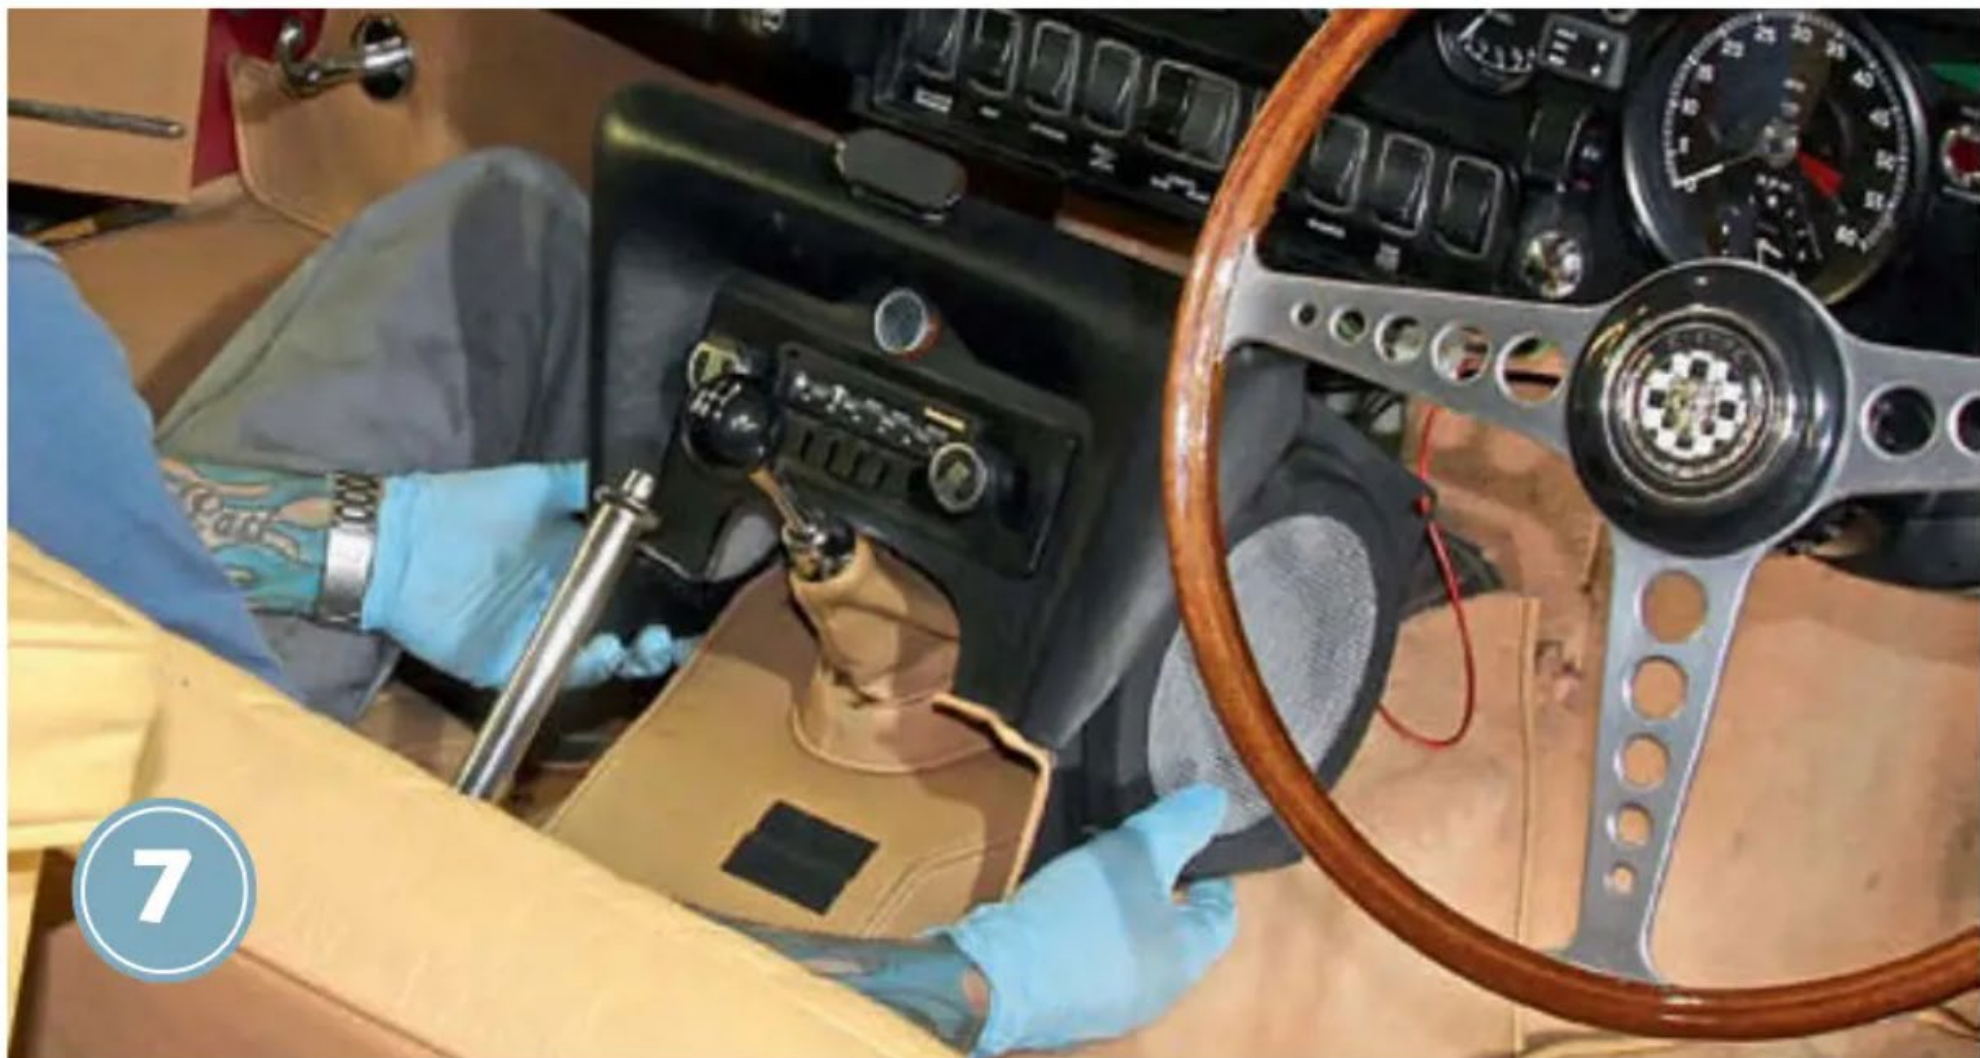
The propshaft needs to be detached from the gearbox, which can be accessed via the gearbox tunnel. Sitting in the passenger seat, Shaun removes a storage compartment and the centre console

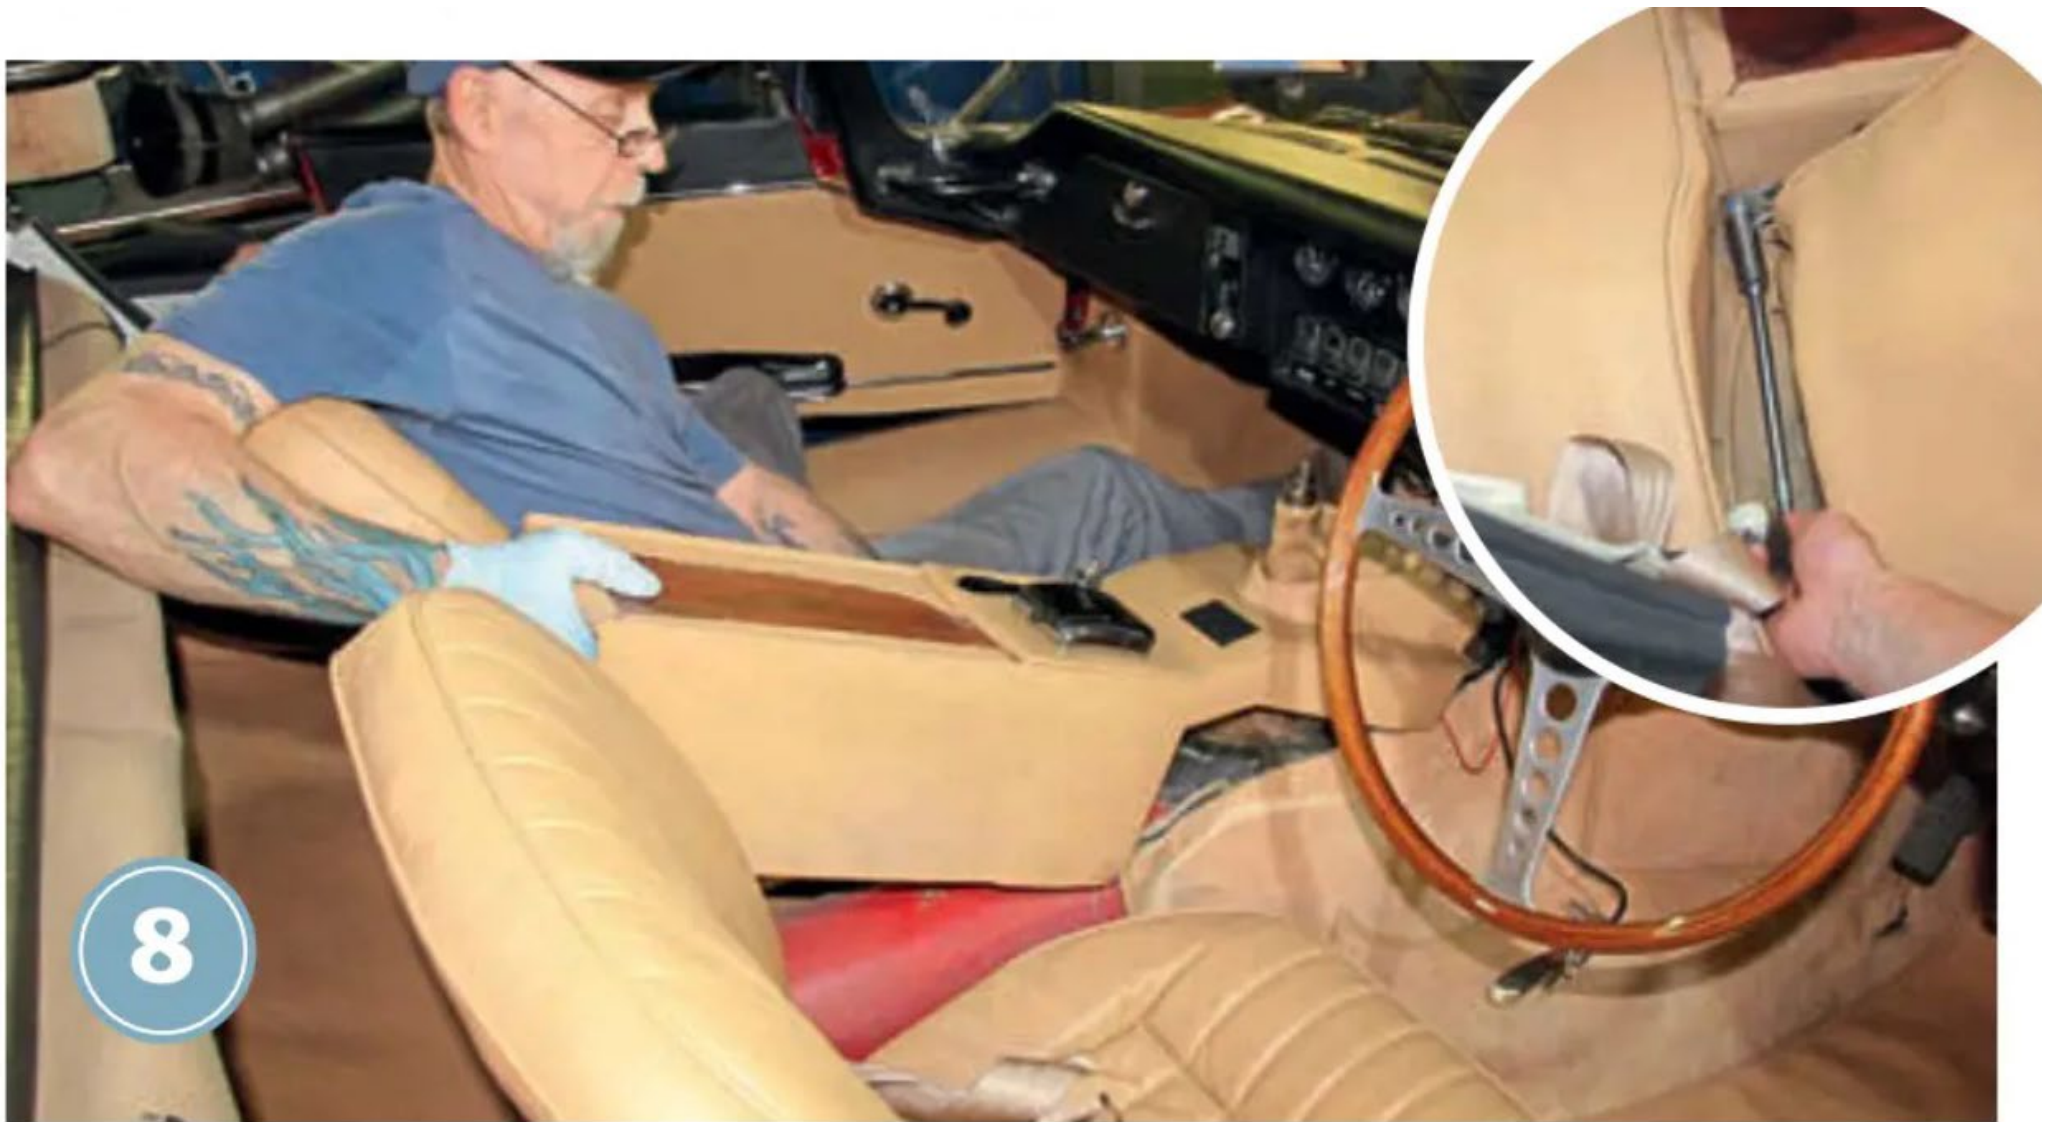
The trim that sits over the propshaft tunnel is removed by undoing any fastenings, along with the 5/8in bolts for the seatbelt socket mounts. This helps to access the propshaft and release the gear stick

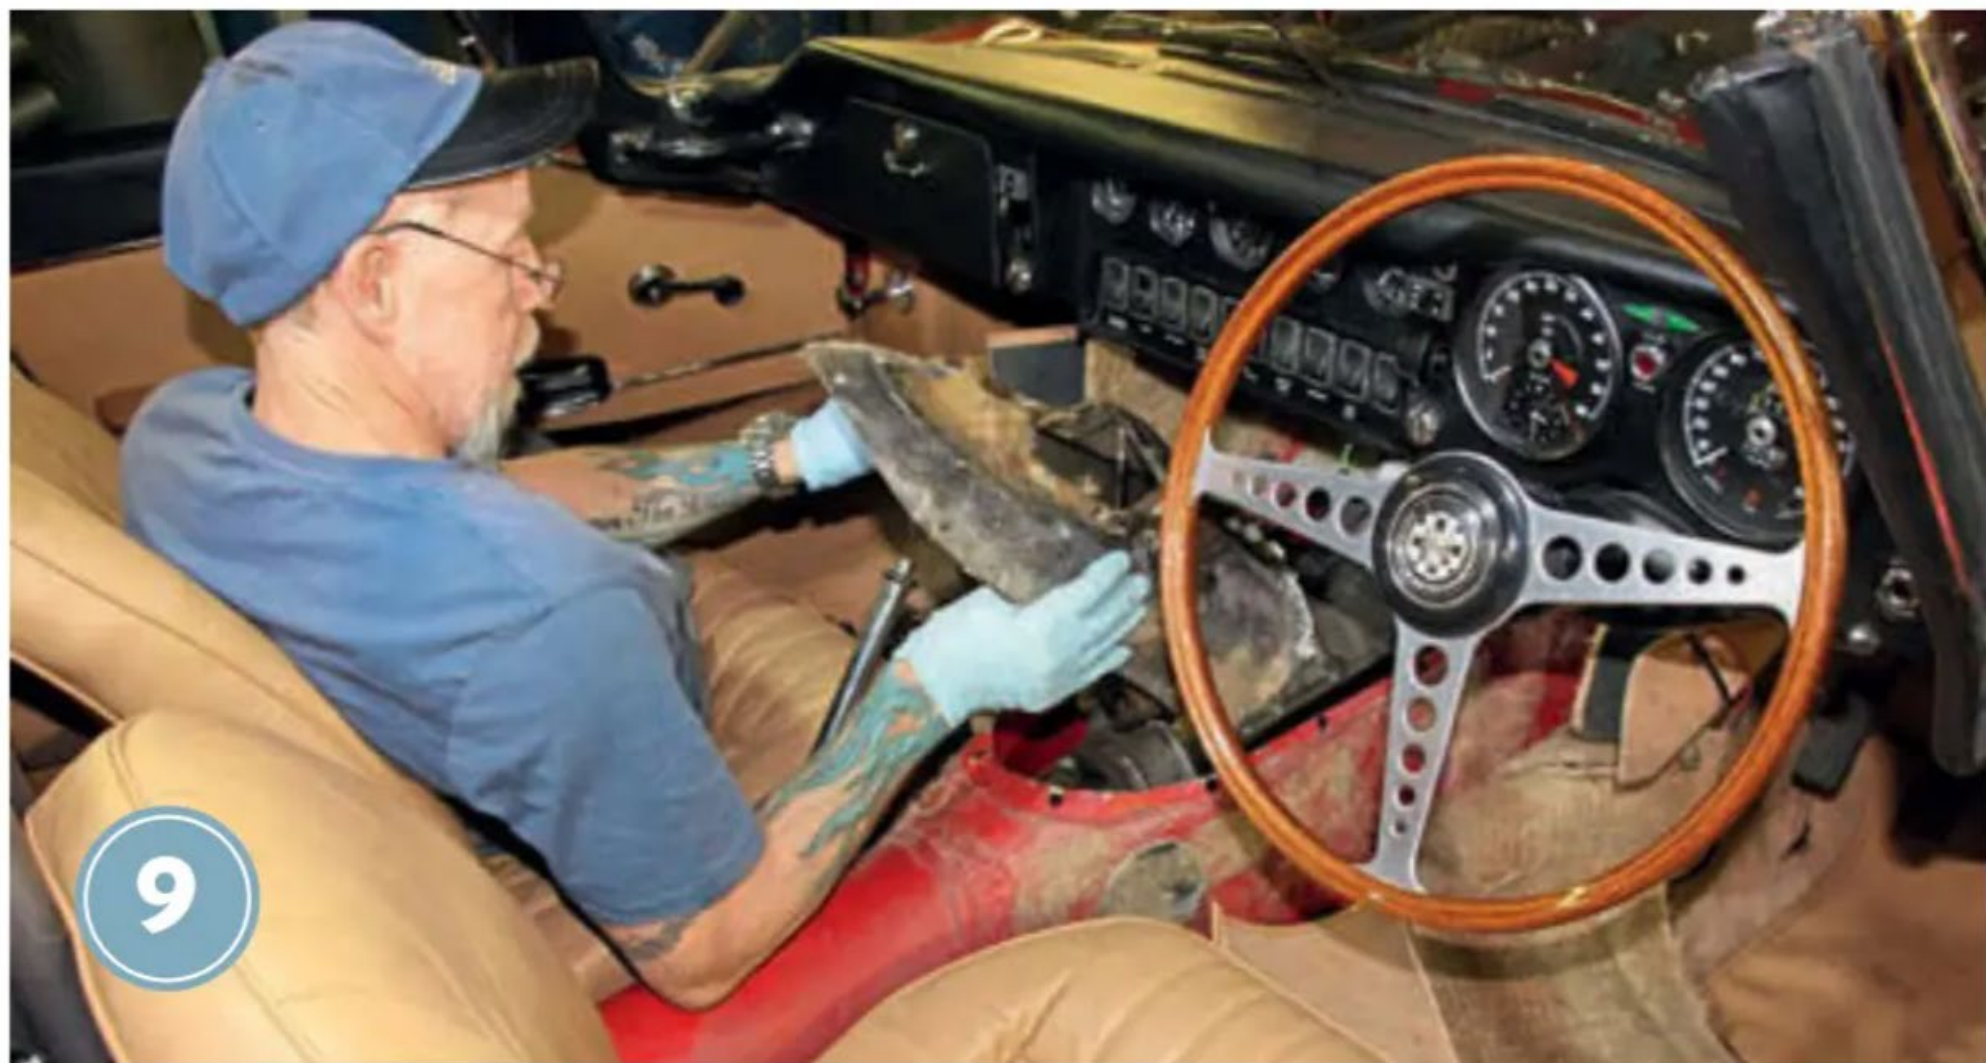
9

Shaun notices that the gearbox tunnel cover isn't standard, but an aftermarket GRP item. It's only secured with a couple of screws, so it's more straightforward than expected to remove

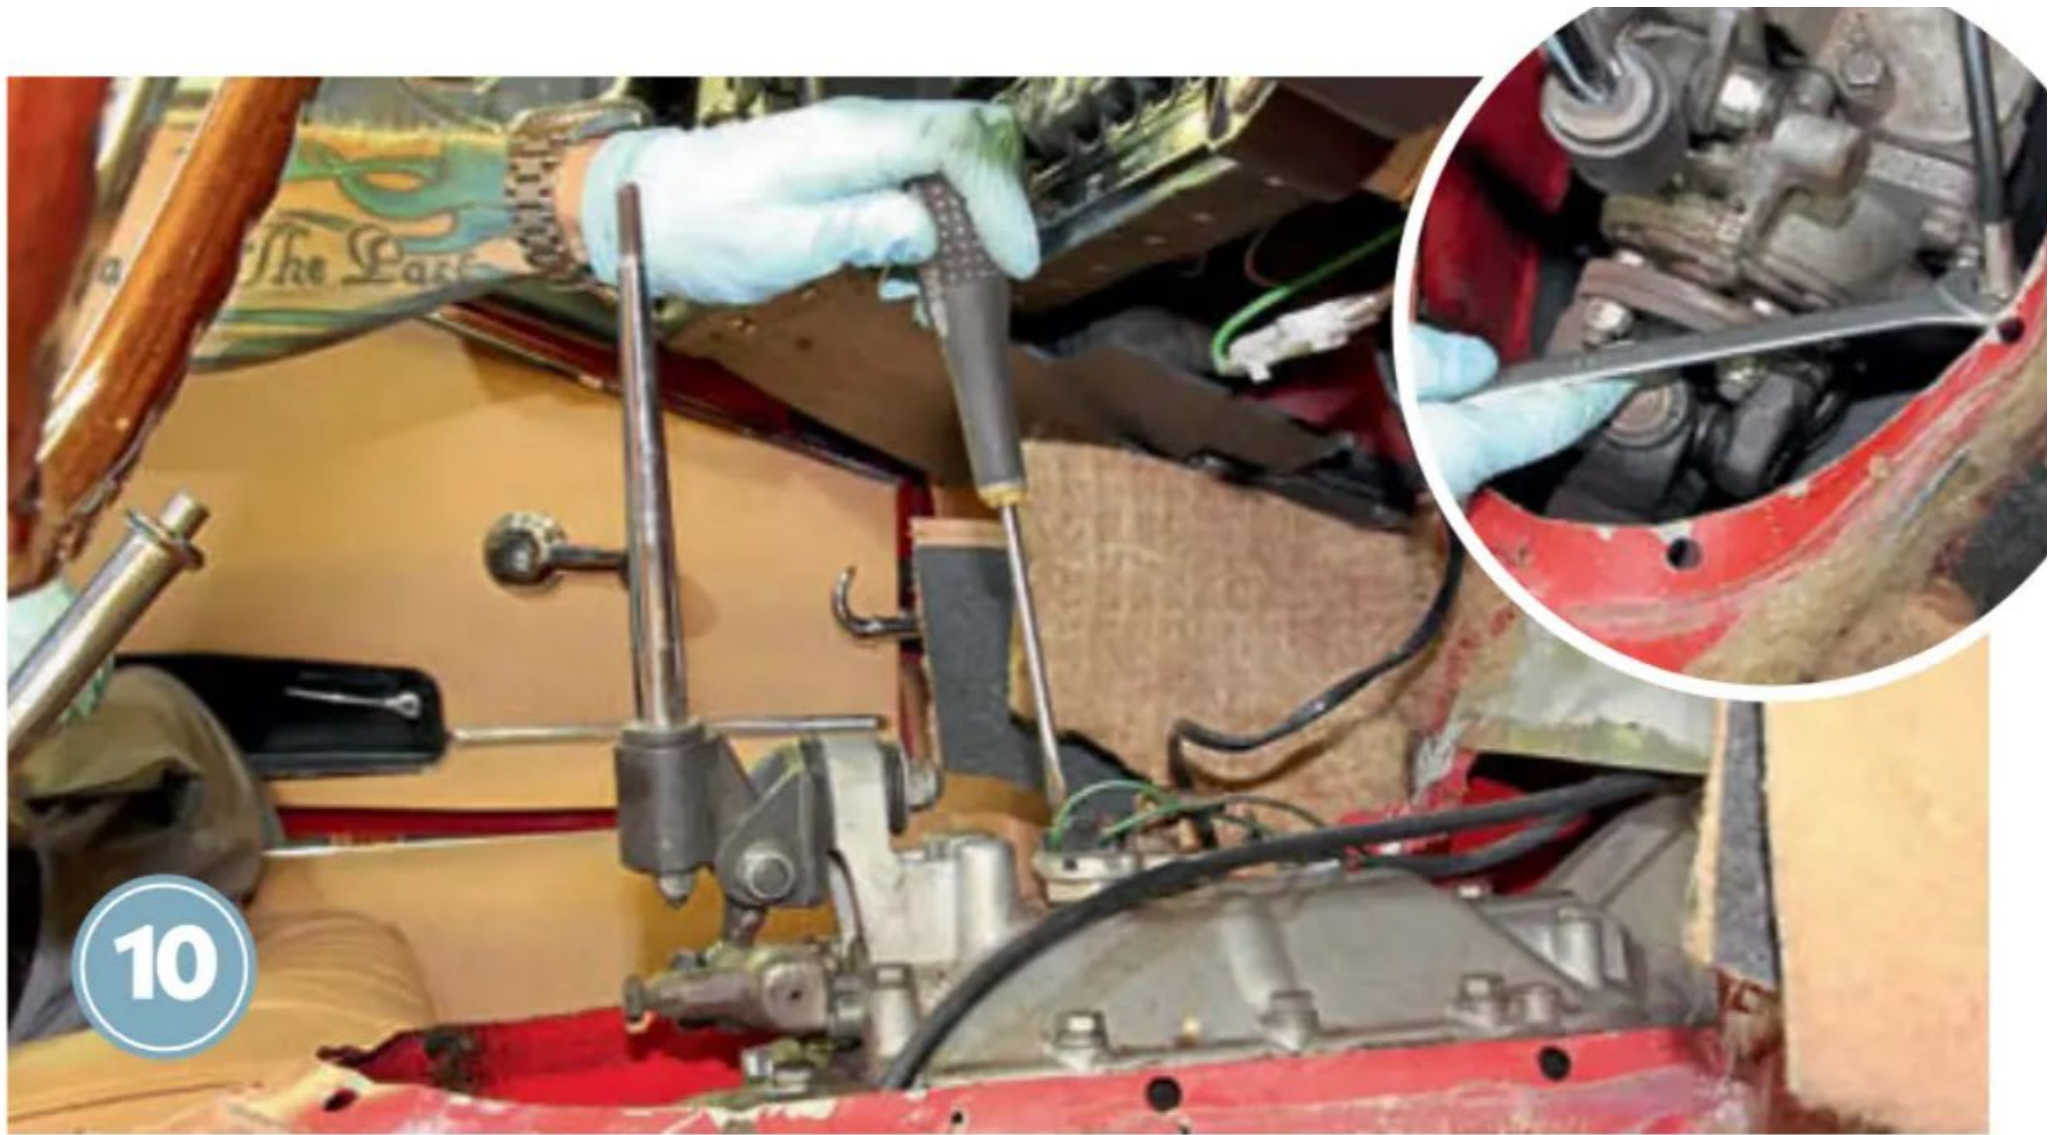
10

The wiring for the reverse light switch is disconnected from the top of the gearbox by undoing a couple of screws. The speed drive cable is also released from the gearbox using a 5/8in spanner

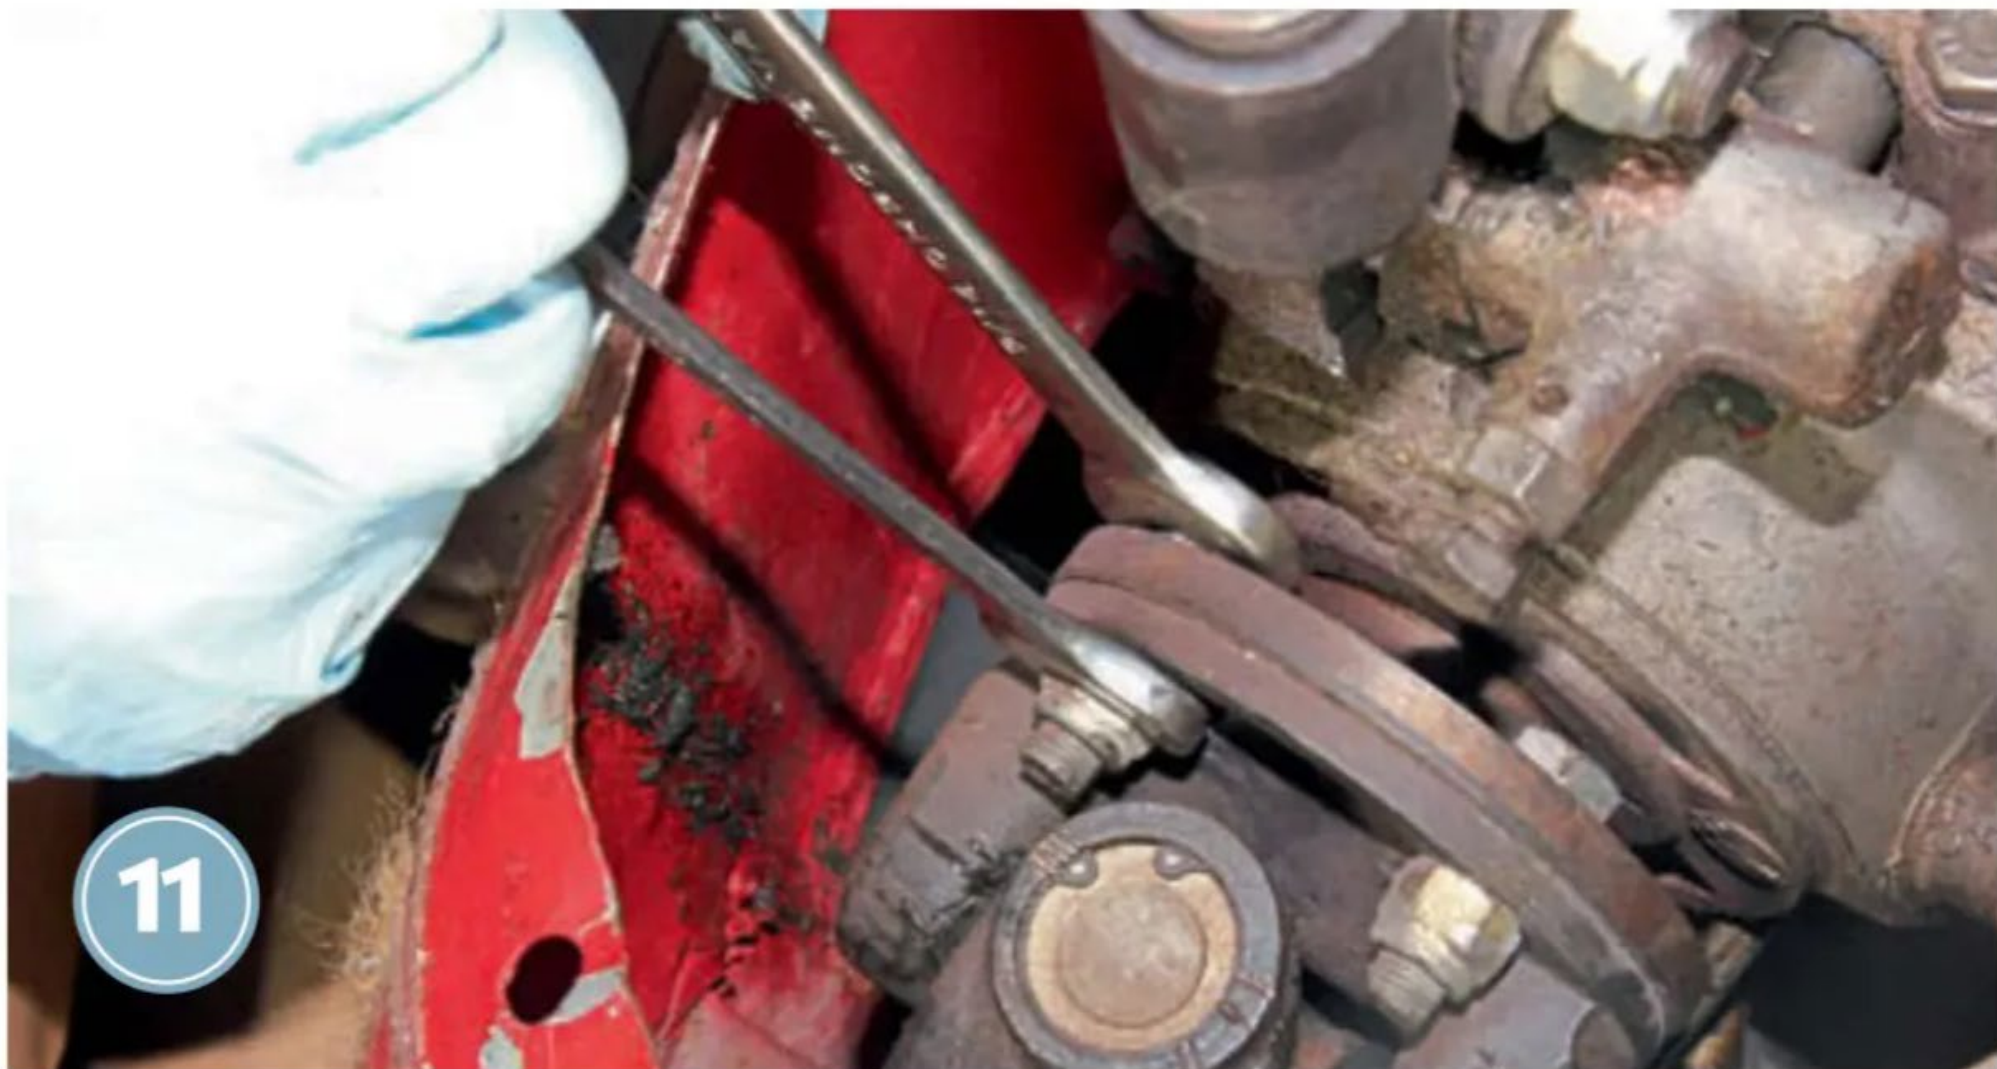
Finally, the propshaft can be detached from the gearbox by undoing four 9/16in nuts and bolts. The E-type is rolled forwards a little to rotate the propshaft and access some of these fastenings

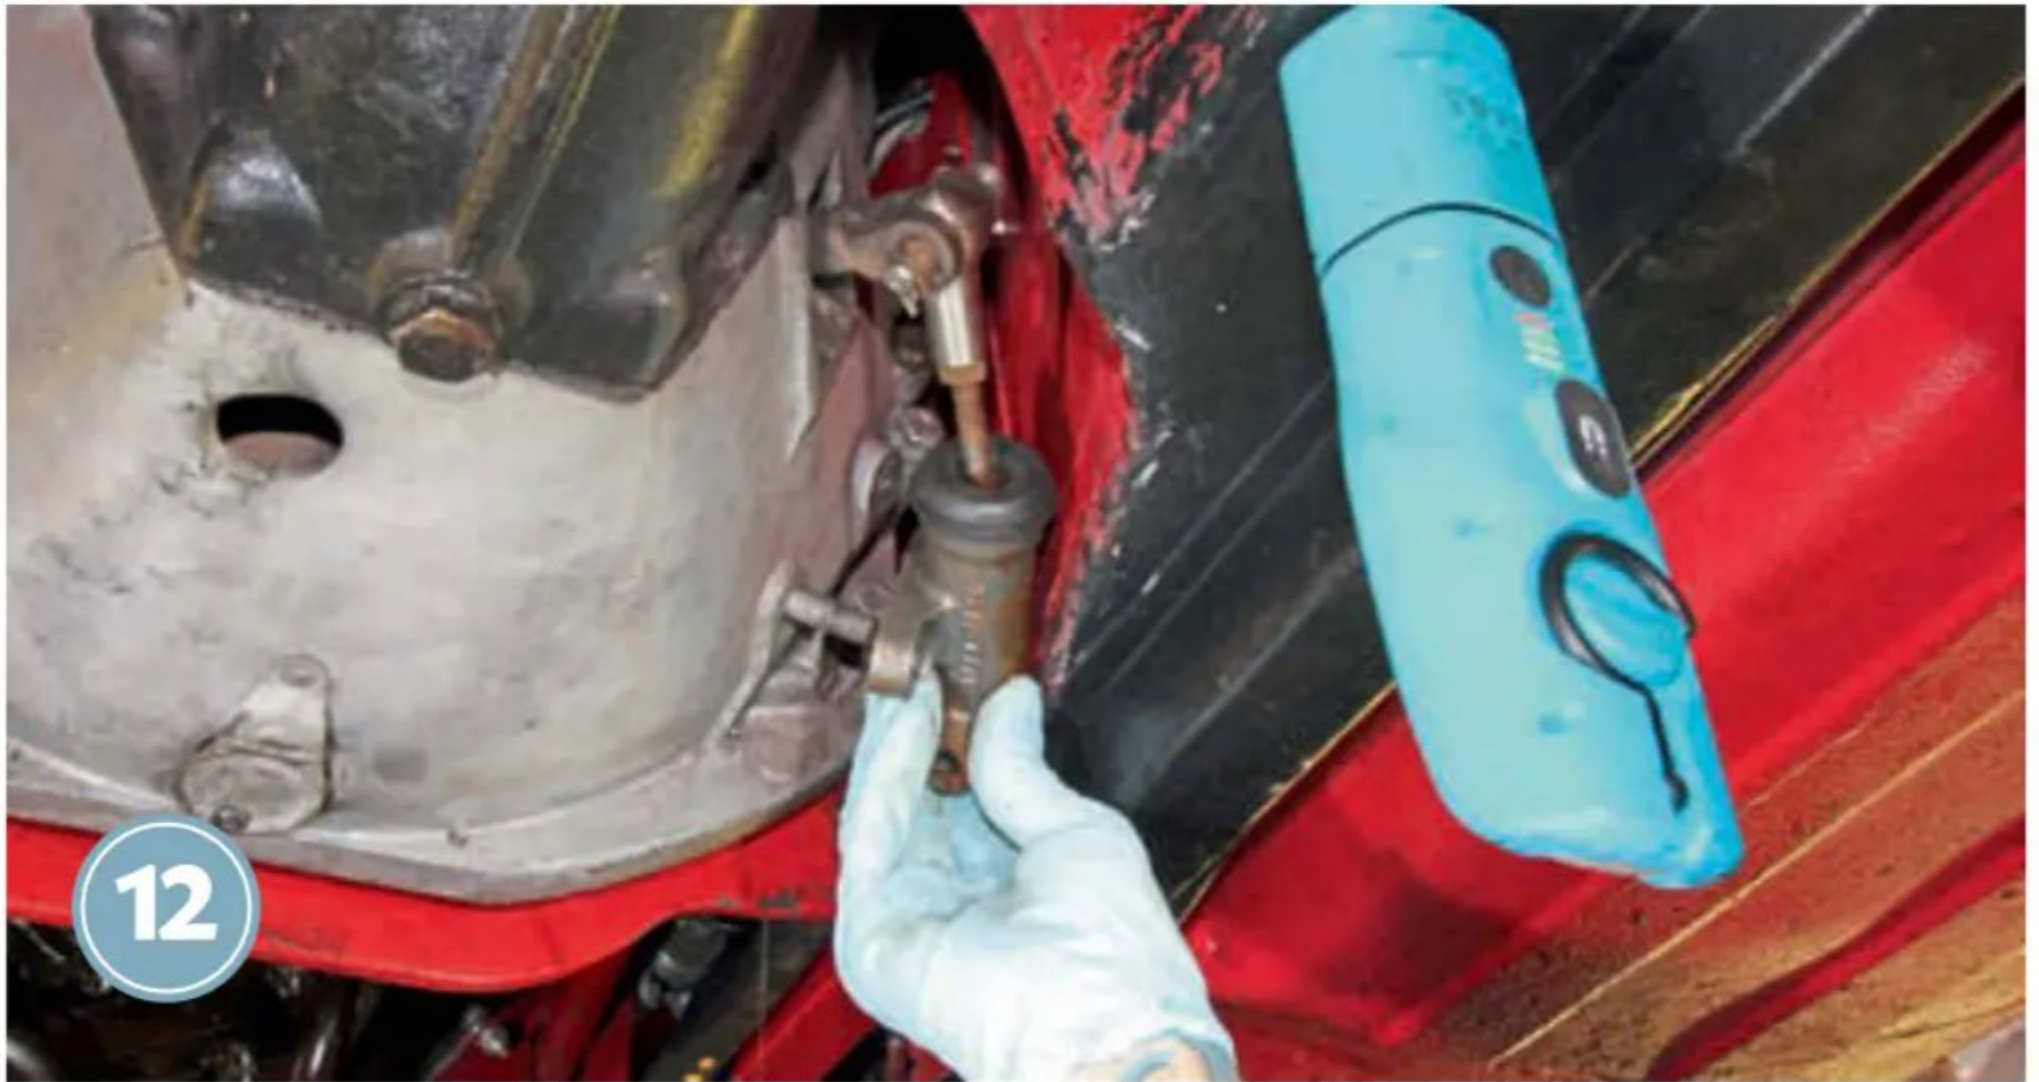
Moving to the underside of the E-type, the feed pipe to the clutch slave cylinder is detached and the fluid drained, then the slave cylinder is removed by undoing its two 9/16in mounting nuts

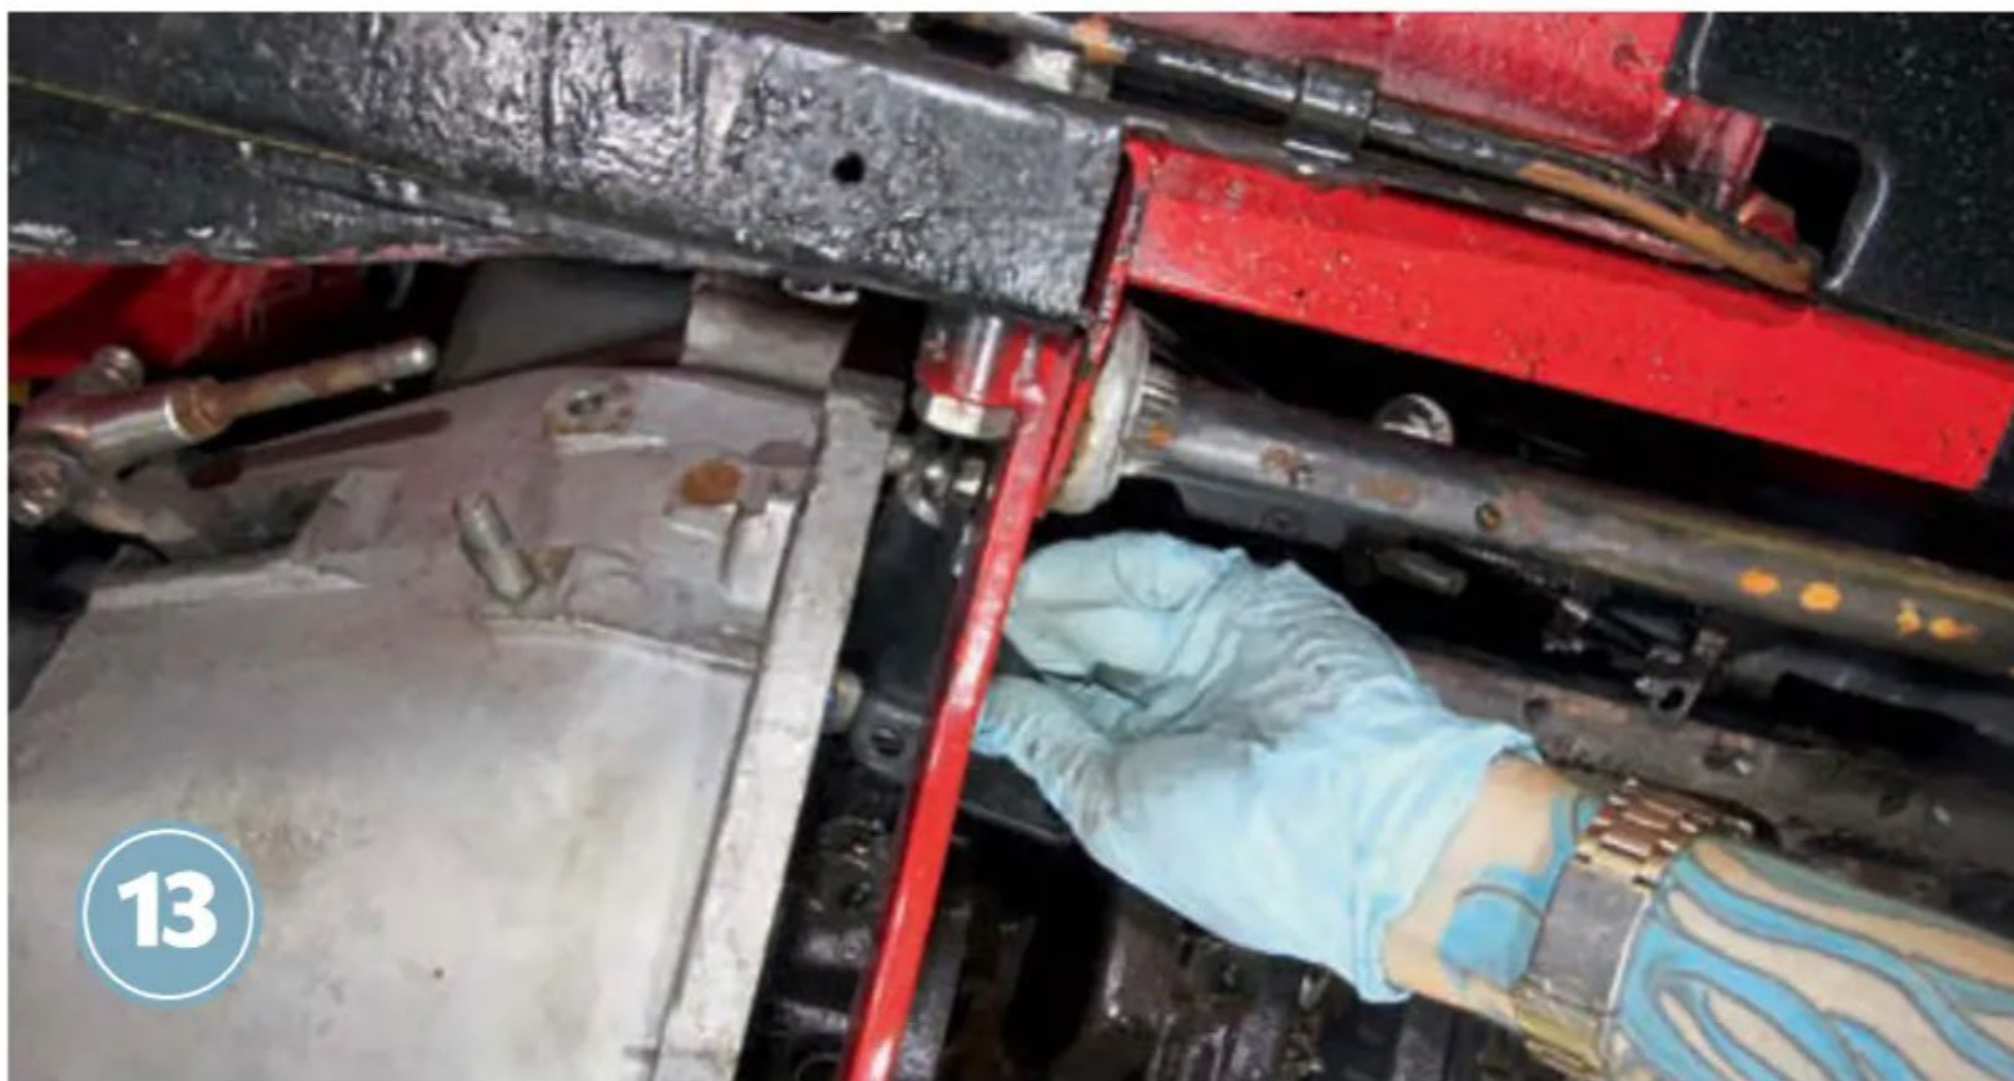
With the clutch slave cylinder removed, there's more space to remove the large reaction plate. First, a small black triangular mounting bracket at each side of it needs to be removed

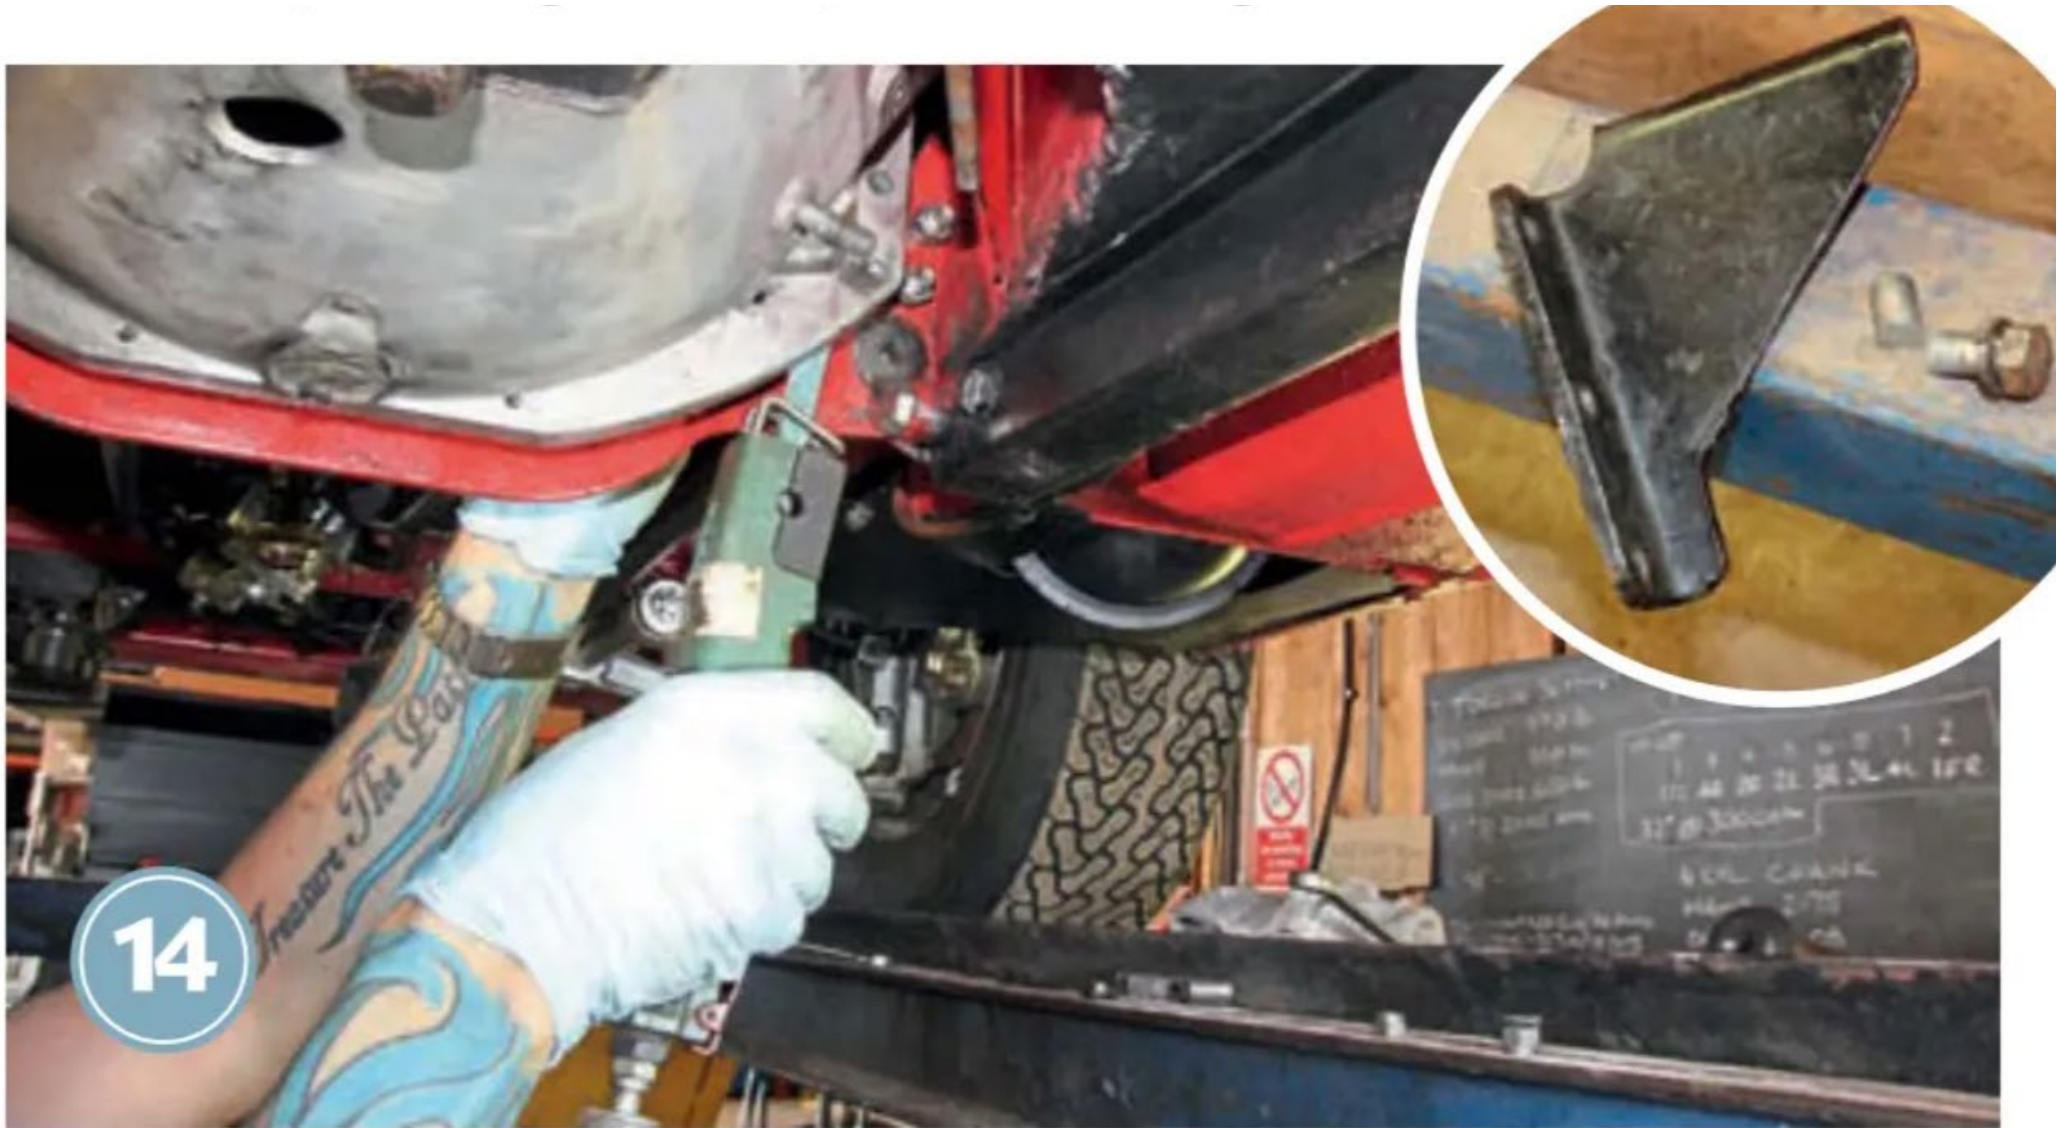
14

On the offside, one of the bolts for the mounting bracket cannot be extracted (it has been incorrectly fitted), so Shaun resorts to cutting through it to be able to remove the bracket

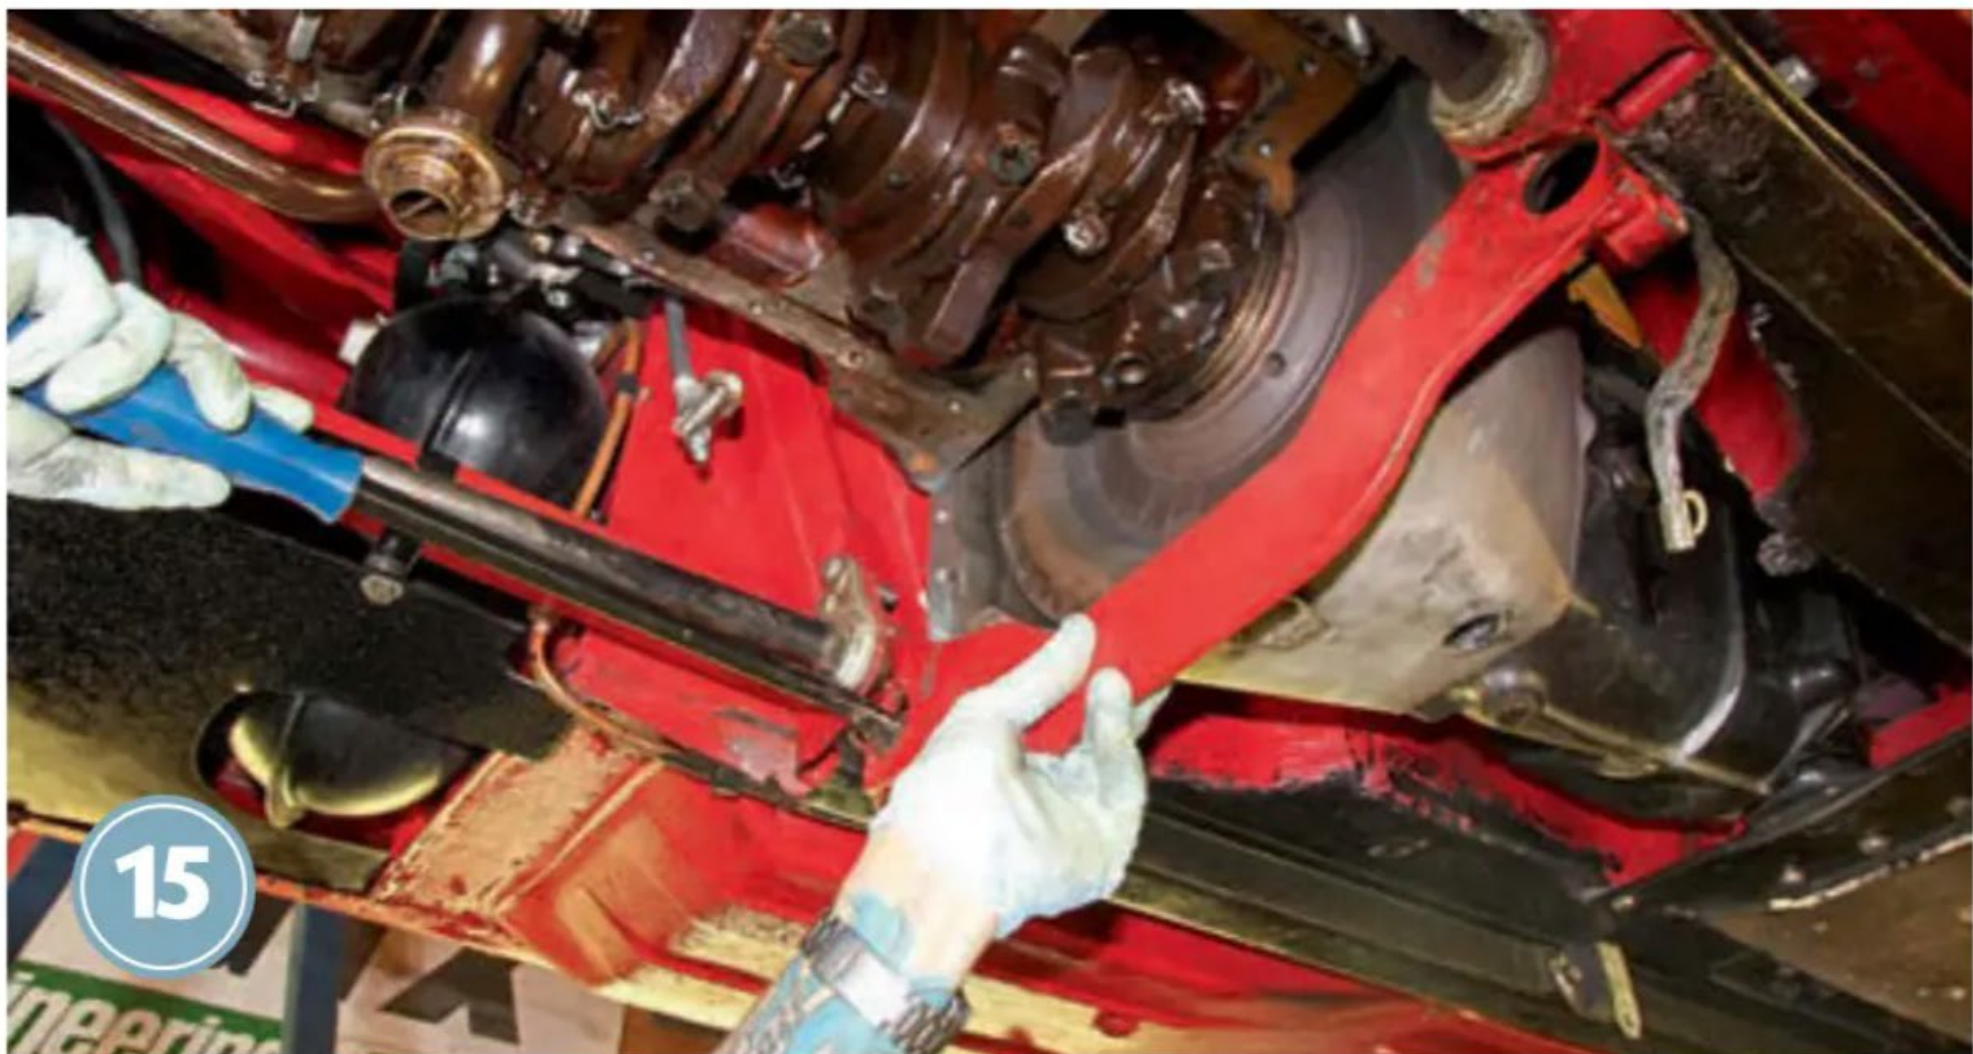
The large reaction plate is secured with 9/16in and 3/4in nuts and bolts at each side. Using a hammer, Shaun detaches it from the ends of the torsion bars, then levers it off and removes it

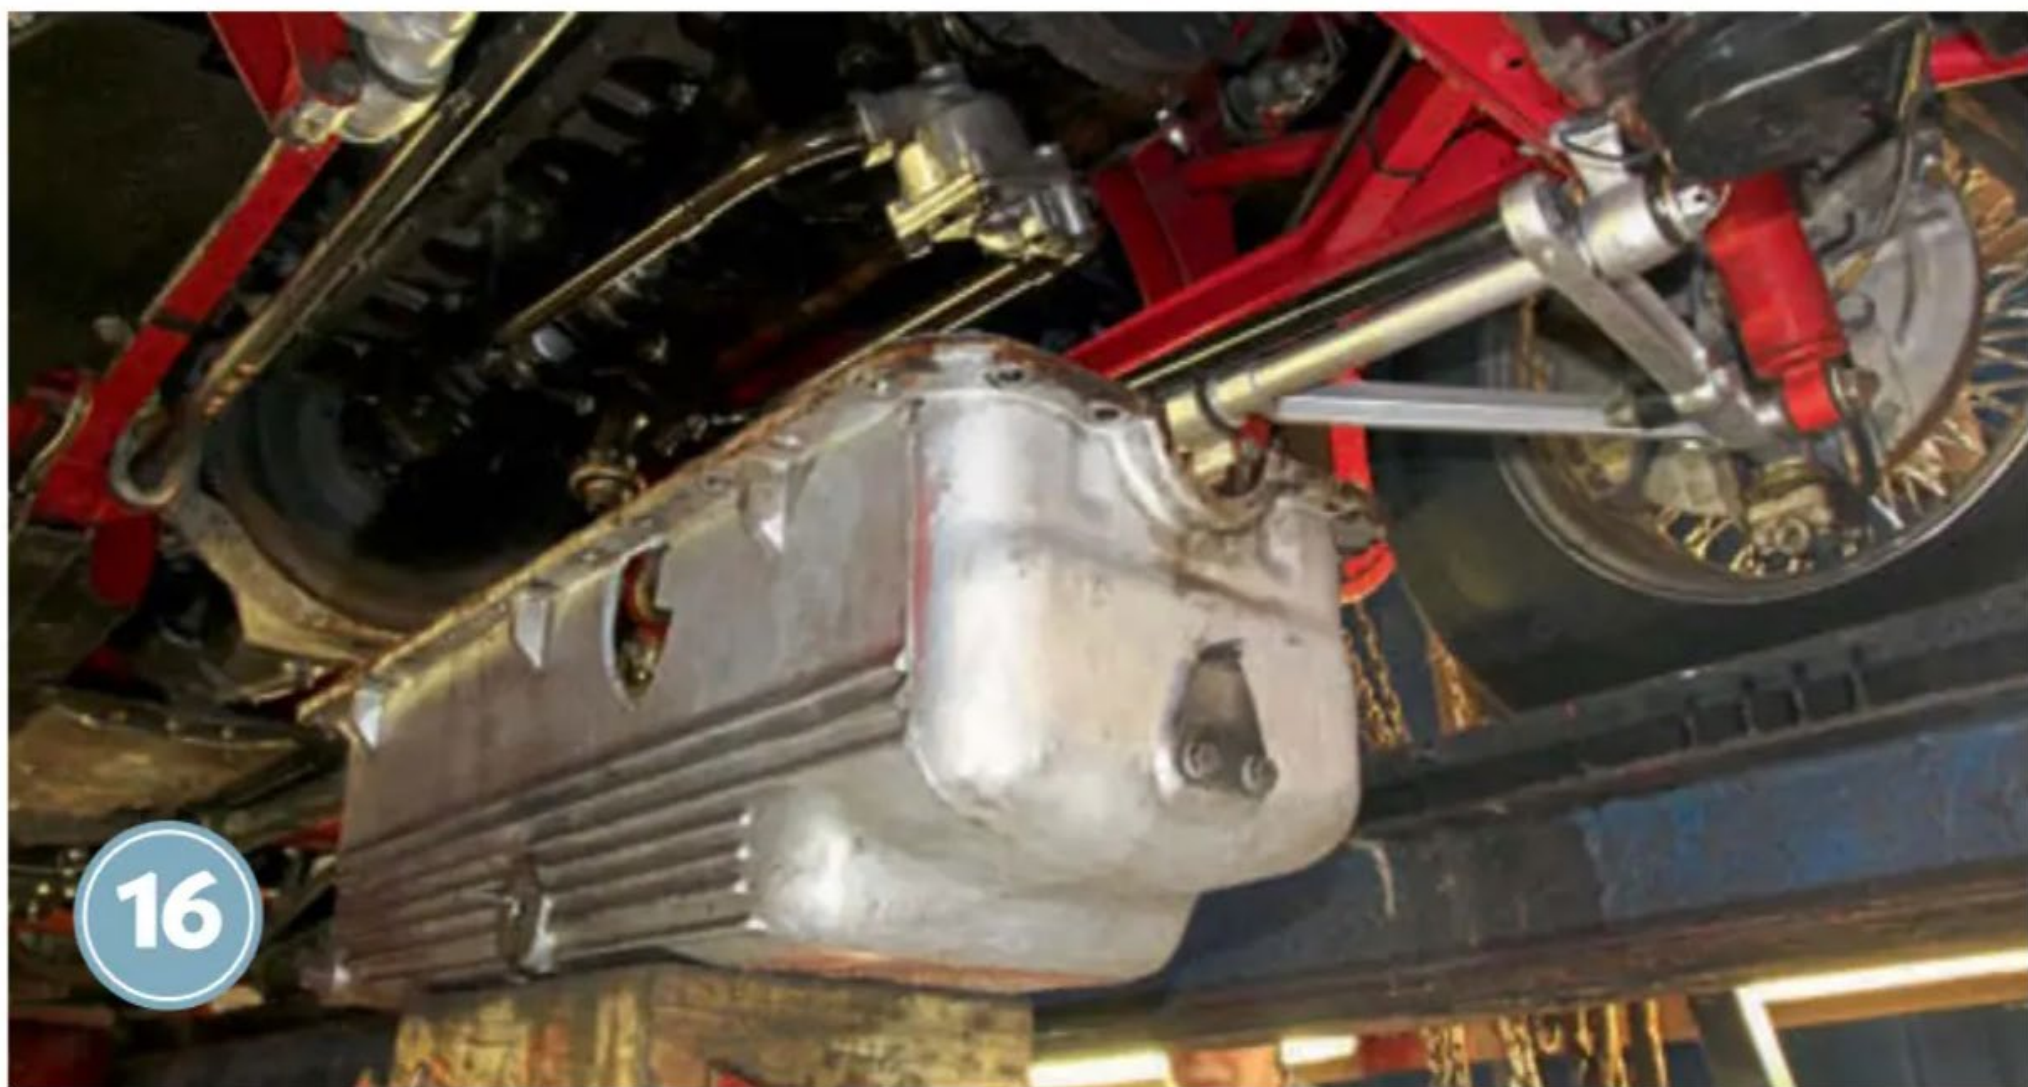
The sump needs to be refitted to be able to sit the engine on a wooden pallet, so it's secured with four of its mounting bolts. It's manoeuvred into position using a transmission jack
