E-type engine removal

PART ONE: In the first of a two-part series, we follow the preparation work required prior to removing the engine and gearbox from an E-type

PART TWO: In the final instalment, we follow the 4.2-litre XK engine and manual gearbox being removed from a Series I E-type

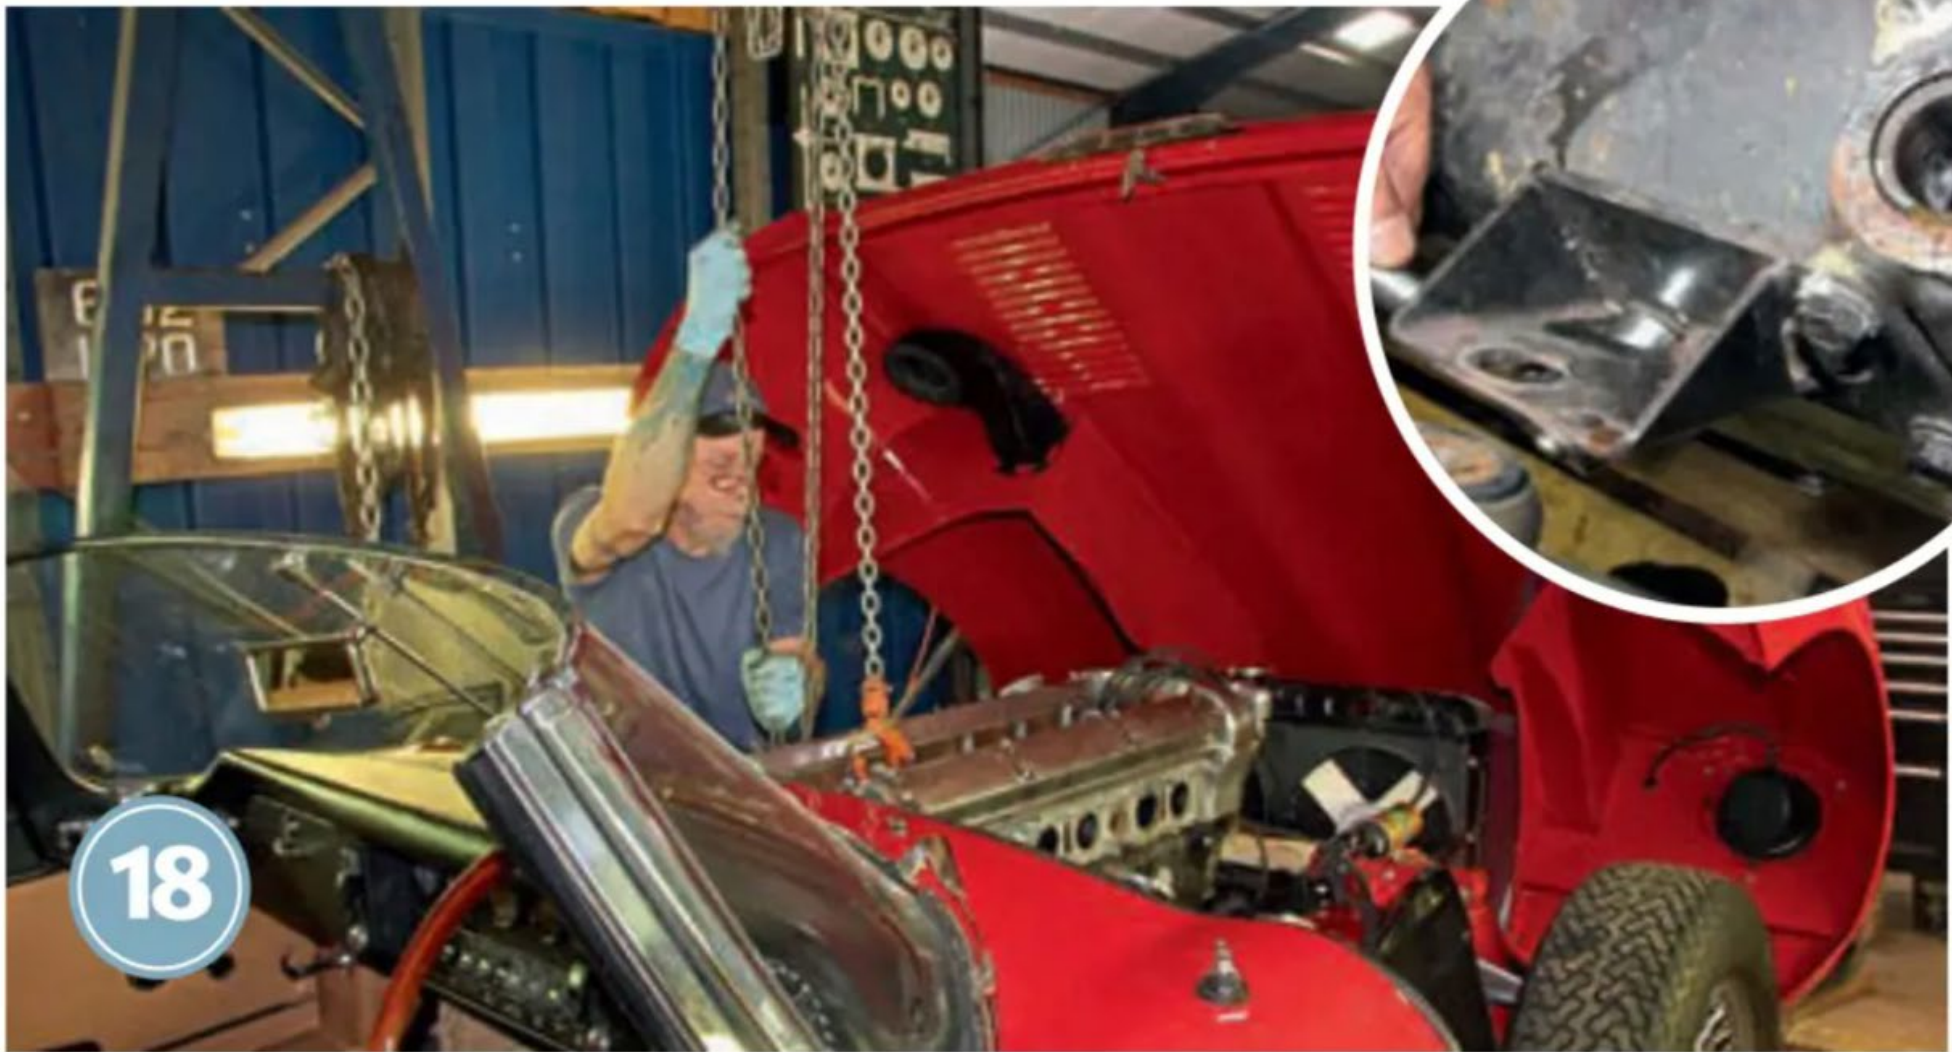
Using a gantry-mounted hoist, the back of the engine is supported. We can now remove the engine mounts at the sides of the block by undoing three 9/16in bolts for each one

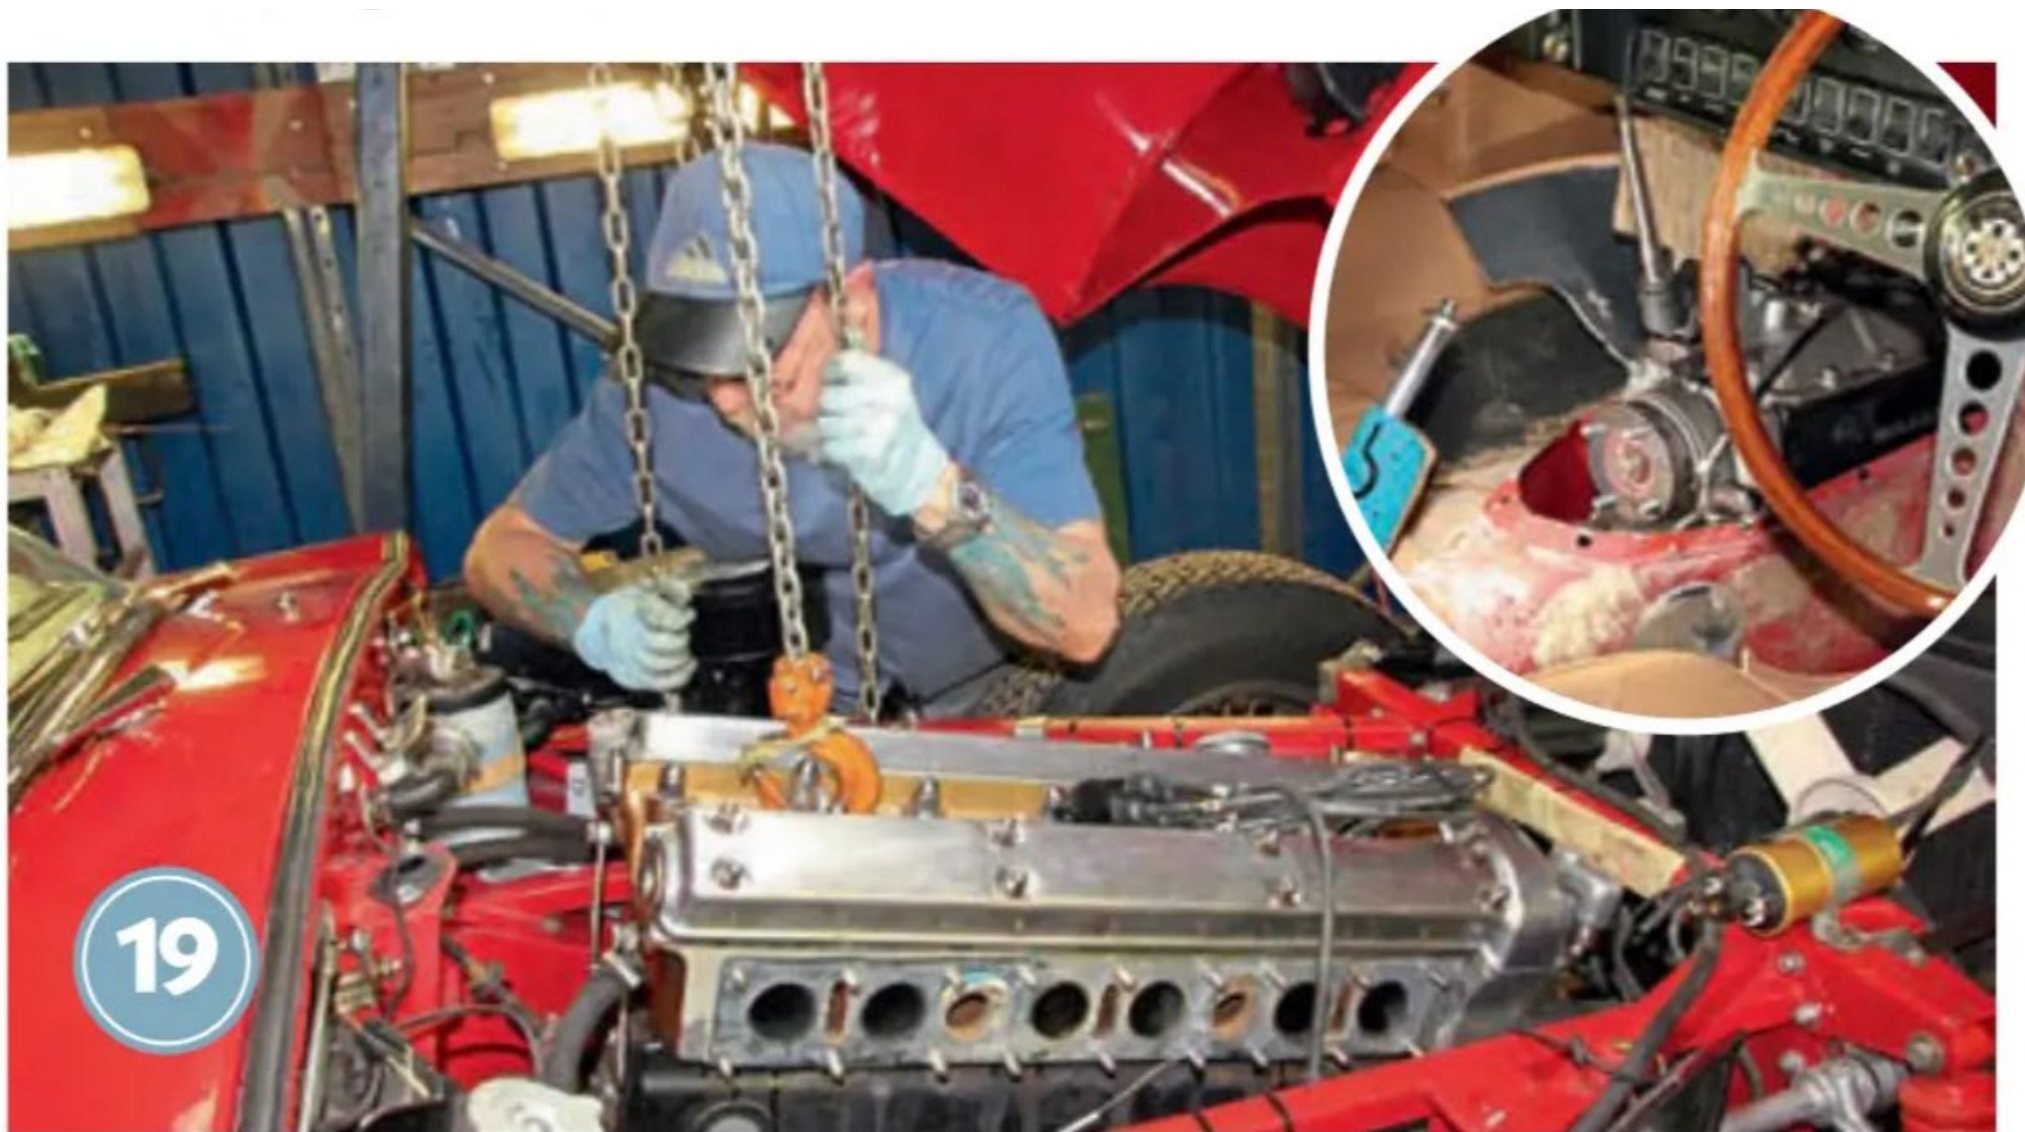
19

The engine and gearbox are now separated from the E-type and need to be lowered on to a wooden pallet below. Shaun slowly lowers the assembly, checking it doesn't foul anything

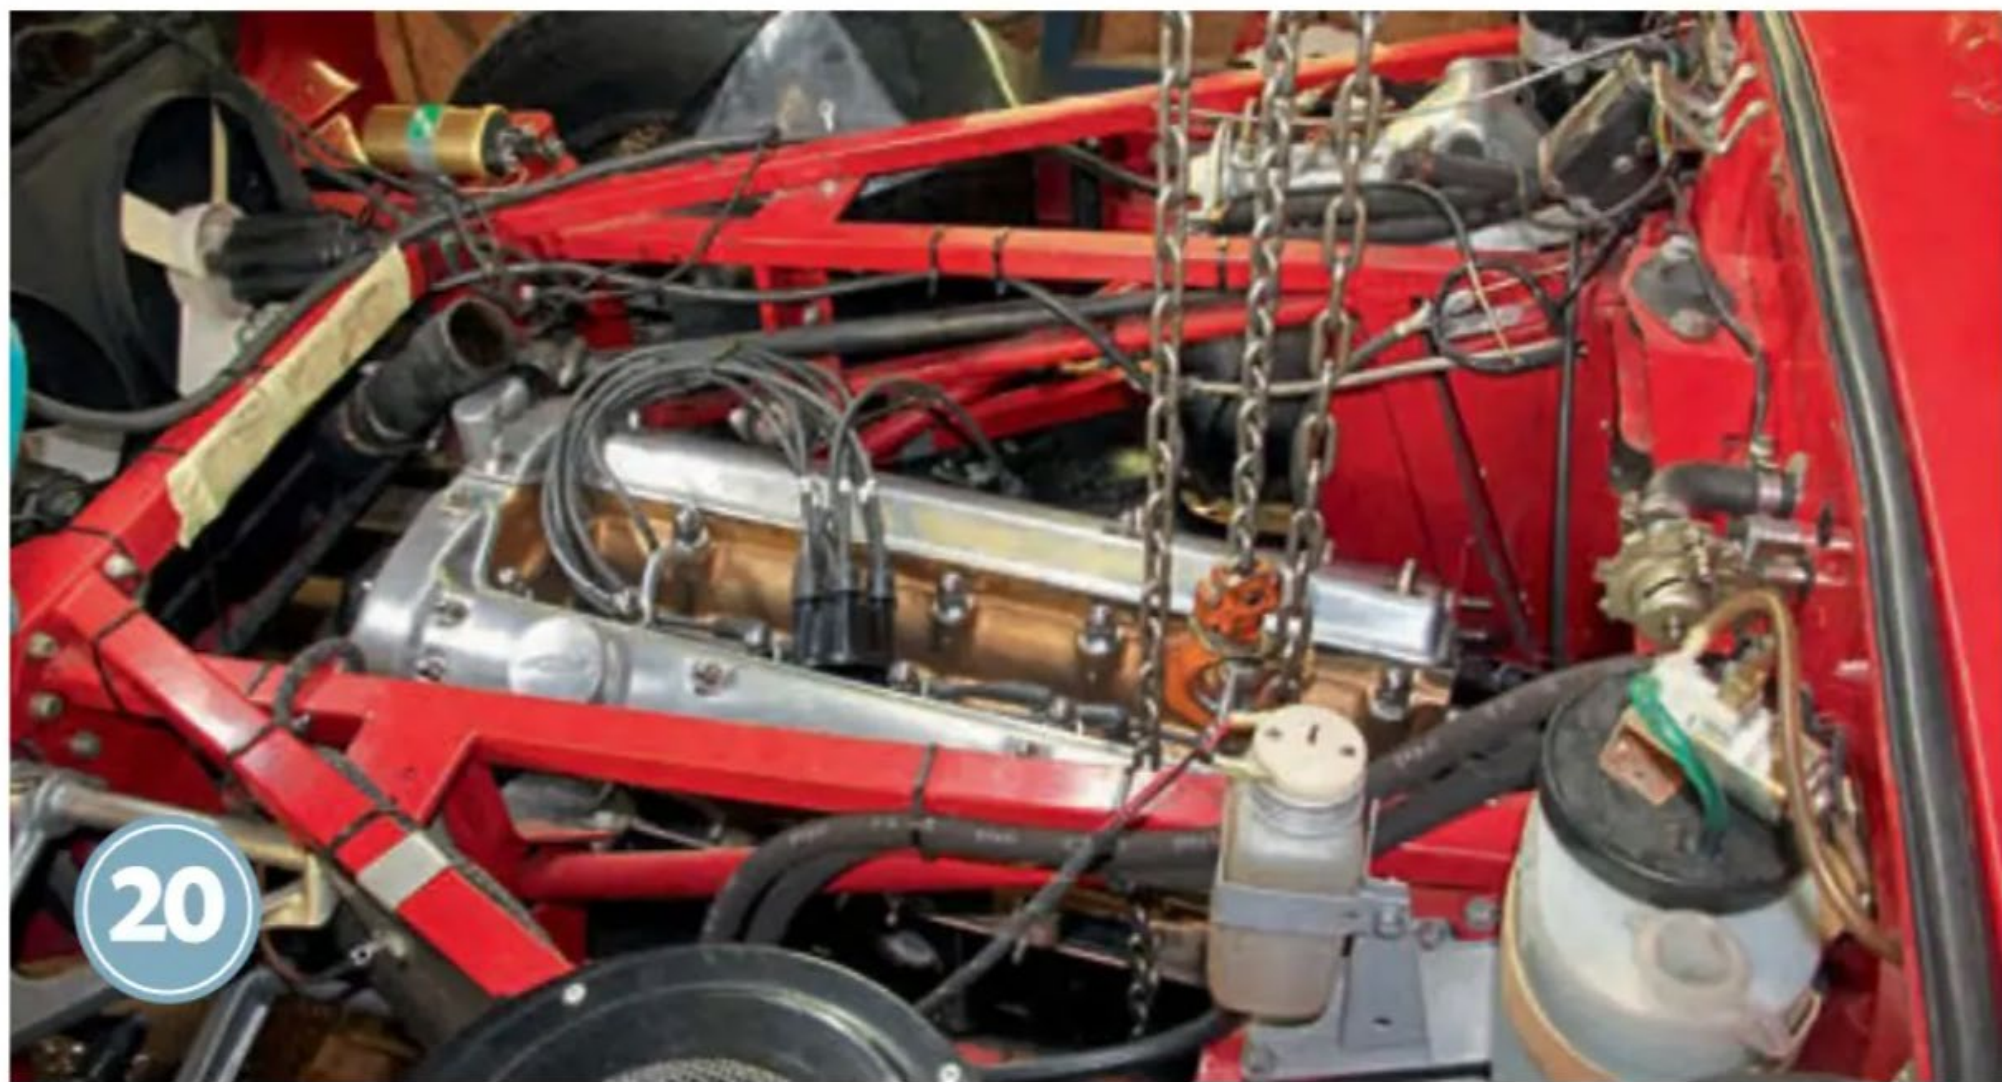
It takes a few attempts to successfully lower the engine and gearbox all the way through the tight space in the E-type's engine bay. Several people help to manoeuvre it through

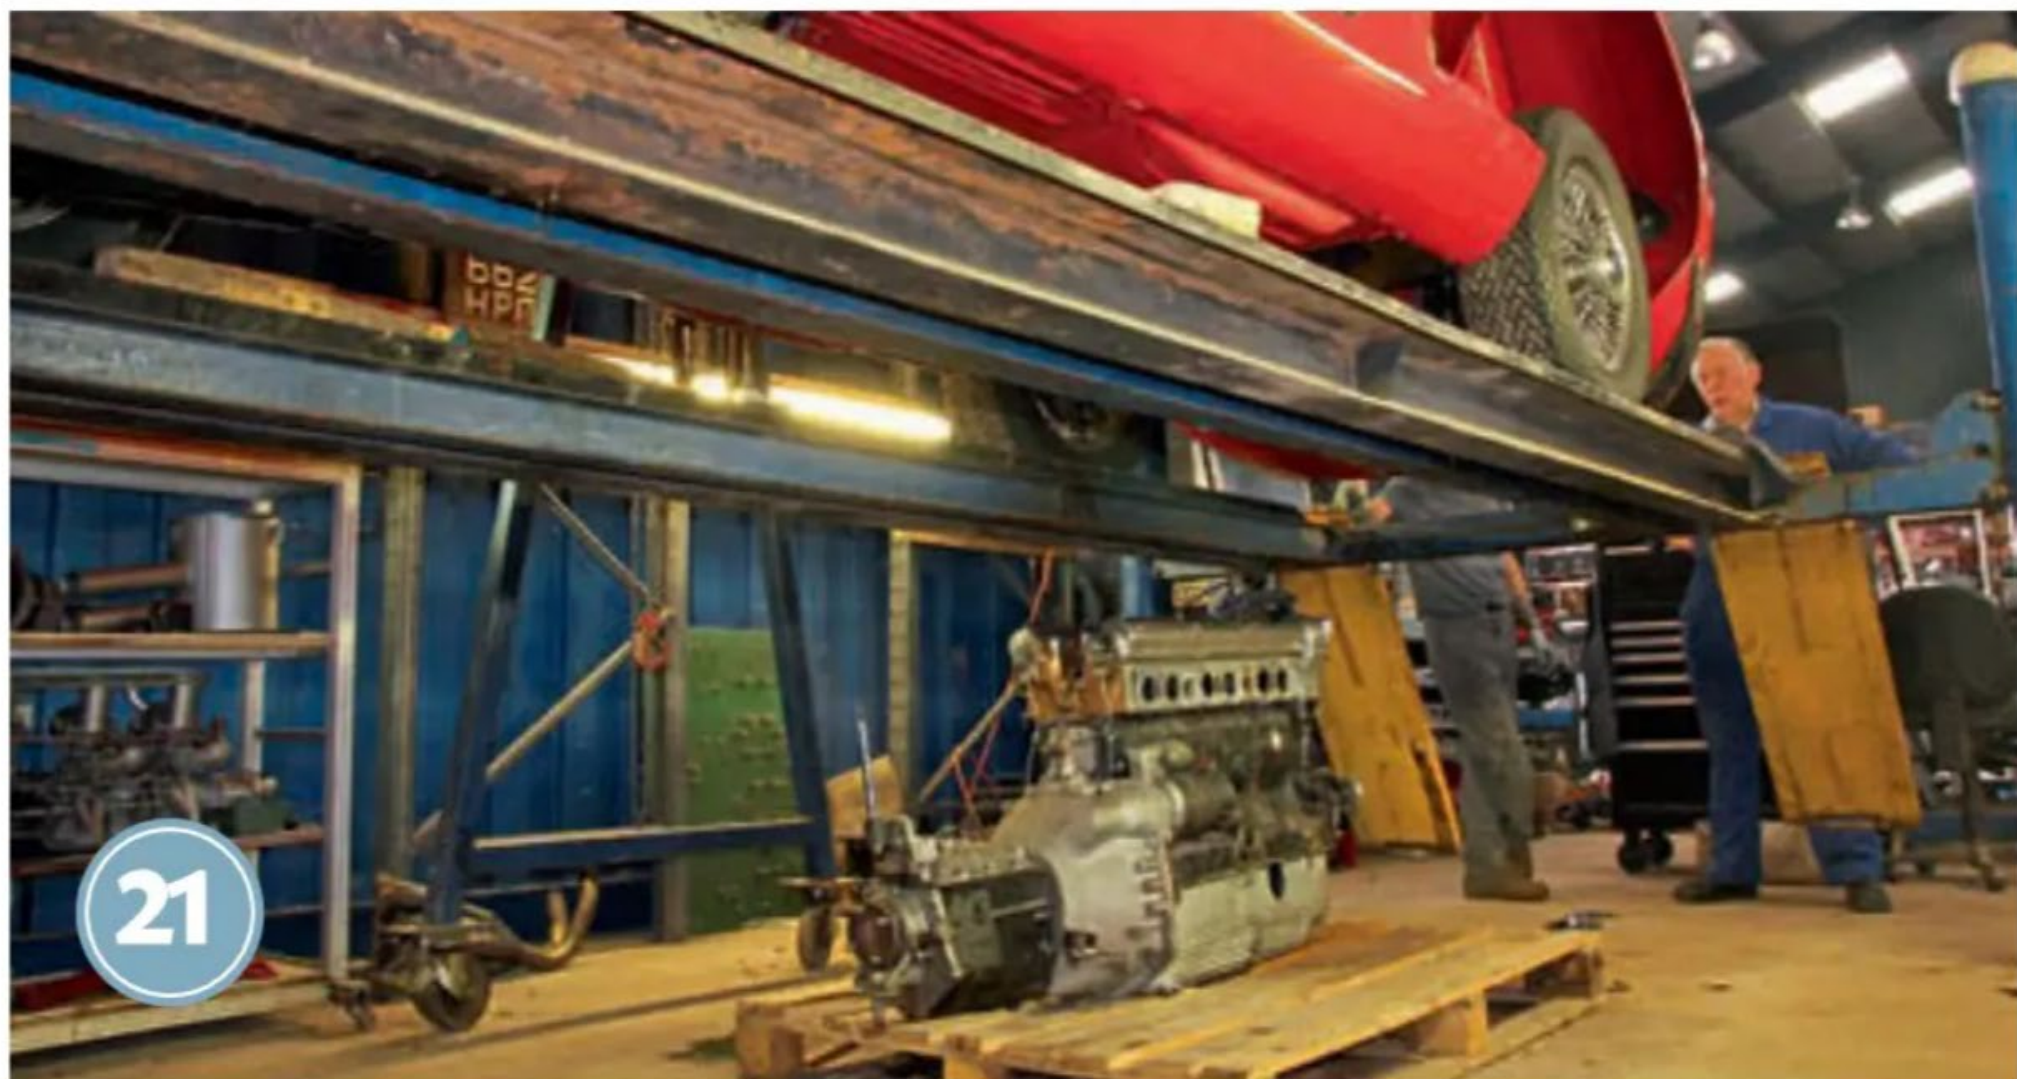
Once the engine and gearbox are sat on the pallet, the hoist is removed and the four-post lift with the E-type sat on it is raised. Six hours has passed as we have slowed down a little with taking photos

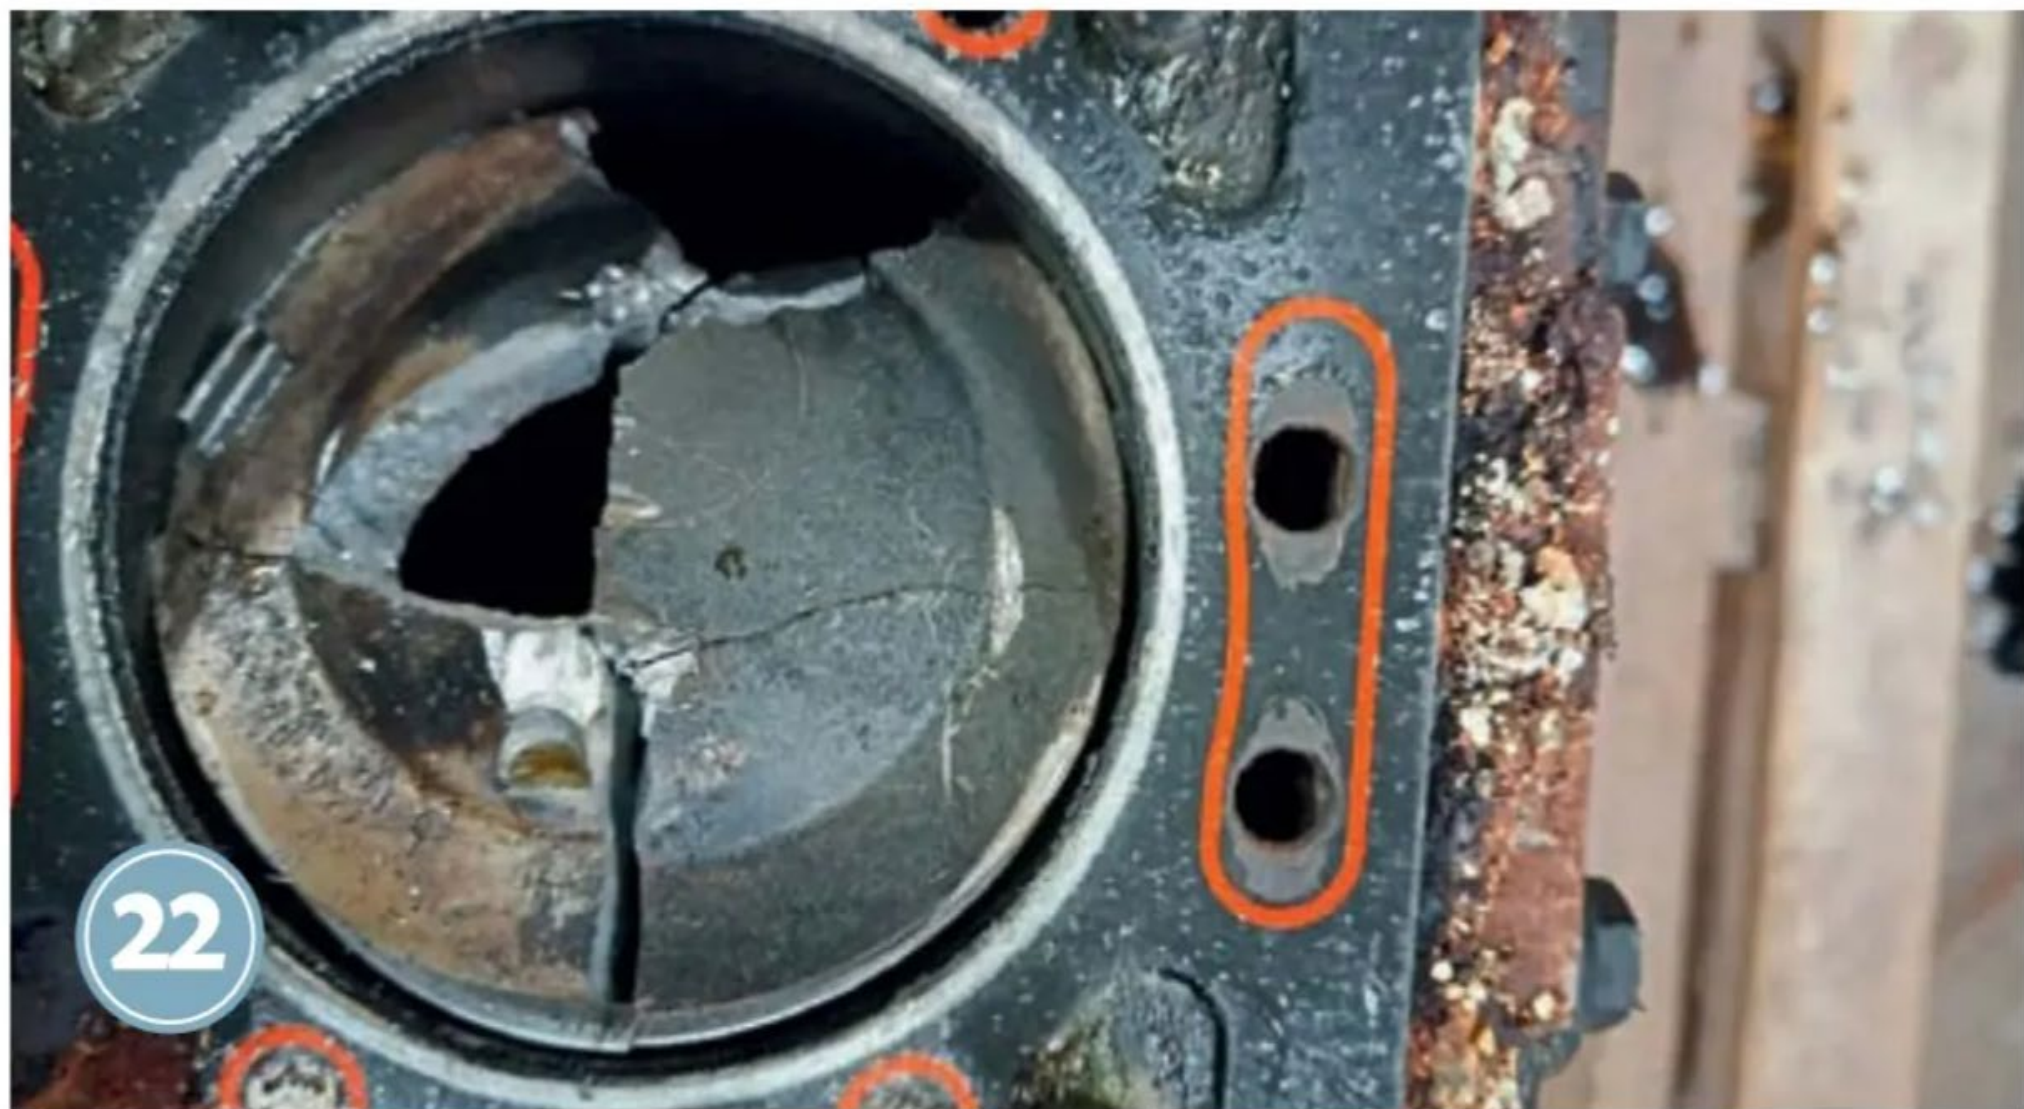
The next day, the cylinder head is removed to discover yet more damage. There's still a piston in cylinder number four, although it has a huge hole in the top of it and not much remaining

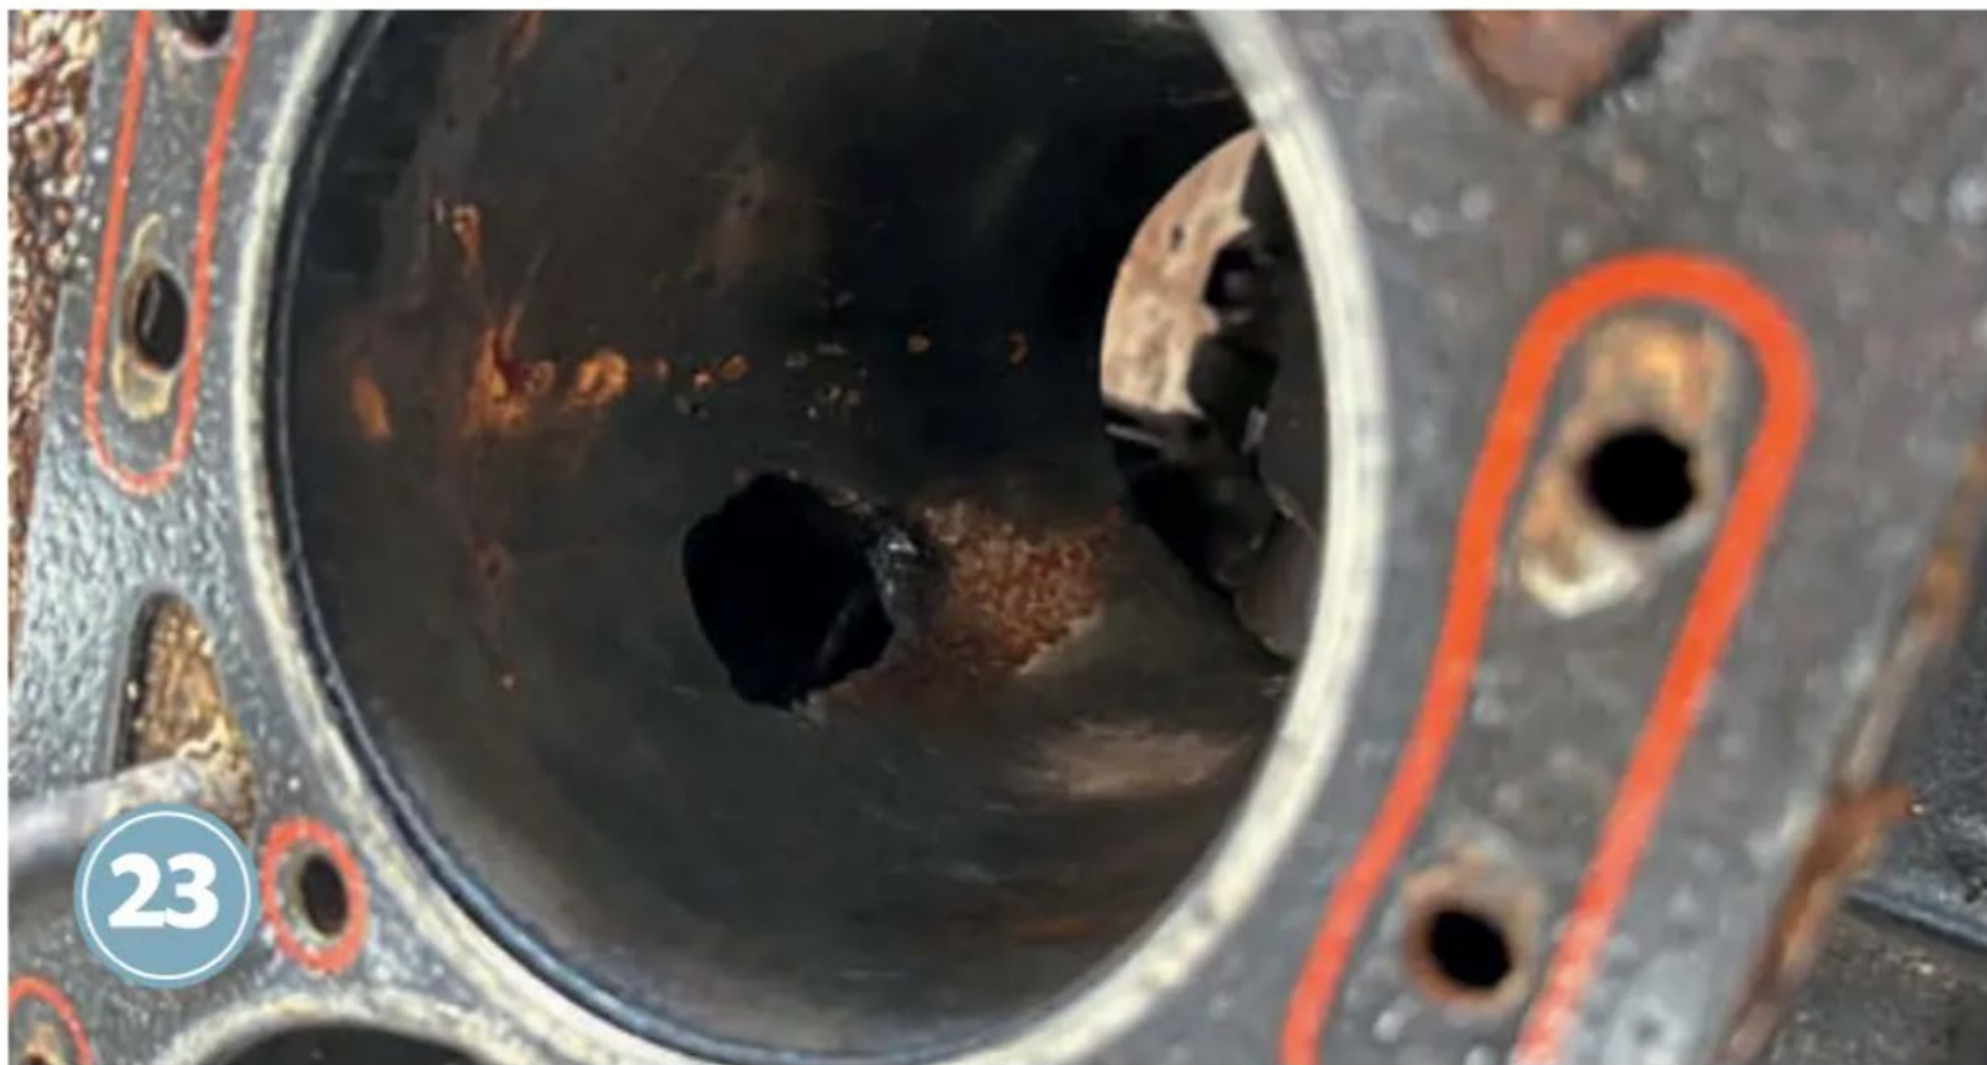
After removing the piston from cylinder number four, we can see why the coolant had escaped – there's a large hole in the wall of the cylinder, which goes through to the coolant chamber

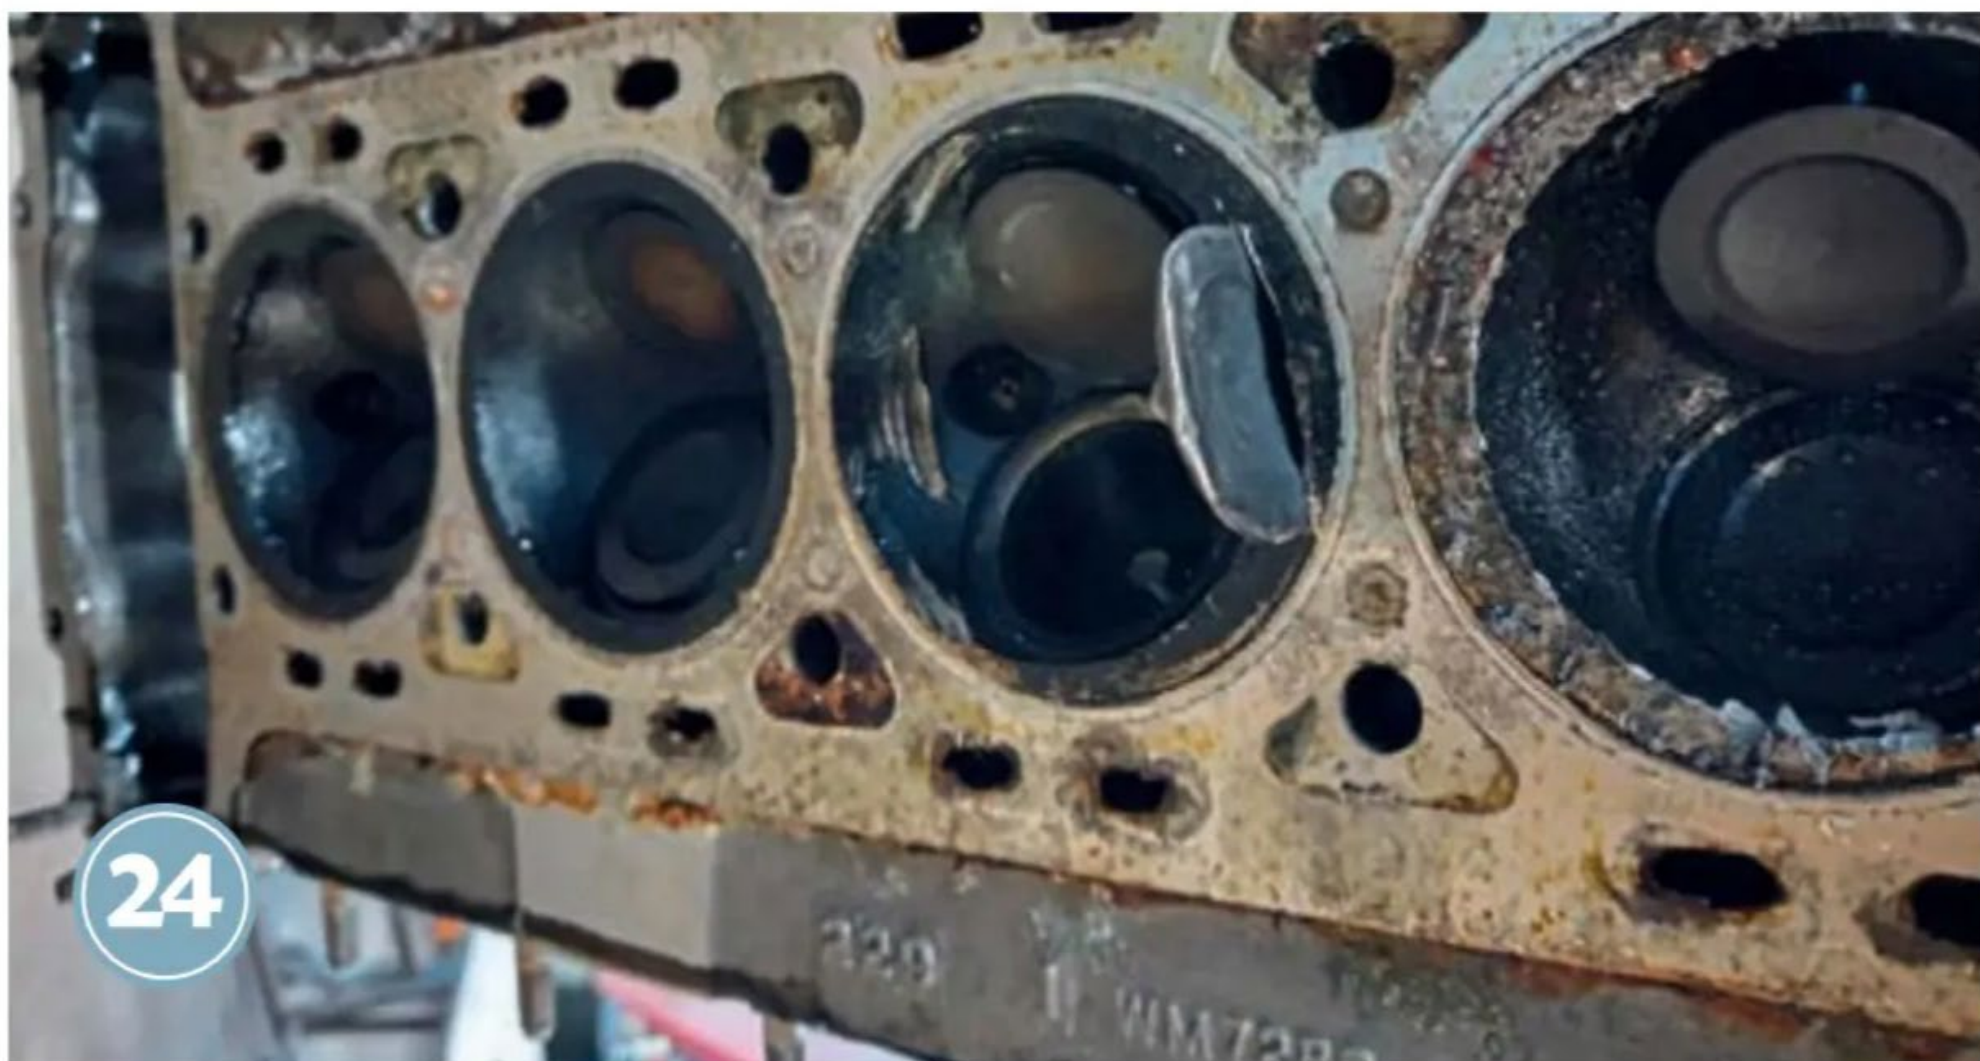
And as for the missing valve in cylinder number four, we discover the remains of it are lodged into the combustion chamber. The impact of the piston has done this, resulting in the damage to it
